Visual Property Inspection

89 Walpole Ave
Toronto, ON M4L 2J2

Date: 20-Aug-2015

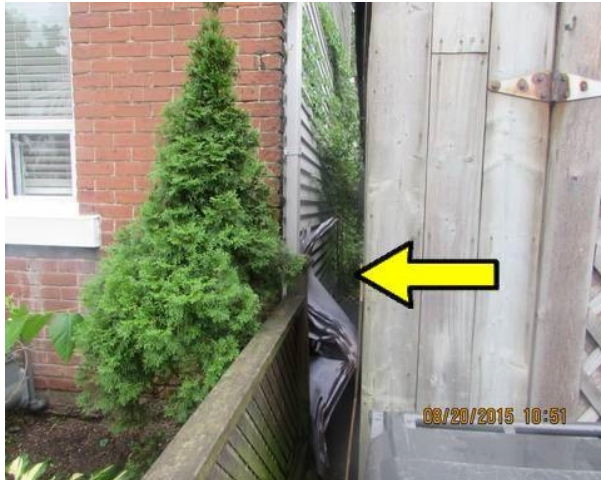
No access to west wall to inspect condition of foundation or lower siding.

No access to west wall. Foundation not visible here.

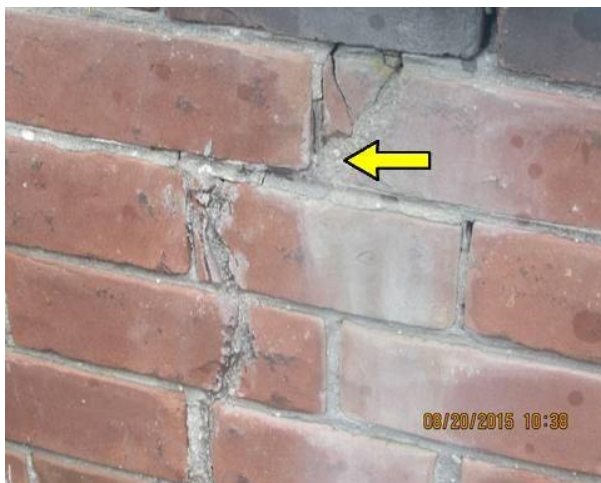
Settlement crack under front window

Settlement crack noted under window on north wall. Fill and seal as required to prevent water and insect penetration.

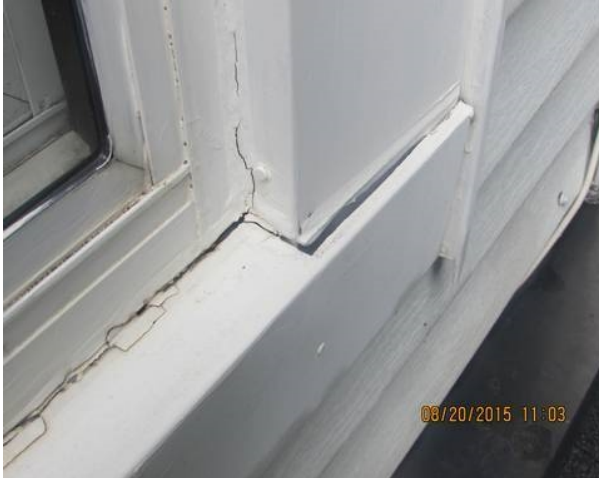
Caulk and seal around windows

Ensure proper caulking and weather seal at all required locations and junctions such as windows, doors, dissimilar materials junctions, etc.

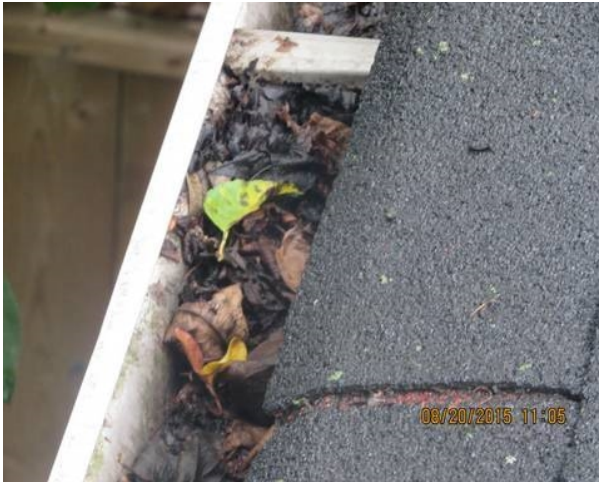
Gutters filled with debris

Clean and maintain leaf debris to promote unrestricted flow away from structure

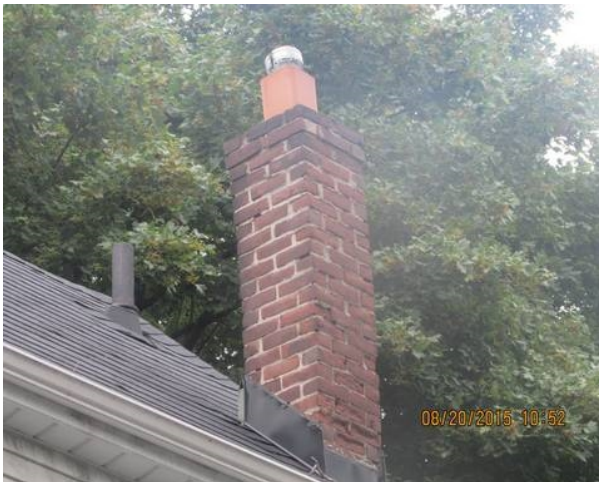
Leaning chimney

Consult a structural contractor to provide methods of chimney restoration to reduce further leaning/movement and potential risk of collapse.

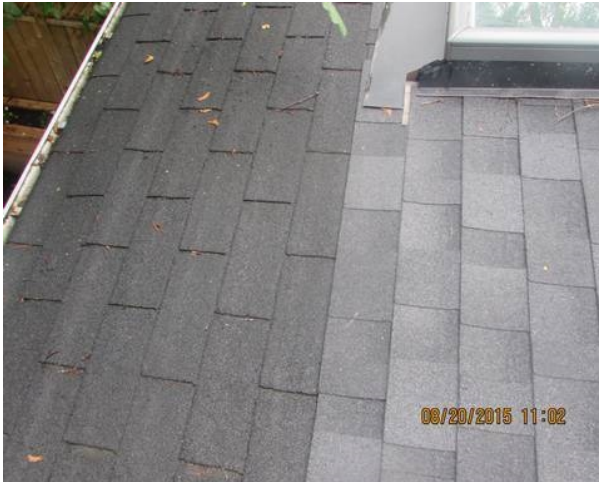
Deteriorating shingles over kitchen

Budget to replace shingles on back extension over kitchen . Shingle material has exceeded typical life expectancy.

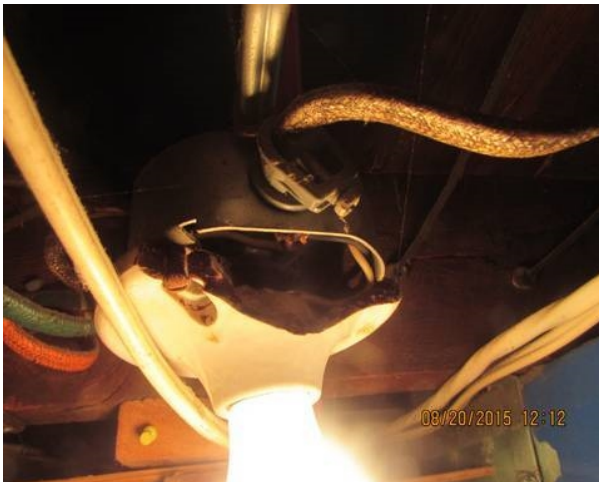
Broken light cover and exposed wires

Replace broken lamp cover to prevent shock and injury from exposed electrical wires.

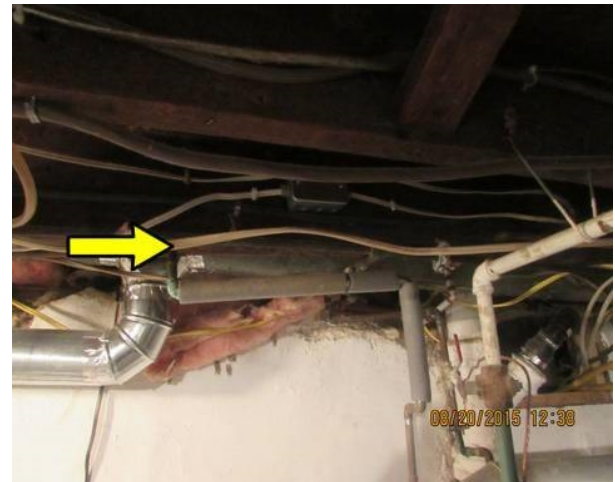
Secure loose wires

Secure all wires to reduce safety hazards.

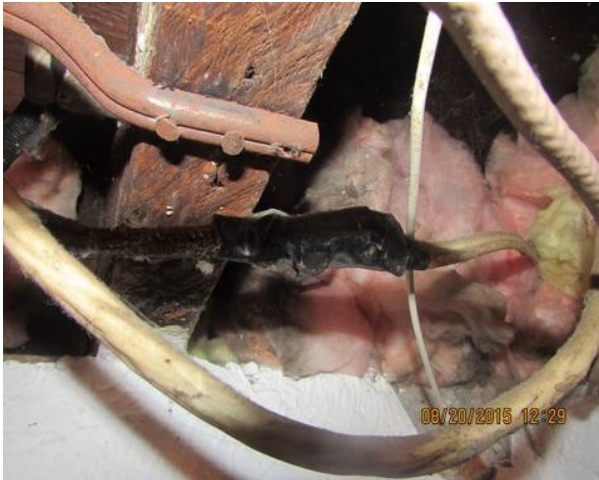
Spliced connections should be inside a junction box.

Install additional junction points to reduce hazards associated with junction box/wire exceeding current capacity .

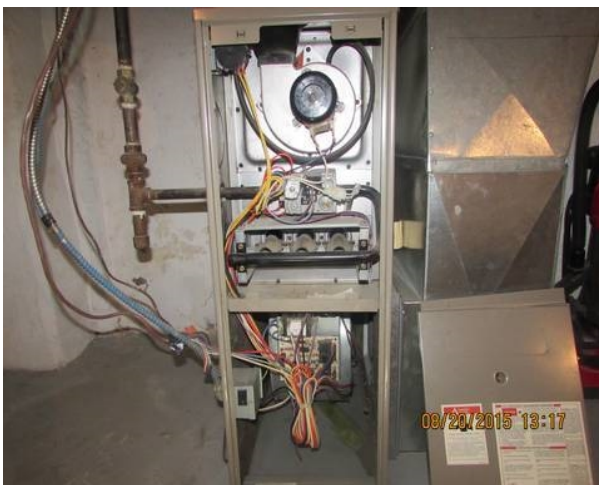
Life Expectancy Typical Middle Exceeded Middle/End*Mid efficiency furnace is 15 years old.*

Mid efficiency furnace
