Visual Property Inspection

3157 St. Clair Ave E
Toronto, ON M1L 1V5

Date: 14-Apr-2016

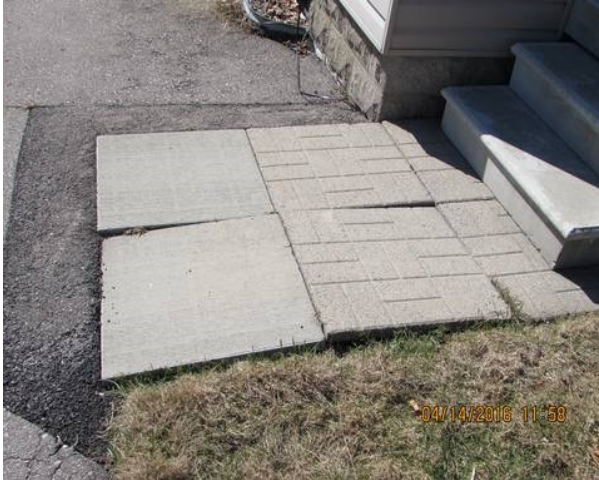
Walkway/Path

Uneven patio stones

Reset/replace steps to provide level treads and even rises to promote safe travel

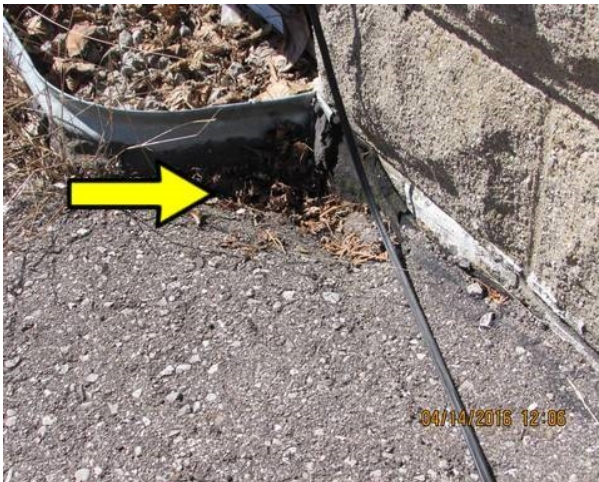
Foundation Wall

Grade slopes toward the foundation

Reslope perimeter grading to direct surface water away from structure to reduce wall deterioration potential water entry and subsequent damages .

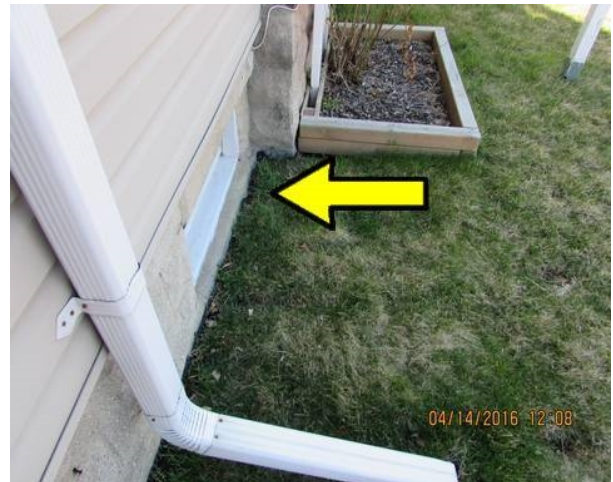
Grade slopes toward foundation

Regrade to slope away from structure to reduce foundation deterioration potential water entry and subsequent damages.

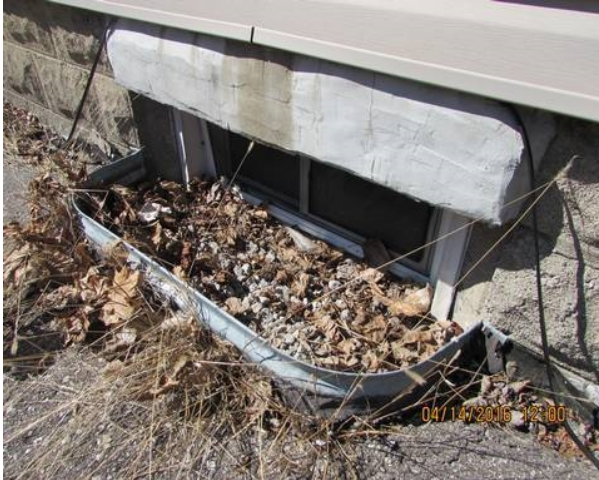
Window Well

Increase window well depth

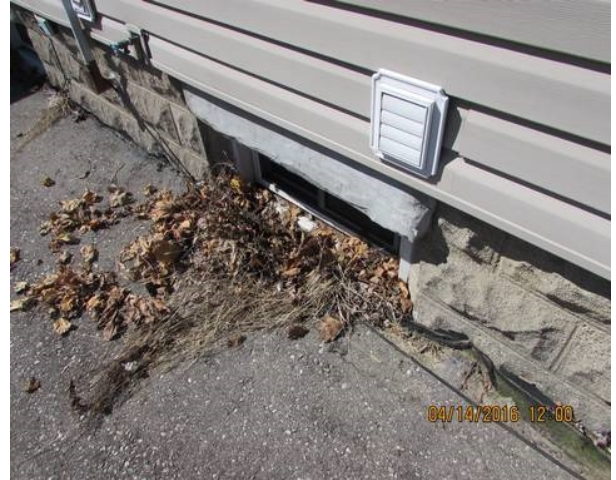
Basement window at grade

Add window wells to windows at grade to prevent water entry and related damages.

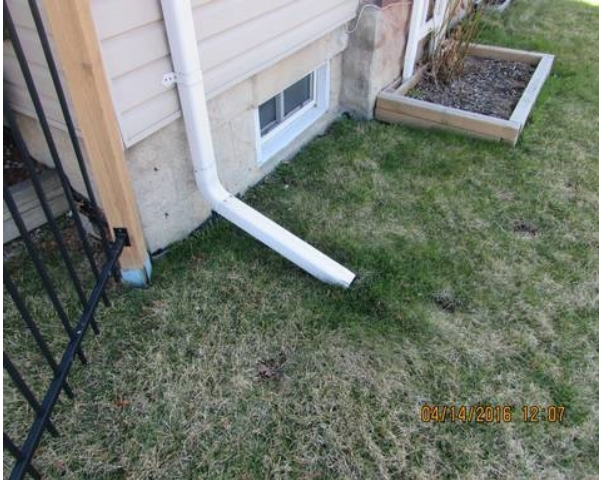
Gutter/Downspout

Downspout discharging to close to foundation

A downspout discharging too close to the foundation is the #1 reason for moisture in a basement. Ensure eaves are clean and clear and discharge six feet downhill.

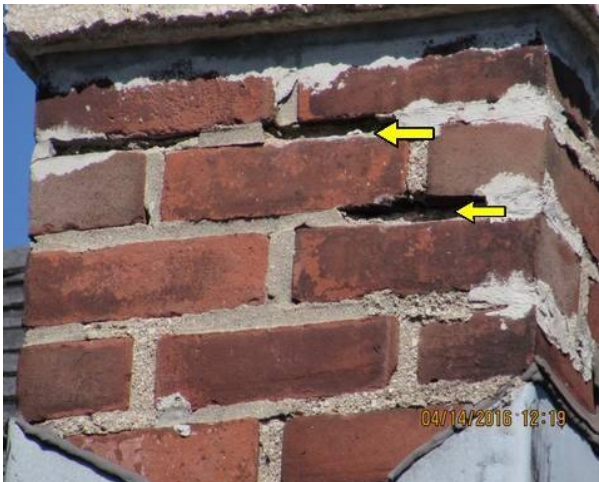
Chimney/Vent

Mortar deterioration at abandoned south chimney

Abandoned south chimney has some minor mortar deterioration. Repair to prevent further deterioration and possible water entry or remove as it is no longer in use.

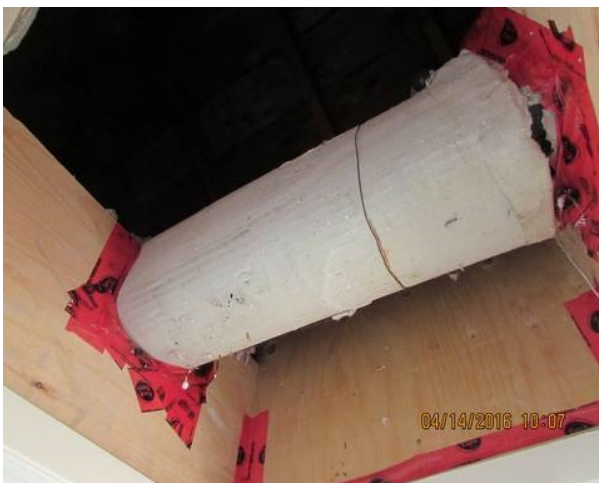
Insulation

Unknown material used for duct insulation

Ducts are wrapped in insulation. The material type is not known and further testing is recommended.

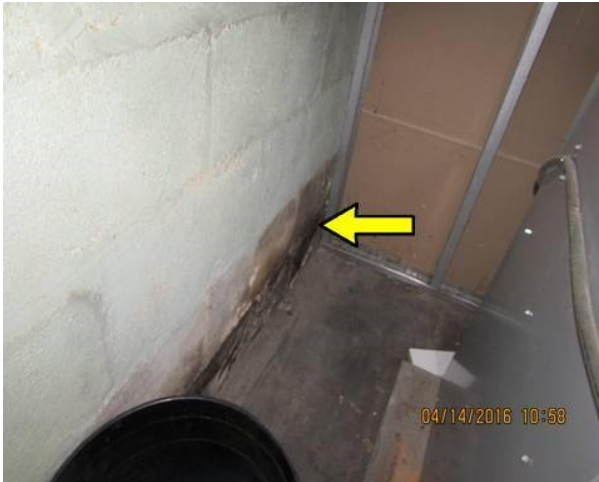
Wall

Staining on wall behind furnace

Monitor staining on wall and floor behind furnace and correct as required. Dry at time of inspection.

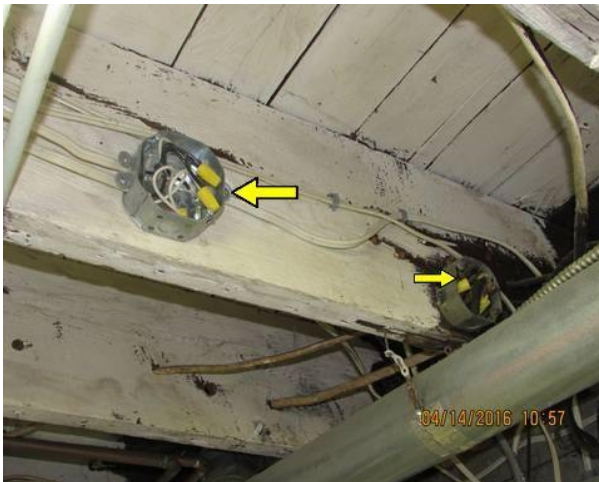
Missing covers on junction boxes

Consult qualified electrician to correct various safety hazards incomplete/incorrect connections noted. A partial list is as follows:

- Replace defective GFCI receptacle on the exterior
- Install covers on all junction boxes and switch boxes
- Install a ground clamp at the water main
- Terminate or remove exposed wire
- Secure loose wires

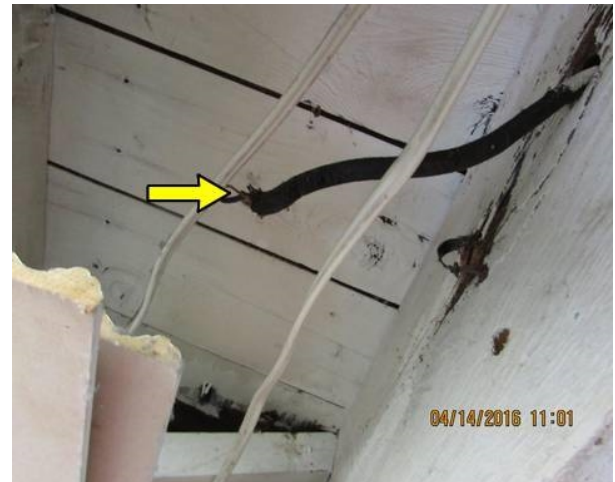
Unterminated and exposed electrical wire

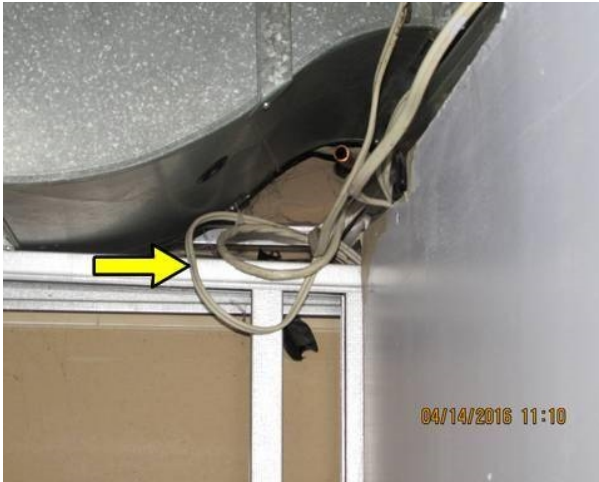
Unsecured wire

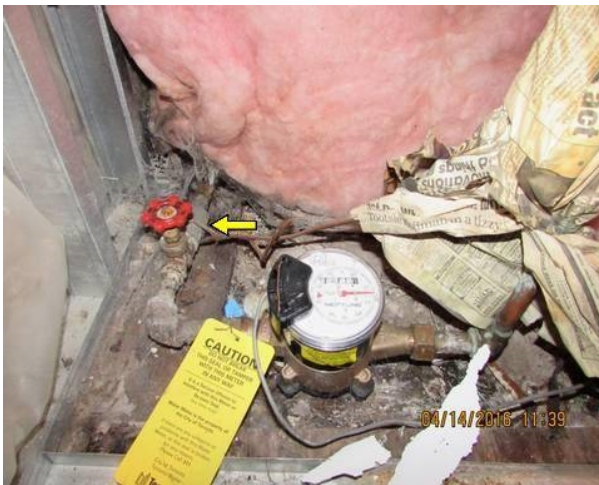
Missing ground clamp

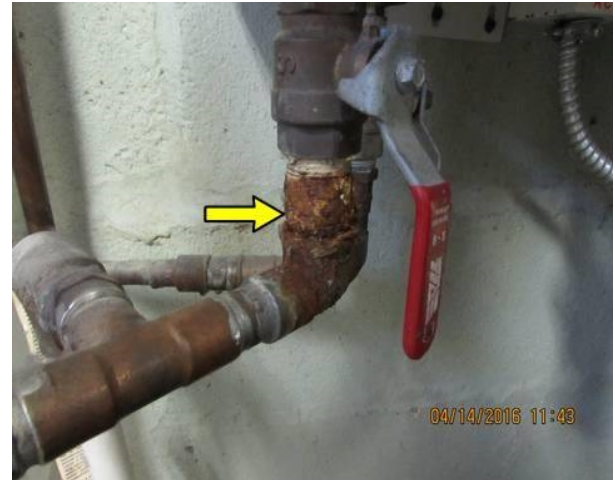
Corrosion on water line

Install a dielectric fitting on the hot water outlet to prevent further corrosion of the copper pipe to prevent eventual failure and water damage.

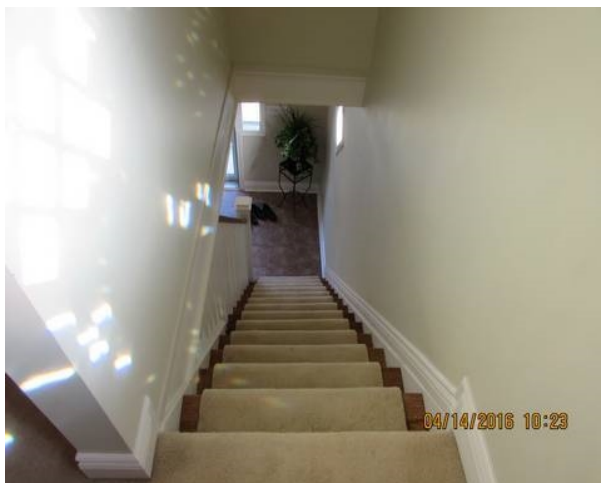
Railing

Incomplete hand rail
