HOME INSPECTION REPORT

109 Riverdale Ave
Toronto

Prepared by: Bob Papadopoulos P.Eng., RHI *

Inspection Date: June 17 2015

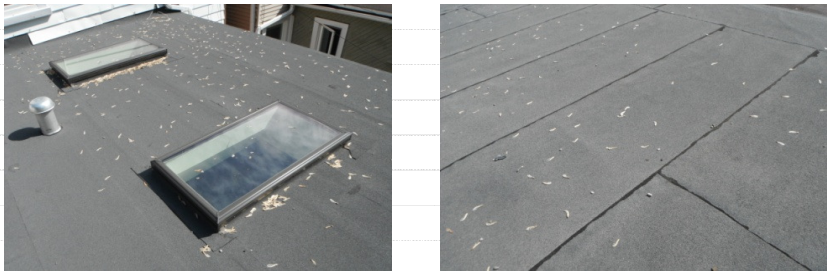
Description				
1.0 Roofing Material:	Location:	4.0 Leakage Probability:	3.0 Chimney(s) Type:	Location:
Modified Bitumen:	Flat:	Low	Brick Shared:	South
Asphalt Shingles:	Porch(s):			
Slate	Bay:			
Limitations				
Roof Inspected By:	Access Limited By:	Chimney Access Limited By:		
Walking On				
Ref#*	Observations/Recommendations			
	1.0 Roofing:			
	Flat Surface: overall surface in good repair, surface is loose in some areas though seams are intact - monitor, skylight in good repair

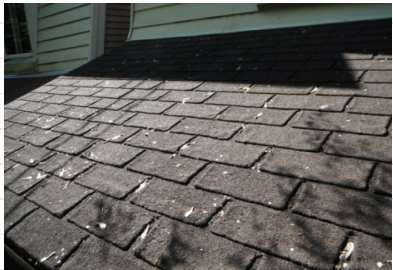
Bay(s): older slate though overall surface in good repair - monitor and repair as required			
	Porch(s): older surface - replace within 1-year

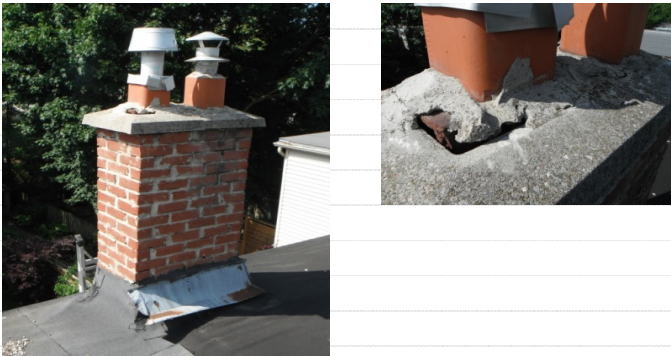
3.0 Chimney(s): rebuilt, requires minor repair at top - seal gaps

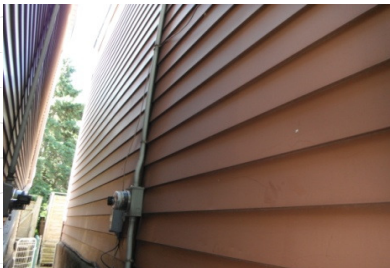
Description			
1.0 Gutters & Downspouts: Aluminum:	Downspout(s) Discharge: Below/Above Grade	2.0 Lot Topography: Flat Away From House	3.0 Walls & 9.0 Wall Structures: Brick Metal Siding Hardboard
Limitations			
Exterior Inspection from Ground Level Restricted Access Under Porch(es)		Restricted Access Under Deck(s)	
Ref#	Observations/Recommendations		
	<p>**1.0 Gutters/Downspouts: require repairs at front porch</p> <p>Soffit & Facia: requires repairs at front porch, maintenance at rear of house upper area</p> <p>3.0 WALL SURFACES: overall well maintained, newer surfaces at rear part of house</p>

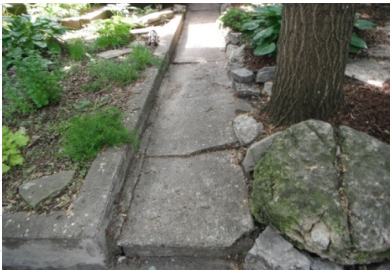
<p>4.0 DOORS/WINDOWS: overall in good repair, basement units - require miner finish around frame</p> <p>5.0 PORCH overall in good repair, provide hand rail</p> <p>5.0 DECK overall in good repair, provide hand rail</p> <p>**7.0 Walk(s): uneven - trip hazard at front area</p>

<p>Note: Maintain Gutters & Downspouts annually. Extend Downspouts at least 6-feet away from the house</p> <p>** Any or all these items may contribute to Basement Leakage. Please see Interior Form</p>

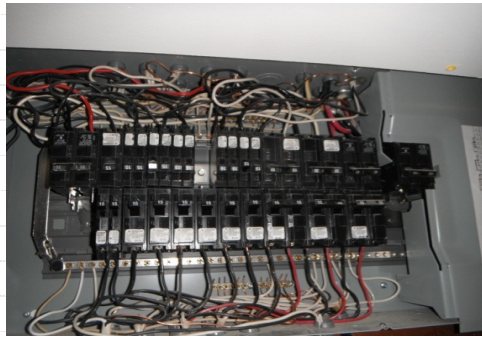
3.0 SERVICE PANEL: **upgraded panel**
