Visual Property Inspection

102 Knox Ave
Toronto, ON M4L 2P2

Report Commentary

Date: 16-Oct-2015

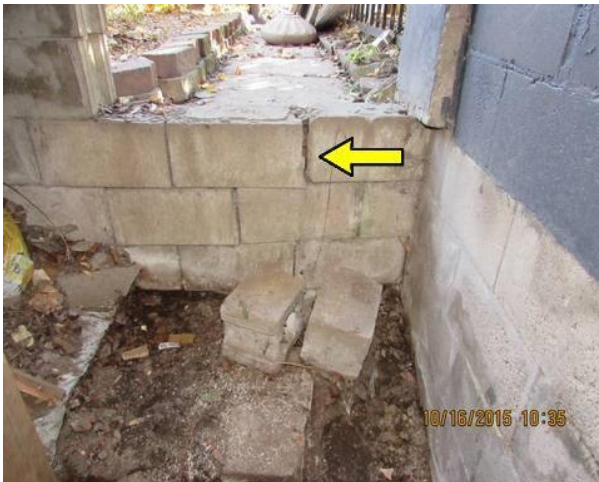
Front Porch

Wall is leaning slightly.

Consult a qualified contractor to repair retaining wall to reduce further movement/leaning and potential safety hazards.

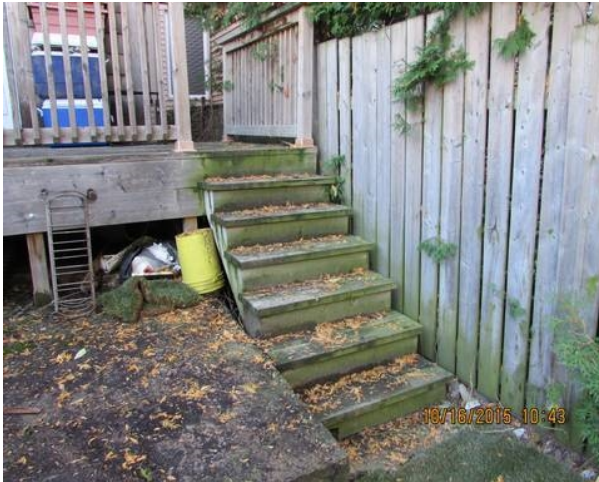
Deck Railing

Missing handrail

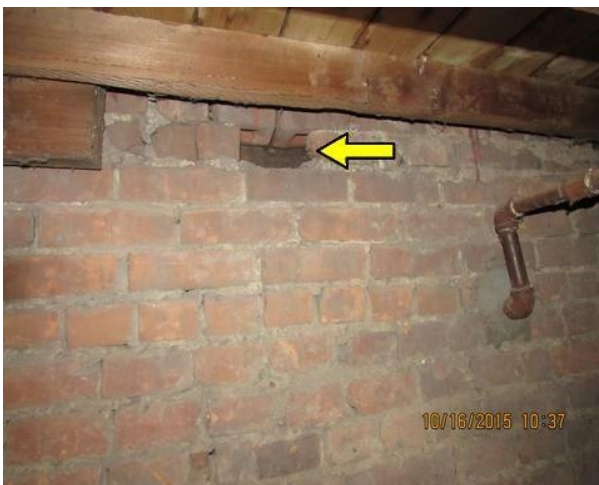
missing brick under porch

Replace missing brick under porch to prevent pest entry and related damages.

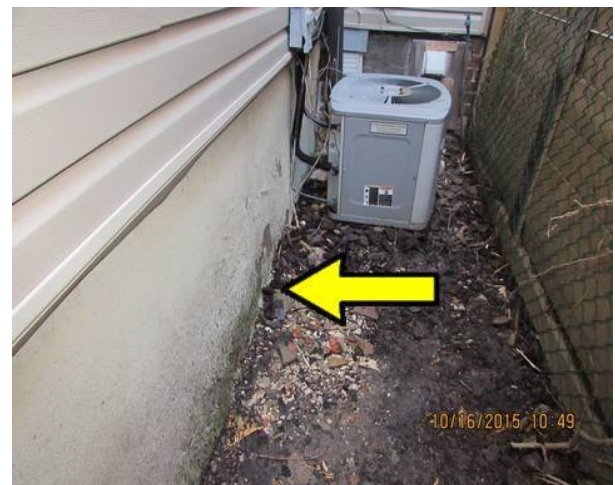
Improve grading and repara foundation in this area

Reslope perimeter grading to direct surface water away from structure to reduce wall deterioration, water entry and subsequent damages .

Repare and seal foundation to reduce potential water entry and subsequent damages

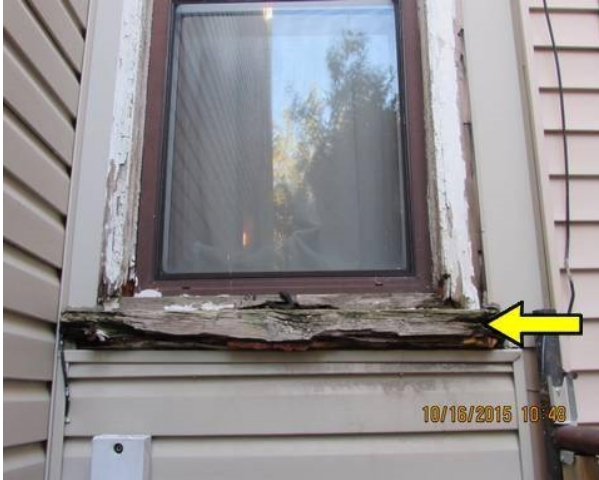
Window Exterior

Rotted window frames

Replace rotten sections of window sill/framework to reduce continued deterioration potentially effecting sound areas.

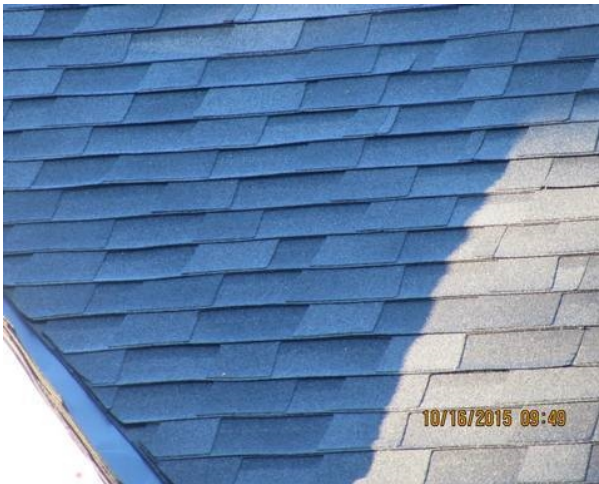
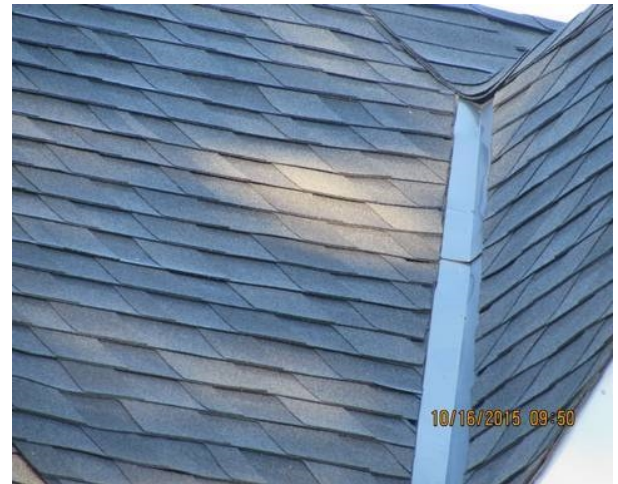
Main Roof

Roof covering is in good condition.

Roof covering

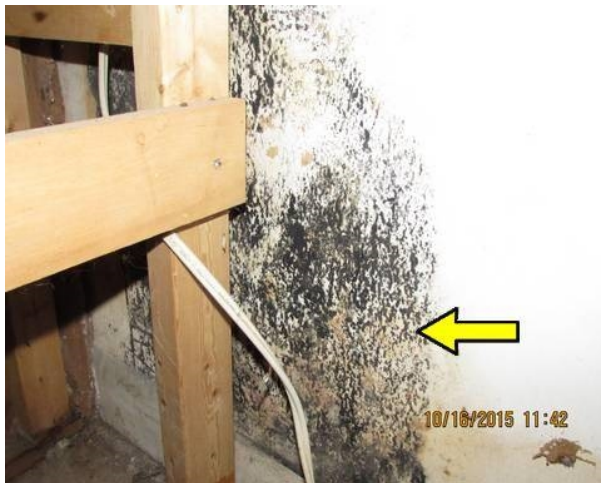
Wall

Staining found on basement wall. Further testing recommended to determine if mould exists in this area.

Staining on basement wall

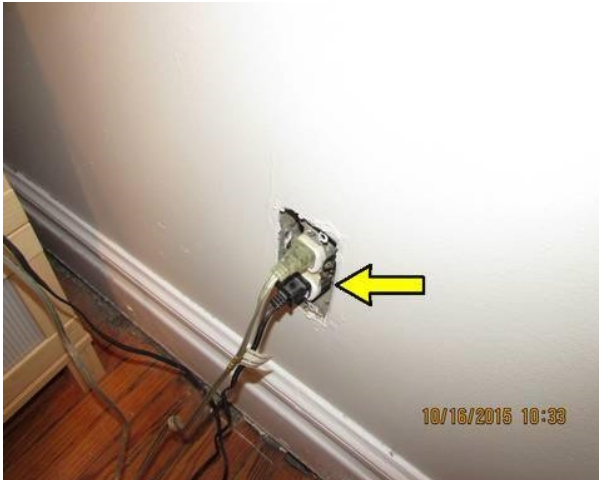
Missing cover plates

Install cover plates on receptacles to prevent hazards from exposed wires.

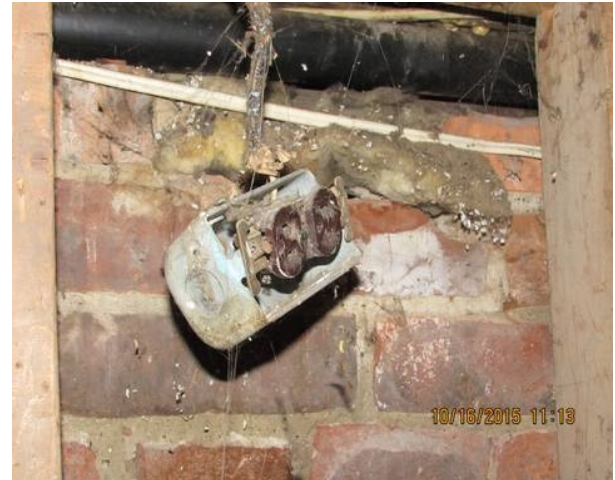
Electrical outlet hanging from the ceiling

Secure light fixture and outlet boxes in basement to reduce stress on wires and cover exposed wires.

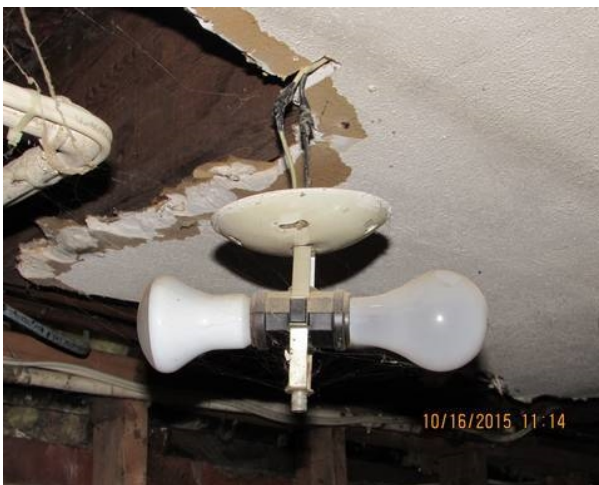
Light fixture not secured

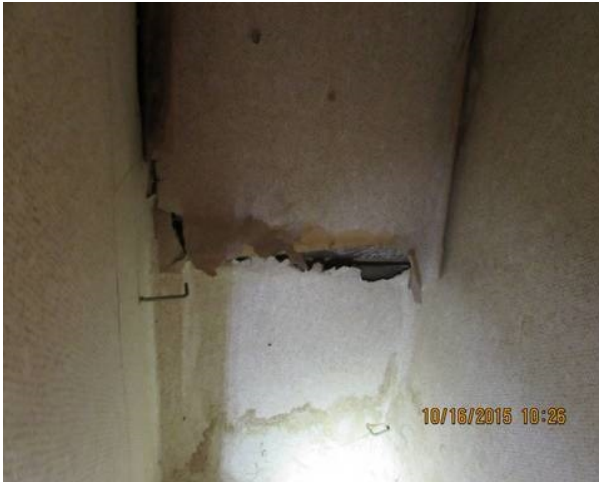
Ceiling

Monitor staining inside closet. Tested dry with a moisture meter at time of inspection.

Damage found inside bedroom closet
