HOME INSPECTION REPORT

159 Oakcrest Ave

Toronto

Inspection Date: Oct 6 2015

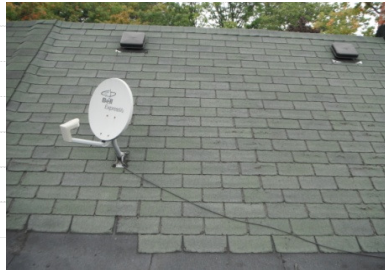
Sloped Surface: [cracking/curling, aging surface, budget to replace within 3-yrs.](#)
[more worn on south side](#)

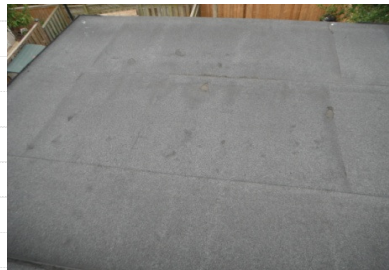
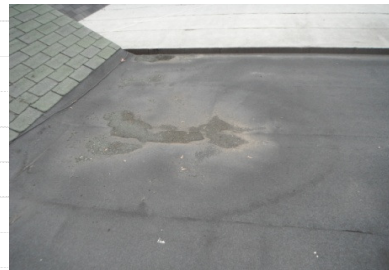
Flat Surface: [overall surface in good repair, ponding in some areas](#)

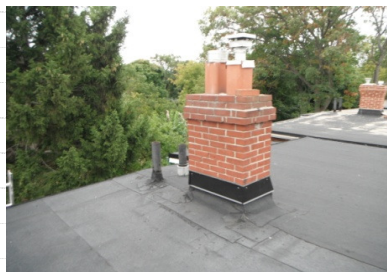
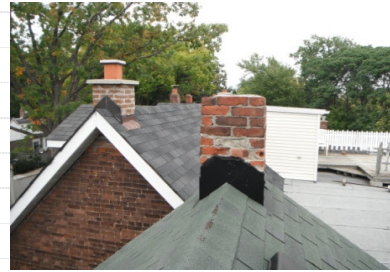
Chimney(s): [not in use though overall well maintained](#)

[Note: Recommend Annual Maintenance Contract for Roof Surface, Flashing Details and Chimney\(s\)](#)

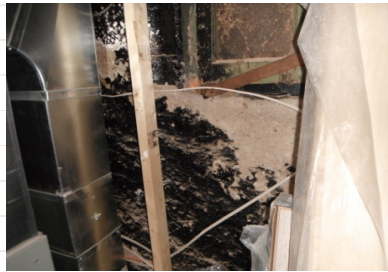
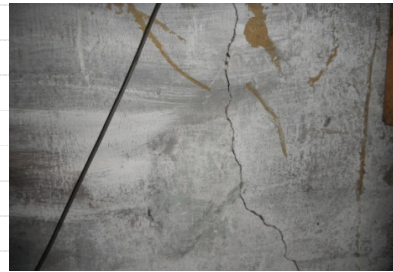
FOUNDATIONS: prior surface spalling - older condition
crack - appears to be typical settlement crack

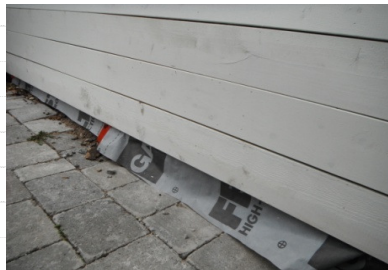
FLOORS/WALLS exterior rear extension: wood components near or at grade prone
to moisture damage - should be sealed to below grade

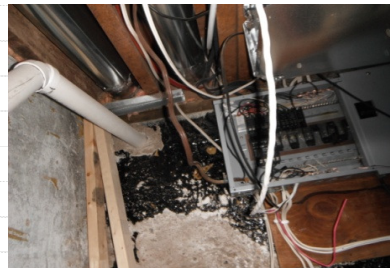
SERVICE PANEL: **loose wires around unit, incomplete work**

Note 1: All recommendations are safety issues - Treat them as high priority.

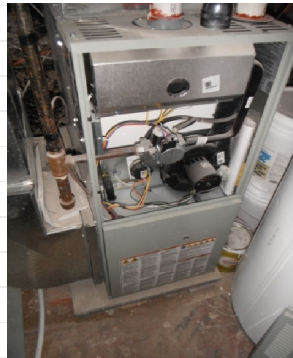
FORCED AIR FURNACE: service annually

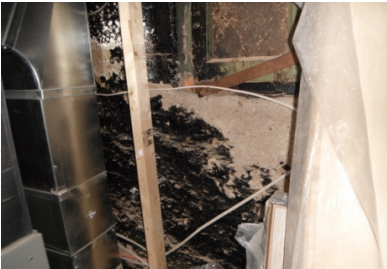
Ref#*	Observations/Recommendations
	Floors/Walls/Ceilings: recently renovated Trim/Cabinets/Counters: recently renovated
	Window(s): incomplete in upper levels, new in basement
	**Basement Leakage: furnace room: sealant has been added to interior of foundation wall likely to minimize moisture, overall appears to be older condition

** Steps recommended in order to minimize basement leakage

1. gutters, downspouts, grading, driveways: [ongoing maintenance and repair/see Exterior](#)
2. cracks/form ties on foundation: [monitor/repair as required](#)
3. excavation/damp-proofing: [monitor basement, consider step 3 as a last resort should leaking persist](#)
