HOME INSPECTION REPORT

242 Milan St

Toronto

Inspection Date: Oct 23 2015

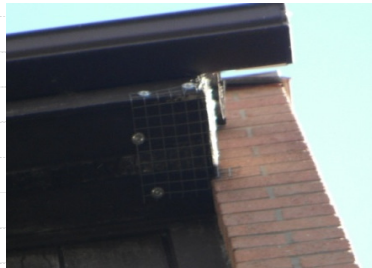
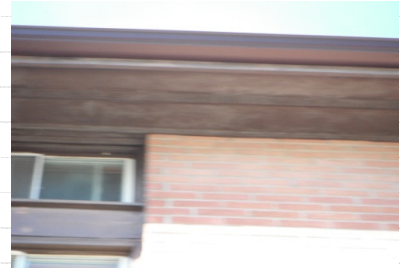
Wood siding: requires general repairs and maintenance, water damage at under side front under garage opening - requires repairs

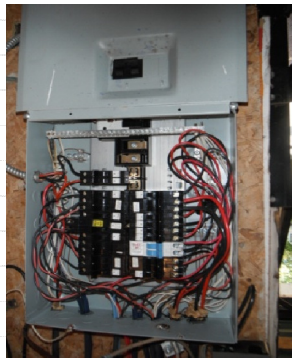
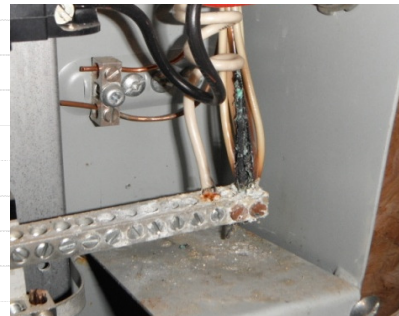
SERVICE PANEL: overall in good repair, corroded component and overheating wiring requires repair
