## Visual Property Inspection

62 Kerr Rd  
Toronto, ON M4L 1K5

# Report Commentary

Date: 24-Jan-2016

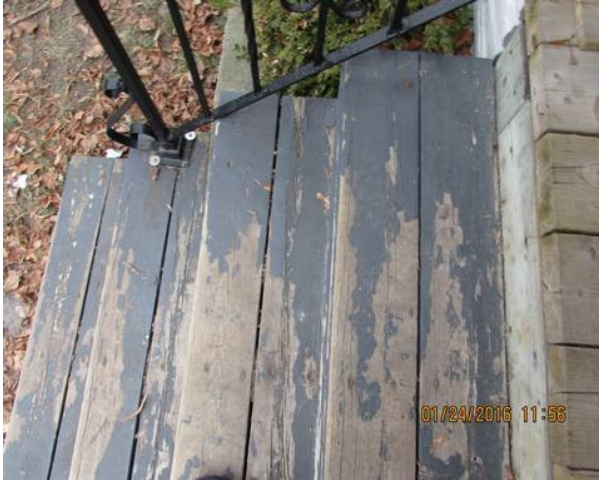
**Front Porch**

Steps are showing their age and should be sealed to prolong their age. Replace as necessary.

Peeling paint at porch steps

Paint/seal and maintain porch to promote intended weathering protection.

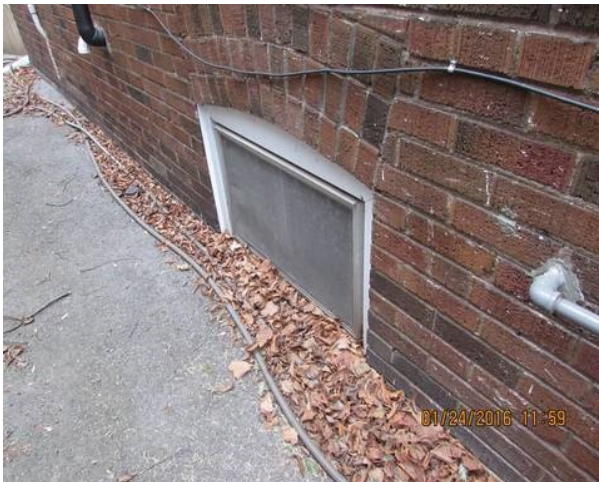
**Window Well**

Windows at grade

*Window wells should be added to promote intended drainage away from structure.*

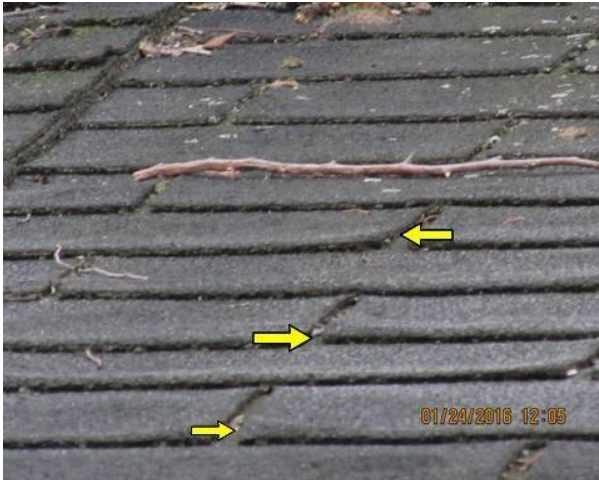
### Main Roof

*Shingles are just starting to curl. Anticipate replacement in the next two to three years. Inspect annually and replace as necessary.*

Shingles starting to show signs of wear.

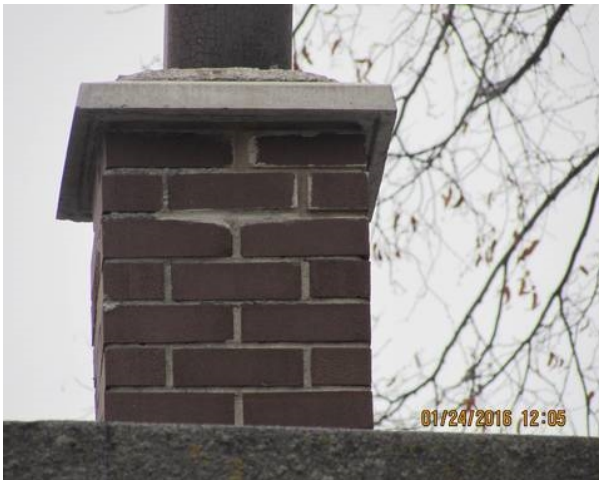
### Chimney/Vent

Abandoned chimney. Brick is in good condition.

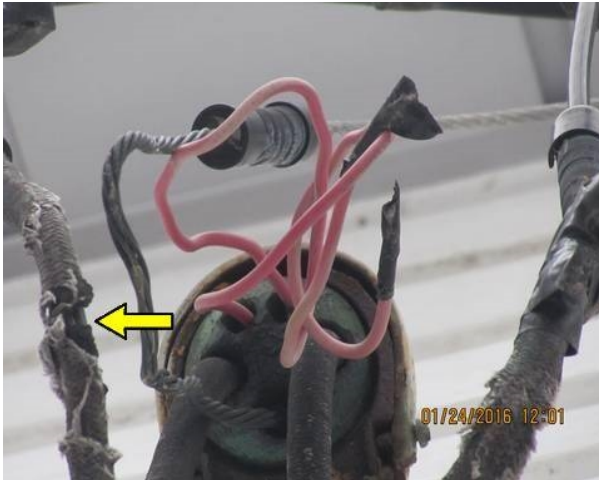
**Entrance Cable**

Deteriorated sheathing on entrance cable.

*Consult utility to further investigate damaged sheathing and exposed connections at mast to ensure safety.*

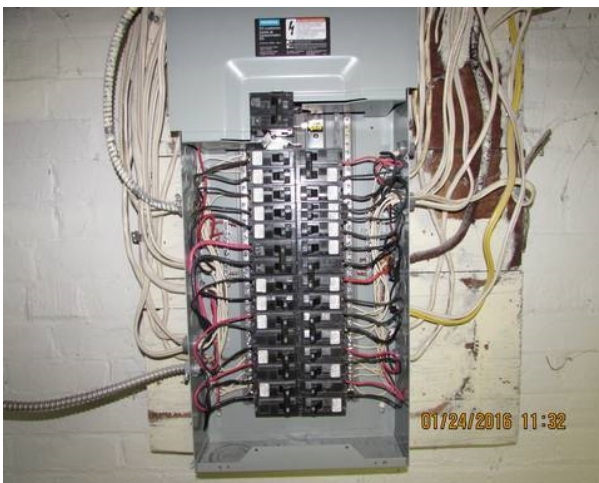
**Distribution Panel**

Electrical panel. 100 Amp service

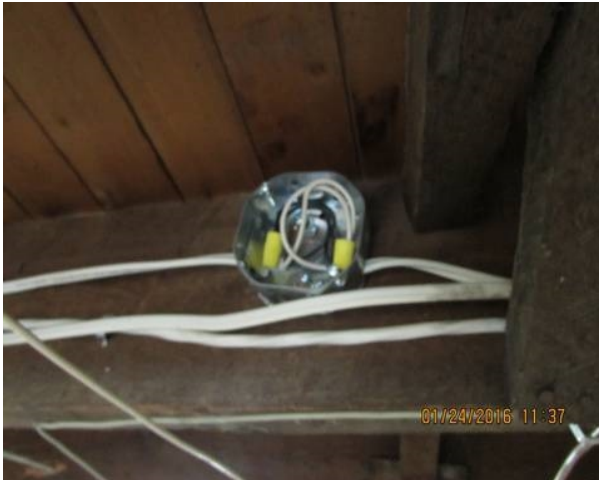
Missing cover on junction box

*-Install covers on junction boxes to prevent hazards from exposed wires.*

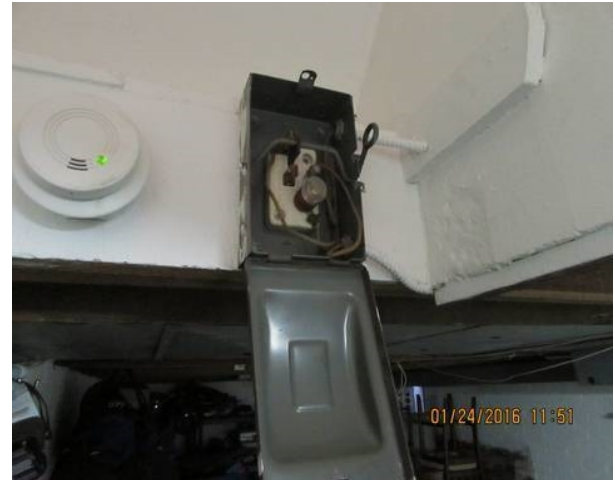
Obsolete glass fuse breaker panel used for furnace.

*-Replace obsolete glass fuse disconnect for furnace. Replacement parts are difficult to obtain.*

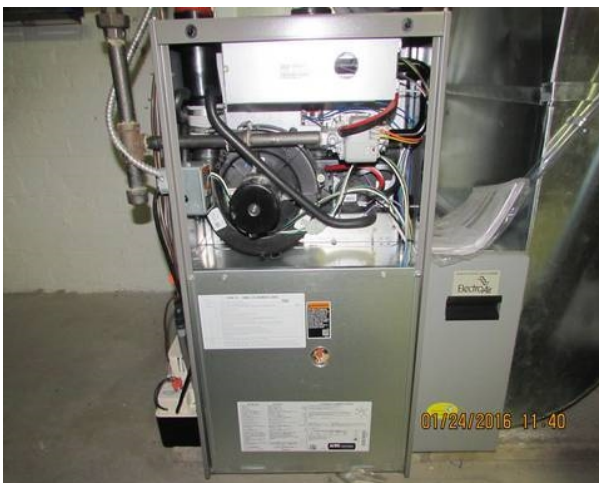
**Heating System**

High efficiency furnace is less than 1 year old and functioning as intended. Typical life expectancy is 20 years.

High efficiency furnace

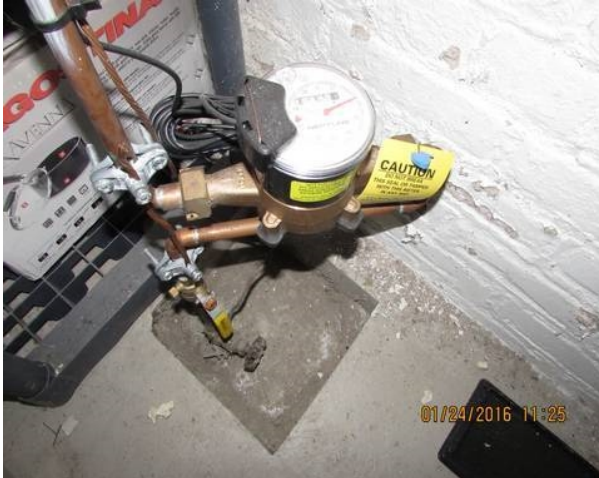
**Public Supply**

Water meter and main shut off. Lead supply.

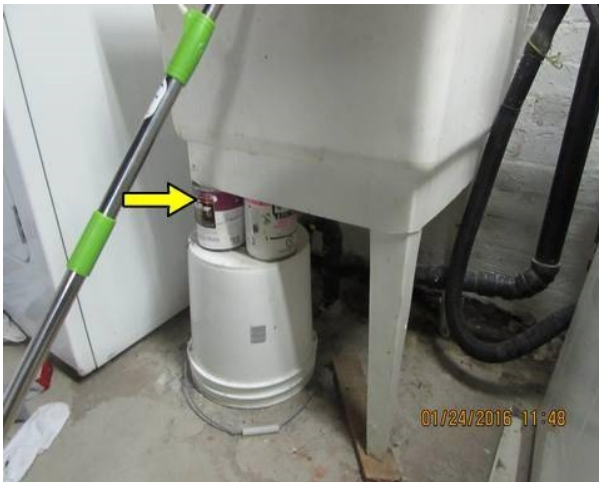
**Tub/Faucet**

Damaged laundry tub. Leg missing.

*Budget to replace damaged laundry tub to prevent stress on plumbing.*

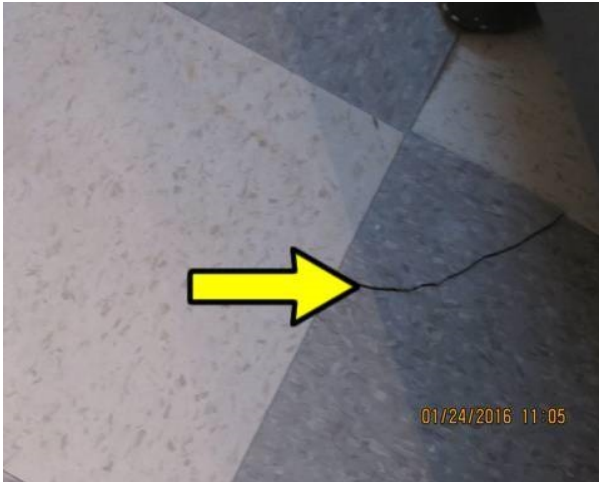
**Floor**

Cracked floor

Repair or replace flooring wear cracked to prevent water entry and related damages.
