**Visual Property Inspection**

15 Sidney St.  
Toronto, ON M4V 2G3

# Report Commentary

Date: 17-Feb-2016

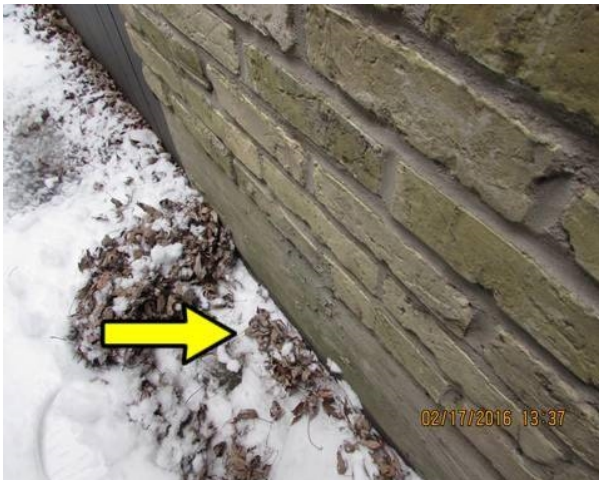
Grade slopes toward building here. North east corner

Improve grading at north and south sides of the building to slope away from structure to reduce foundation deterioration and potential water entry into home.

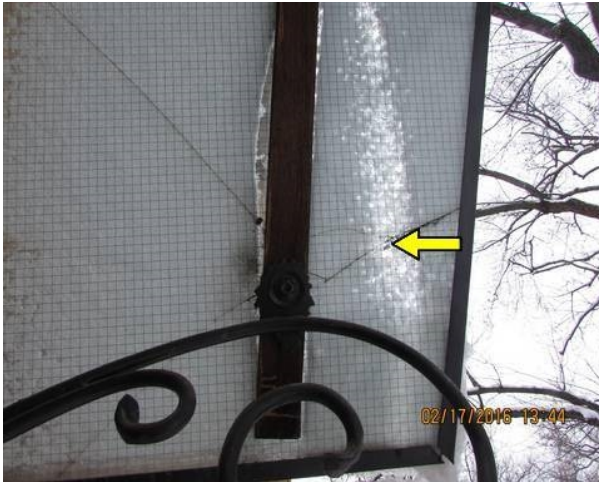
Cracked glass above porch

Monitor cracked glass over the porch and replace as necessary.

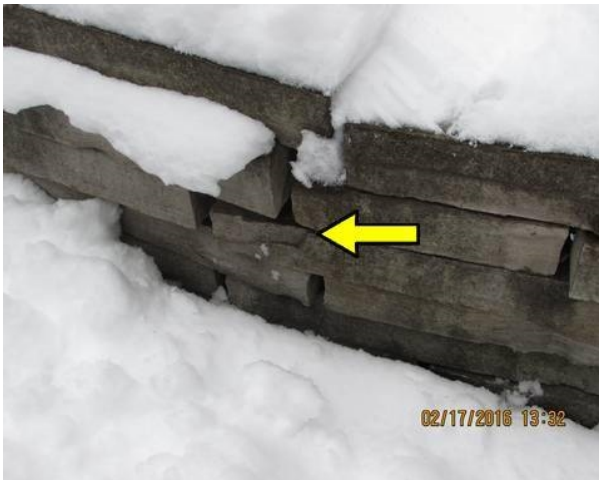
Retaining wall movement

Monitor retaining wall movement and correct as required to reduce potential safety hazards

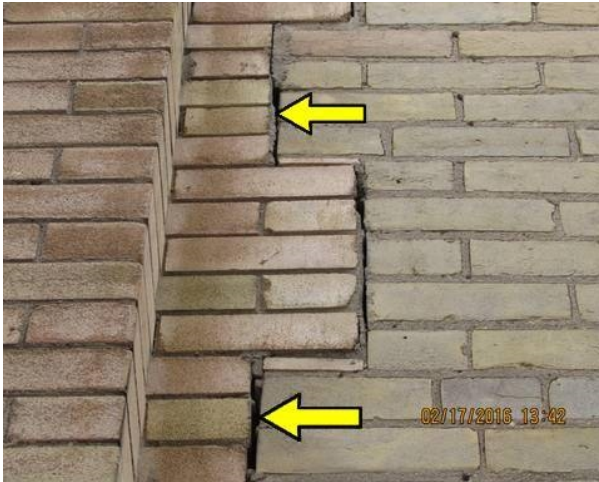
Settlement crack

Settlement cracks noted on North and South sides of the building should be filled and sealed and monitored to prevent water entry into home and subsequent damages.

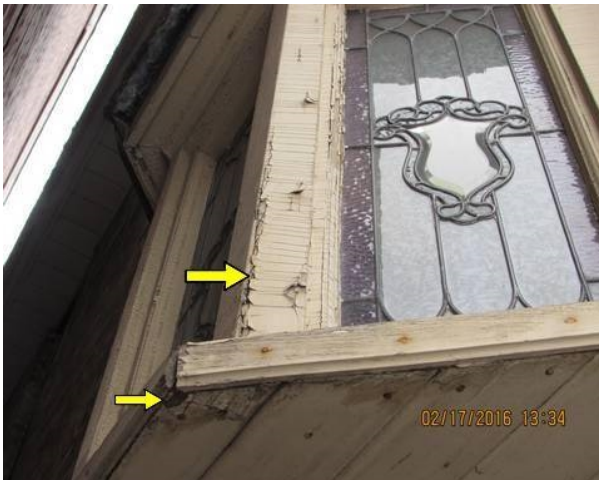
Deteriorating paint around window

Maintain wood windows/trim work to reduce deterioration

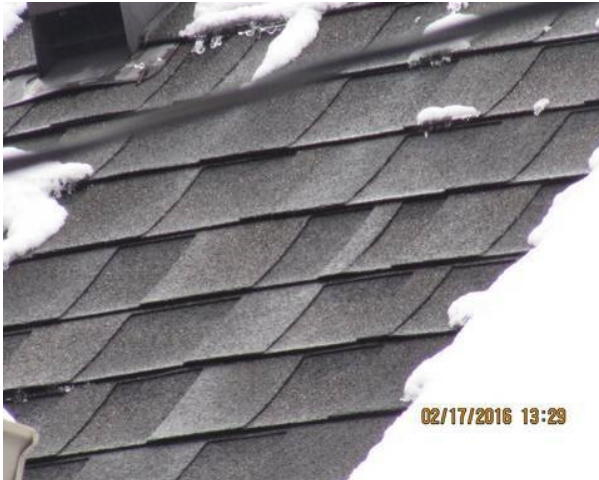
*Roof is snow covered at time of inspection however the roof was accessed from a skylight on the 3rd floor.  
The shingles are in good condition in this area.*

Roof covering

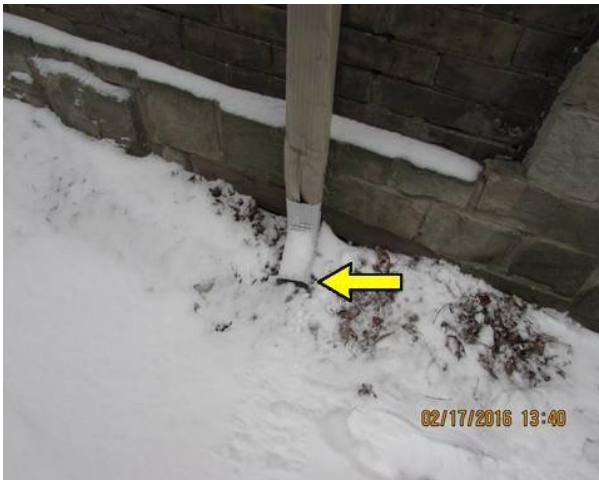
Downspout discharging to close to the foundation

Extend all downspouts away from foundation to reduce wall deterioration, potential water entry and subsequent damages.

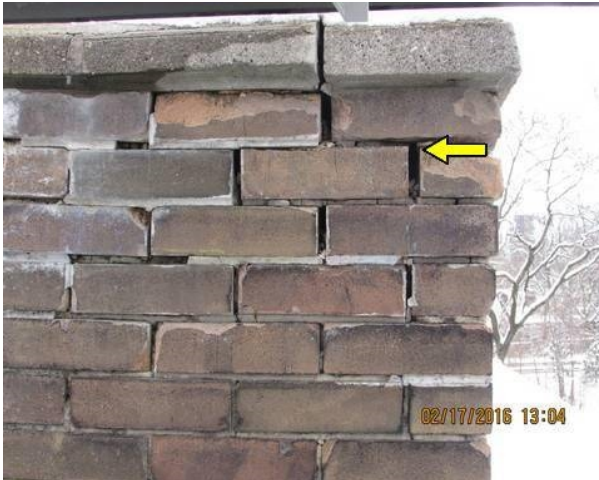
Mortar deterioration at south chimney

*Repoint and maintain brickwork on south chimney to reduce water penetration and damages due to freeze/thaw cycles.*

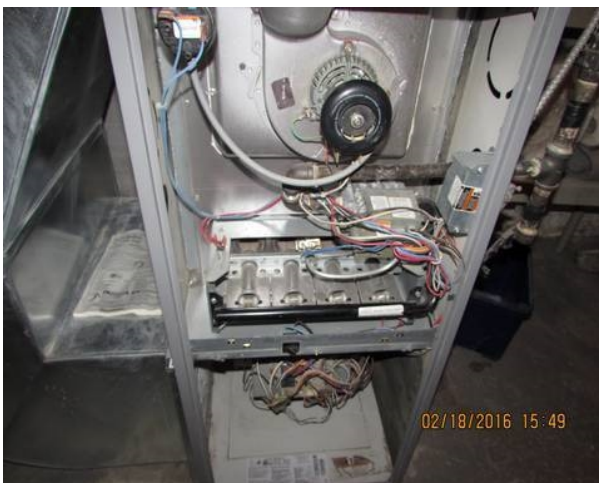
*Mid efficiency furnace is 12 years old and functioning as intended at time of inspection. Typical life expectancy is 20 years.*

Mid efficiency furnace

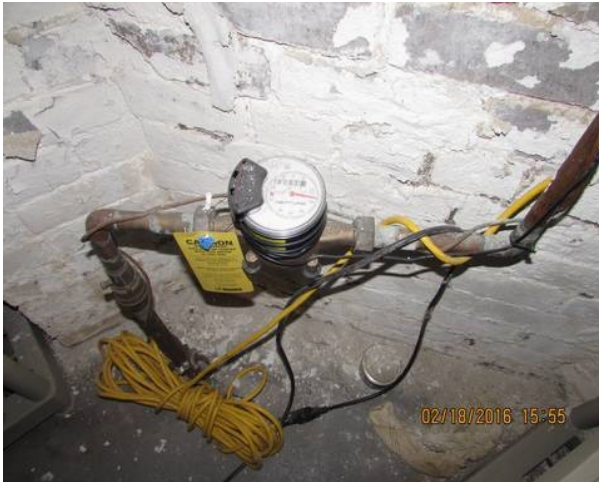
Copper water main, Main shut off and meter

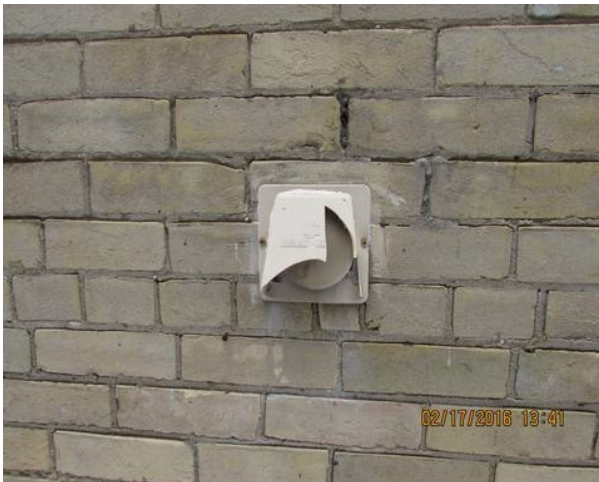
Broken dryer vent cover

Replace broken vent cover to discourage animal entry.

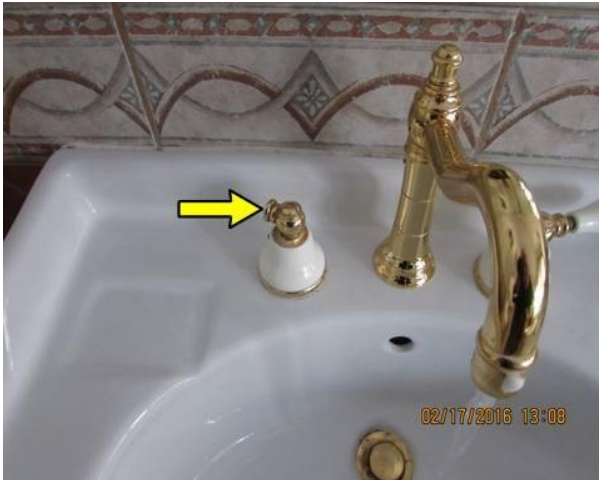
Missing handle for hot water

Replace faucet to promote ease of operation. Hot water handle is missing.
