Visual Property Inspection

8 Jersey Ave
Toronto, ON M6G 3A3

Date: 05-Feb-2016

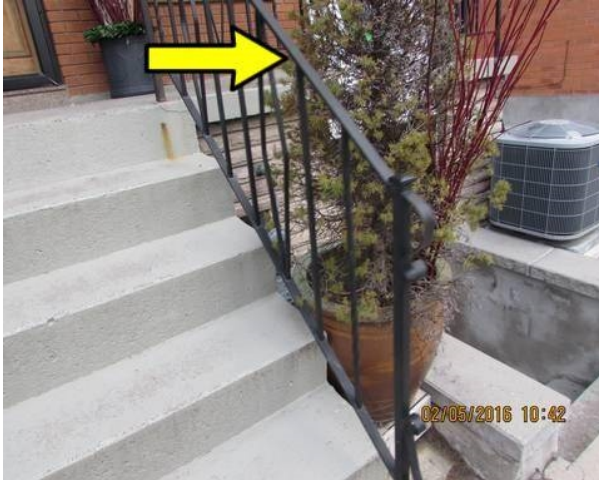
Front Porch Rail

Handrail is loose

Repair loose handrail to promote safety.

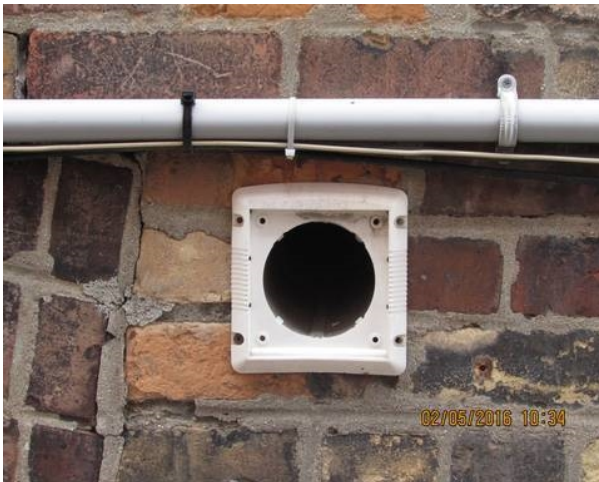
Exterior Walls

Missing vent cover

Install vent covers over open vents to prevent rodent entry and related damages.

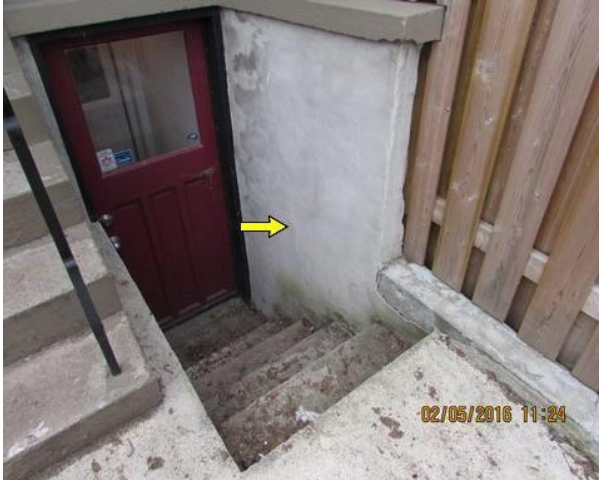
Basement Walkout

Add handrail here

Install handrail to promote safety.

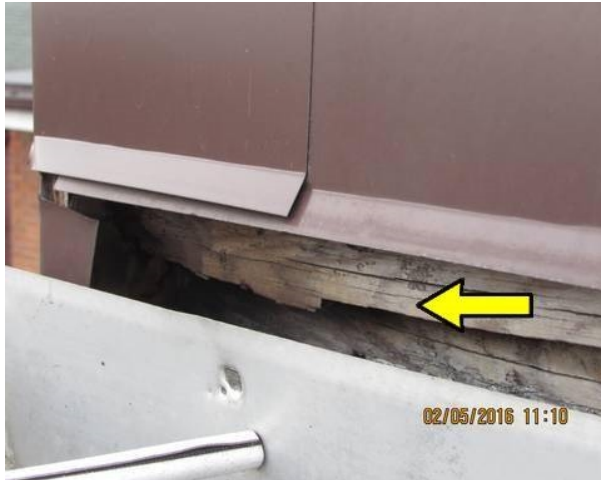
Fascia/Soffit

Rotted fascia board

Further investigate to determine extent of fascia rot and replace as required to reduce continued deterioration.

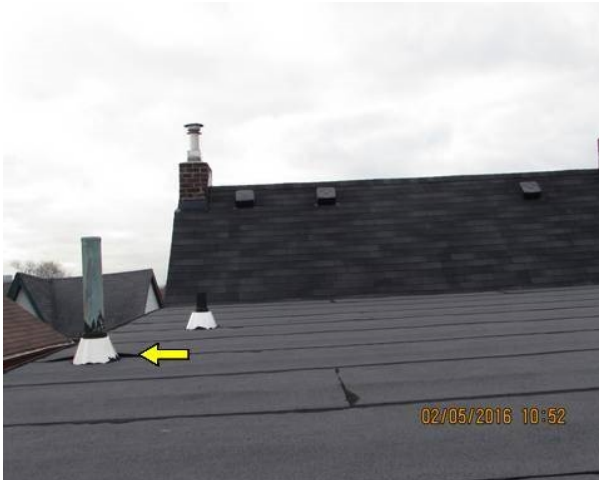
Sec. Roof Life Expectancy

Roofing material is not caulked

Repair membrane around plumbing stack to ensure water does not penetrate in this area

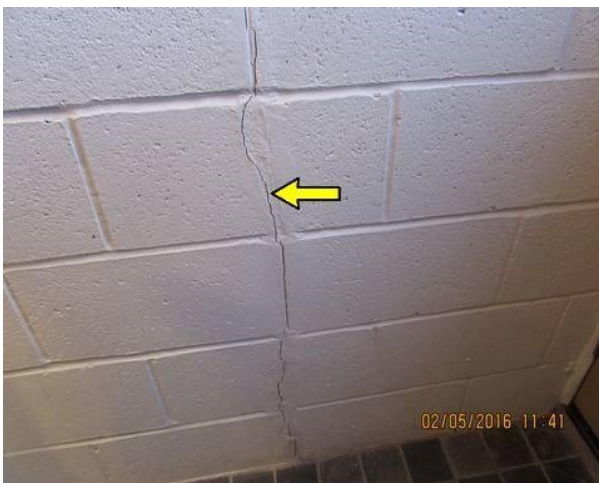
Wall

Settlement crack at basement walkout

Fill and seal cracks to reduce further separation and potential water entry .

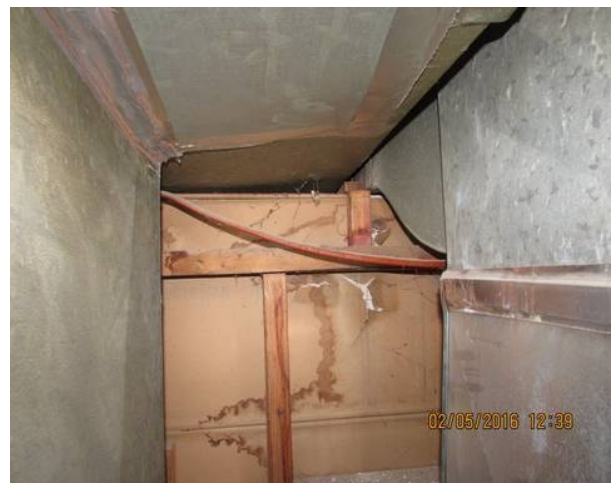
Water stains on drywall behind furnace

Monitor staining on drywall behind furnace. Tested dry at time of inspection.

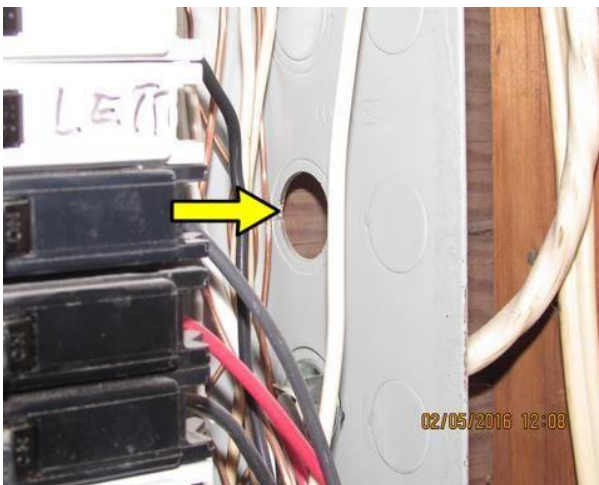
Distribution Panel

Missing grommet in electrical panel

Provide grommets or filler pieces at knockout locations to reduce hazards associated with accessible/exposed wiring

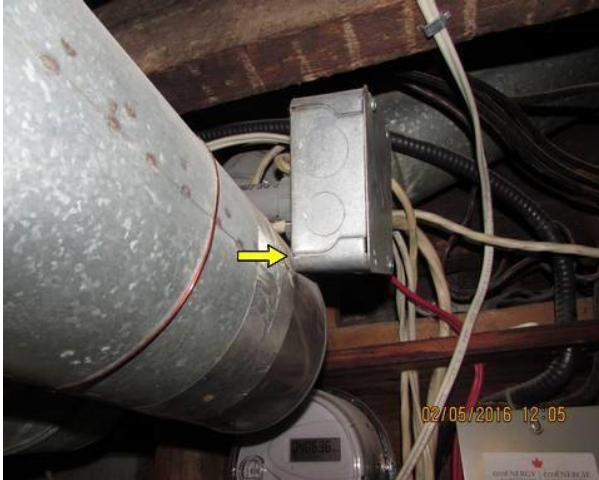
Circuit Wires/Receptacles

Electrical junction box resting on duct

Provide separation between electrical junction box and duct work to prevent ducts from becoming energized.

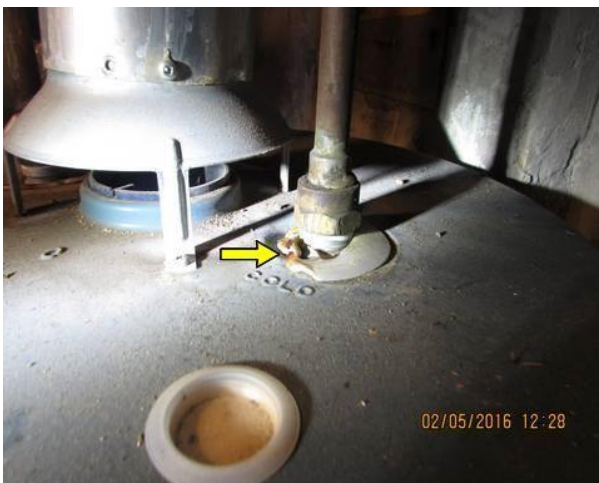
Venting

Burnt plastic at top of water heater

Consult qualified heating technician to correct venting to promote safe exhaust. There is evidence of burning on the top of the tank.

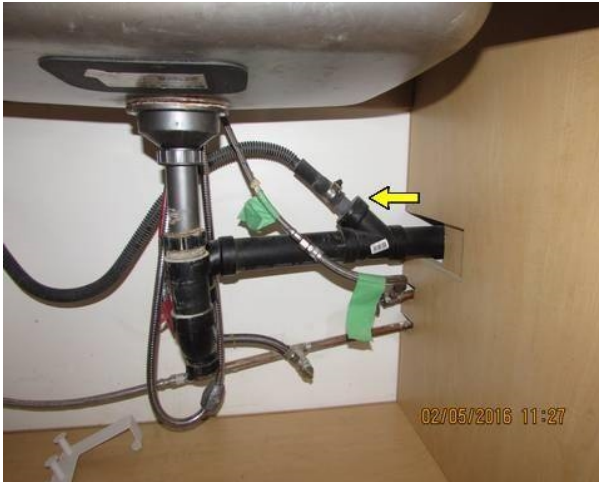
Trap/Drain

Dishwasher drain on wrong side of trap
