Visual Property Inspection

109 Kent Rd
Toronto, ON M4L 2X5

Date: 25-Feb-2016

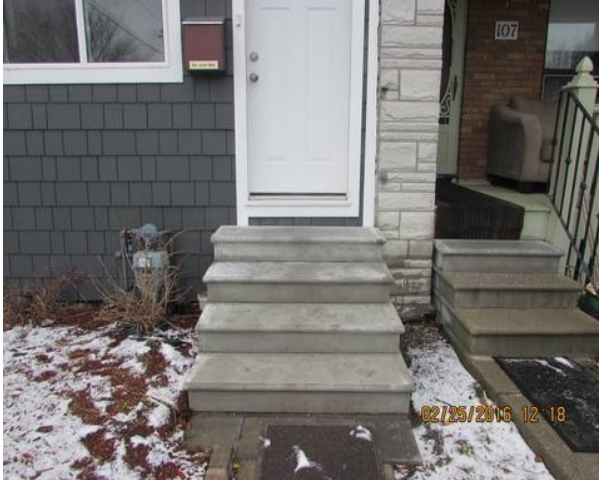
Front Porch Rail

Missing handrail

Provide handrail to promote safety

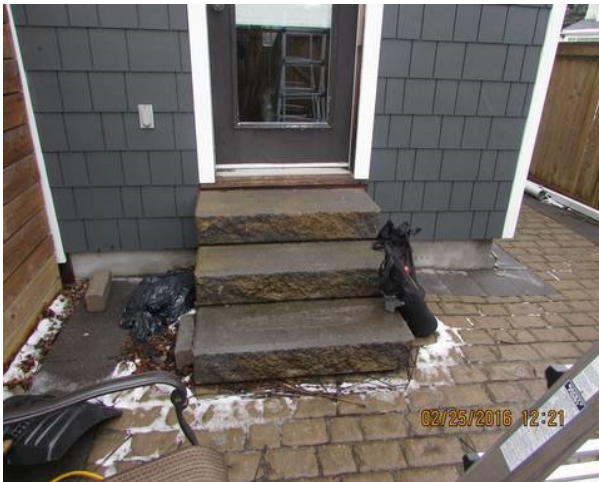
Deck(s)/Patio(s)

Missing handrail

Provide handrail to promote safety

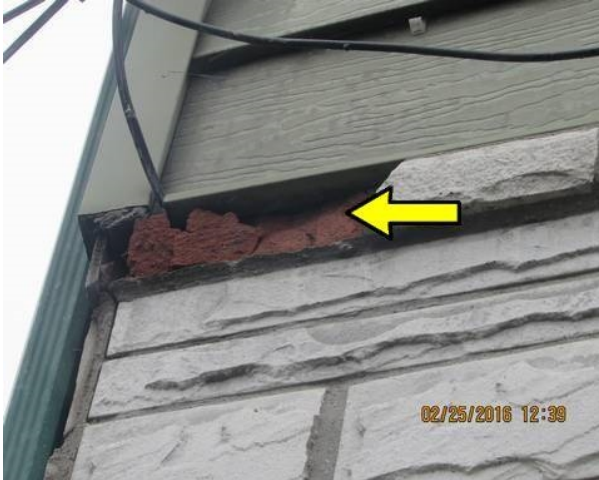
Exterior Walls

Damaged brick siding

Repair brick siding on North wall to prevent further deterioration

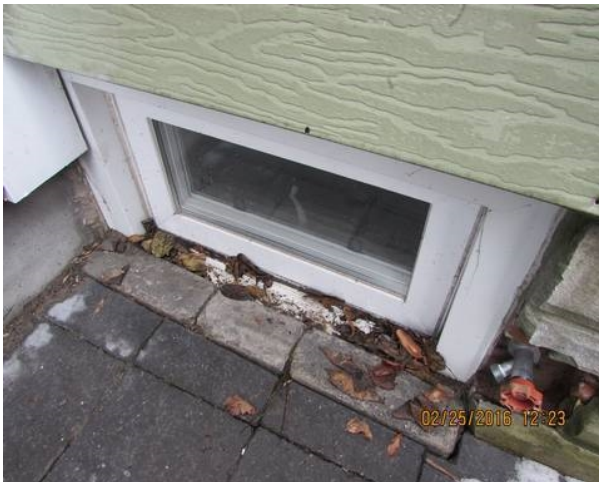
Window too close to grade

Monitor basement window on east side as it is to close to grade. A well would be optimal here. A window cover installed here would help keep water away.

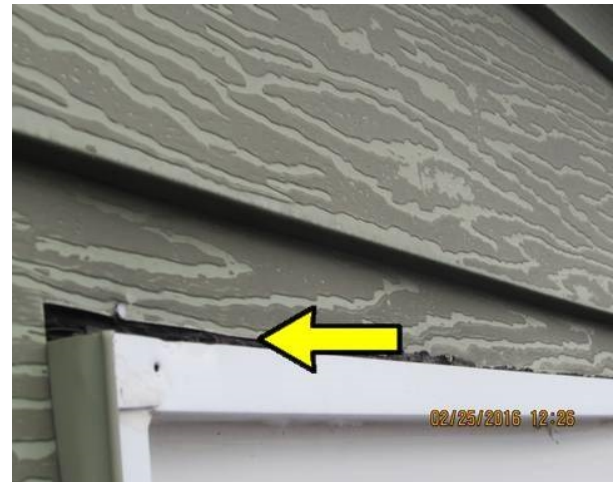
Gap between window and siding where water can penetrate

Seal and/or caulk joints and gaps around windows to reduce air exchange water penetration and subsequent damages.

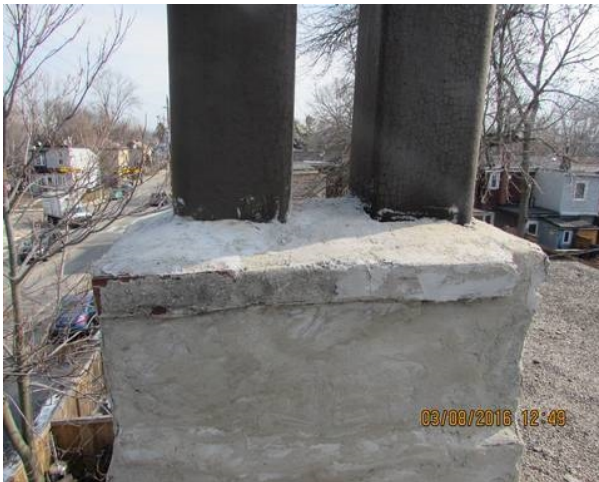
Chimney Cap

Chimney cap has been recently repaired and is in good condition.

Chimney cap recently parged

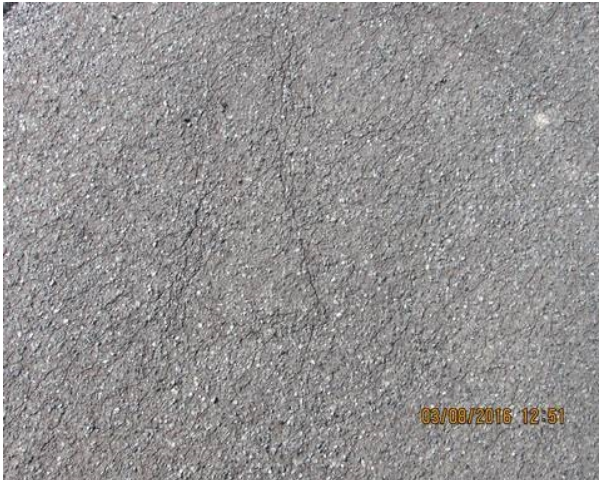
Sec. Roof Life Expectancy

*Flat roof material appears to be end of life on the upper portion of the roof . The membrane is cracking .
Repair or replace as necessary to maintain performance.*

Upper Flat roof membrane cracking

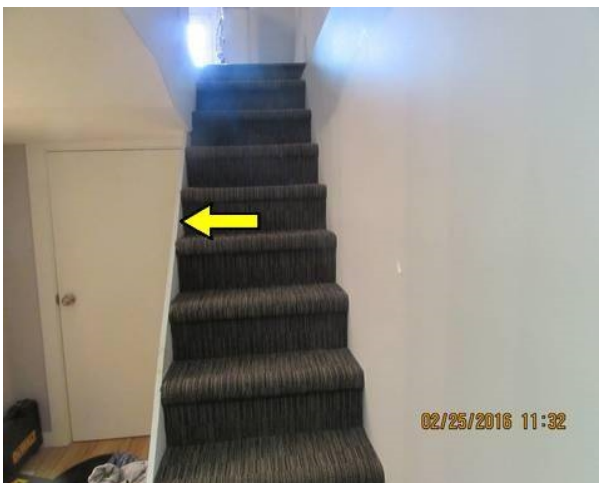
Railing

Missing guard and hand rail

Install guard and handrail to promote safety

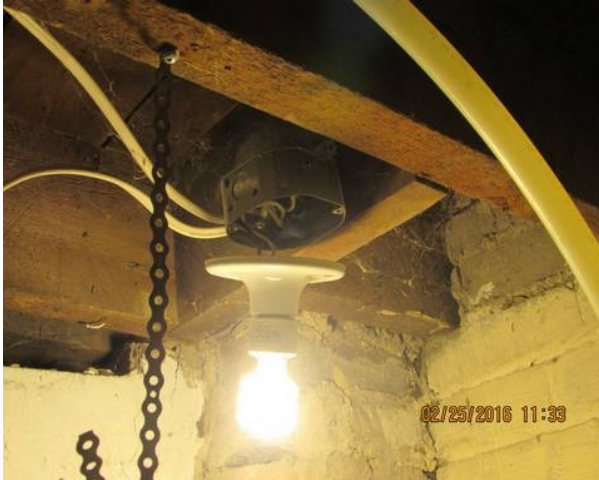
Light fixture not secured

Secure light fixture to prevent hazards from exposed wire.

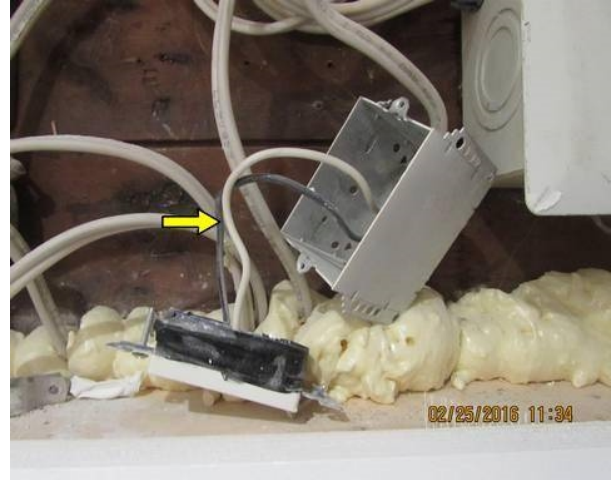
Exposed receptacle wires

Secure outlet to receptacle box to prevent hazards from exposed wire.

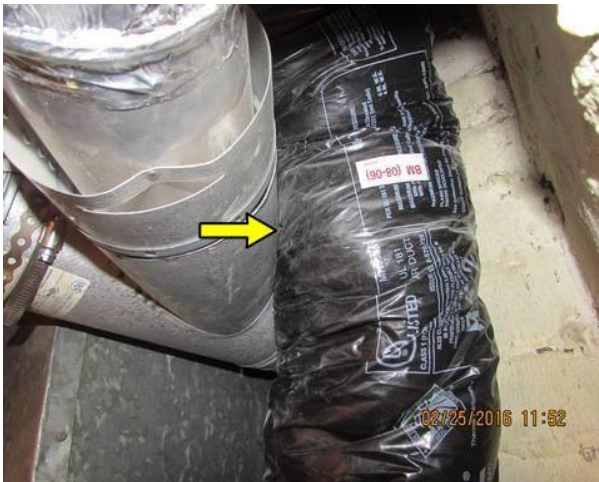
Plastic pipe wrap resting on heating vent. Provide separation here.

Relocate combustible material away from venting to prevent fire.

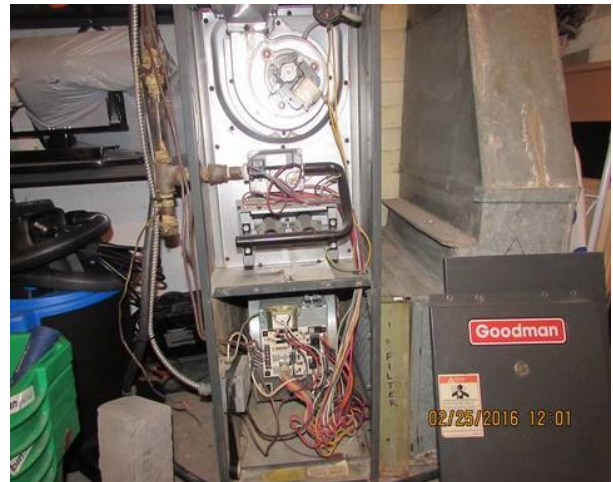
Mid efficiency furnace is 12 years old and functioning as intended at time of inspection. Typical life expectancy is 20 years.

Mid efficiency furnace

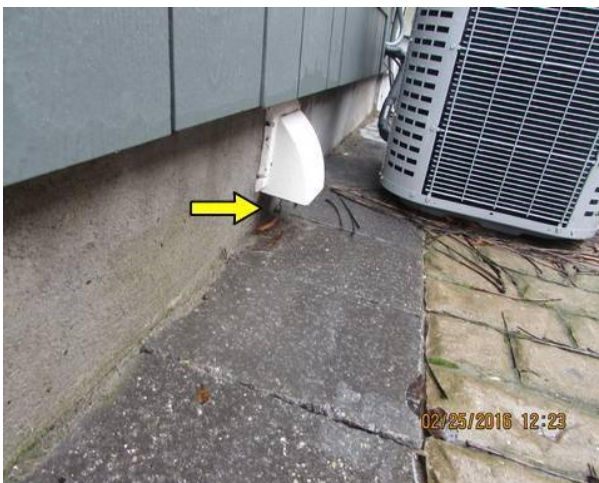
Dryer Vent

Dryer vent to close to grade

The exterior vent should have 18 inches of clearance from grade to prevent blockage from snow. Monitor this area and keep snow clear. Relocate if necessary.

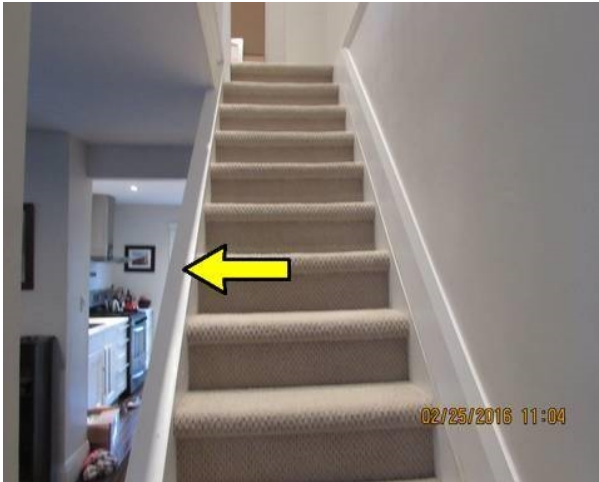
Railing

Missing guard and handrail

Install handrail and guardrail to promote safety
