Visual Property Inspection

130 Kalmar Ave
Toronto, ON M1N 3G7

Date: 04-Mar-2016

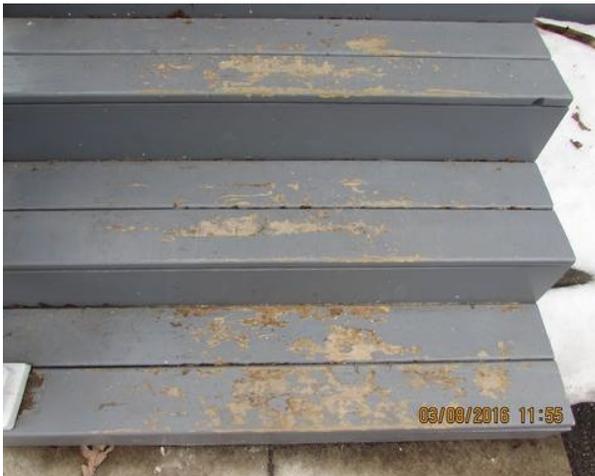
Front Porch

Peeling paint on porch steps

Paint/seal and maintain porch to promote intended weathering protection.

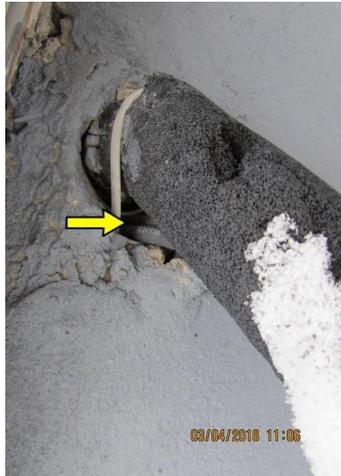
Exterior Walls

Fill exterior holes

Fill and seal exterior holes to prevent rodent entry.

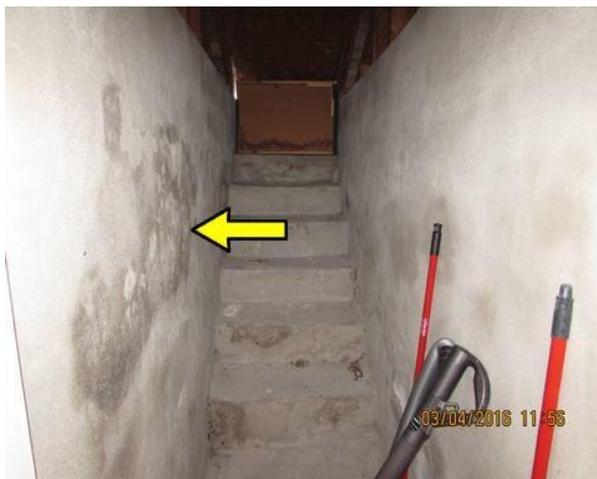
Basement Walkout

Missing handrail at basement walkout

Install handrail for safety

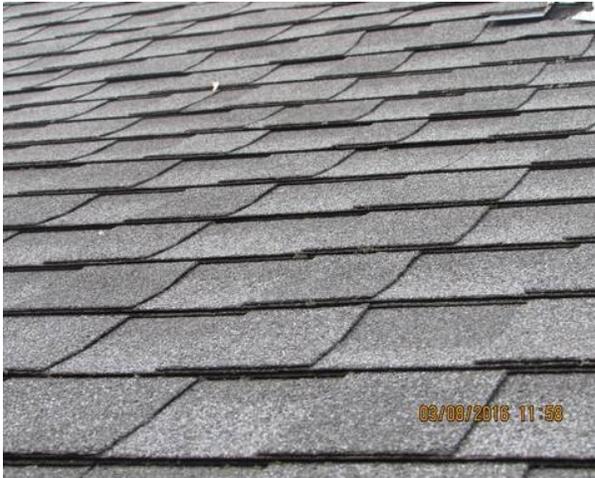
Main Roof

Shingles are in good condition.

Shingles in good condition

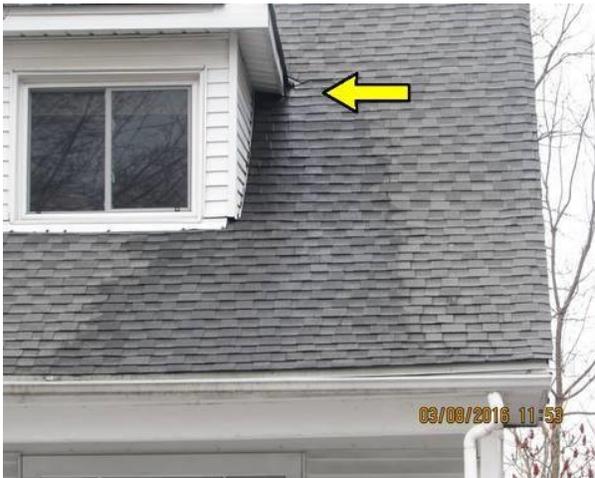
Gutter/Downspout

Large volume of water flowing off dormer

Install gutter system on front dormer and extend to lower gutter system to reduce premature shingle wear.

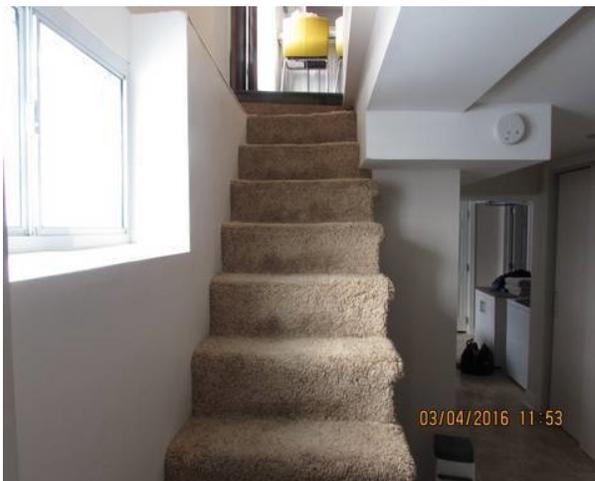
Basement/Structure
Railing

Missing handrail

Install handrail to promote safety

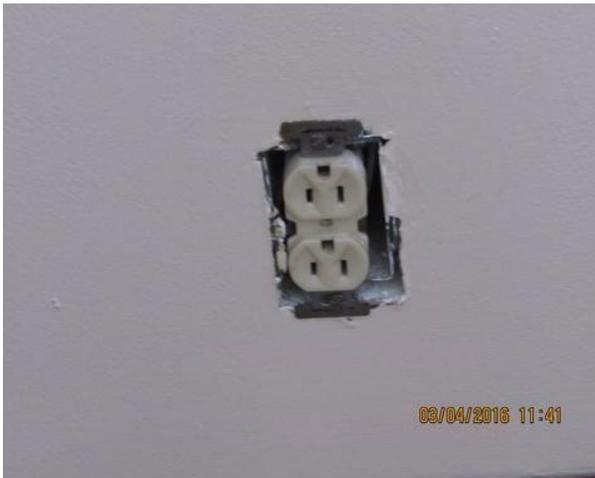
Missing cover plate

Consult qualified electrician to correct various safety hazards :

-Install cover plate on receptacles

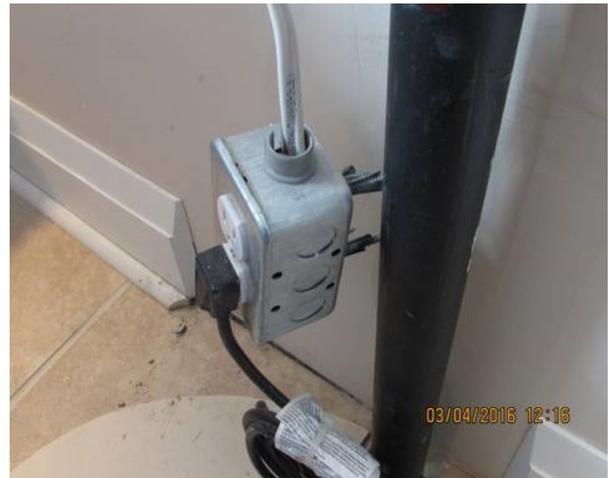
Unsecured electrical receptacle

-Secure receptacles to wall

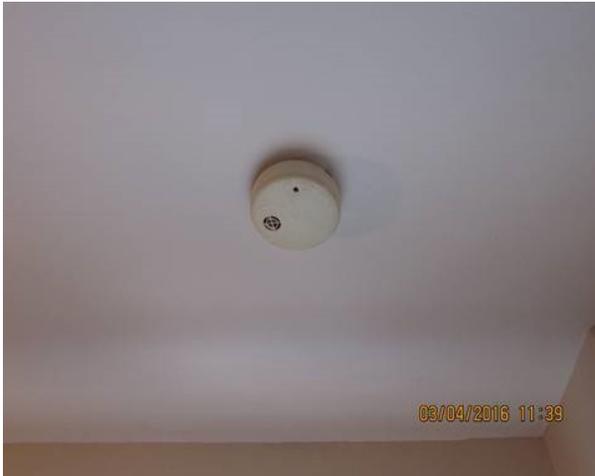
Smoke Detectors

Replace old smoke detectors

All smoke detectors over 10 years old should be replaced for safety as a precautionary measure. Some have a limited lifespan and older technology detectors are not as effective as newer ones.

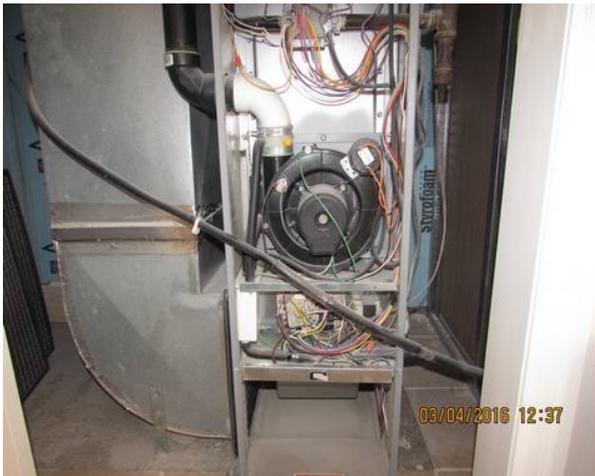
Heating System

High efficiency furnace is 13 years old and functioning.
Typical life expectancy is 20 years.

High efficiency furnace

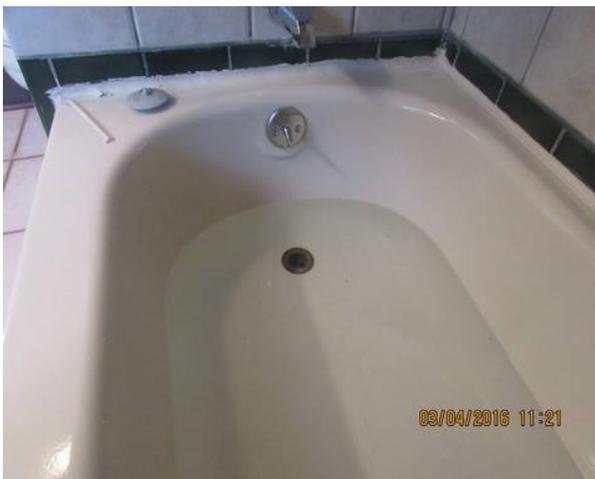
Tub/Enclosure

Slow drainage

Determine cause of decreased drainage in tub and correct as required
