Visual Property Inspection

9 Homeview Ave
Toronto, ON M6N 1S9

Report Commentary

Date: 18-Mar-2016

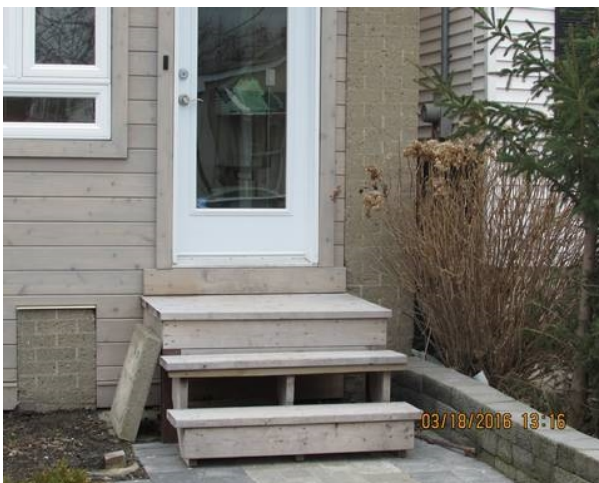
Front Porch Rail

Add handrail for safety

Add handrail for safety

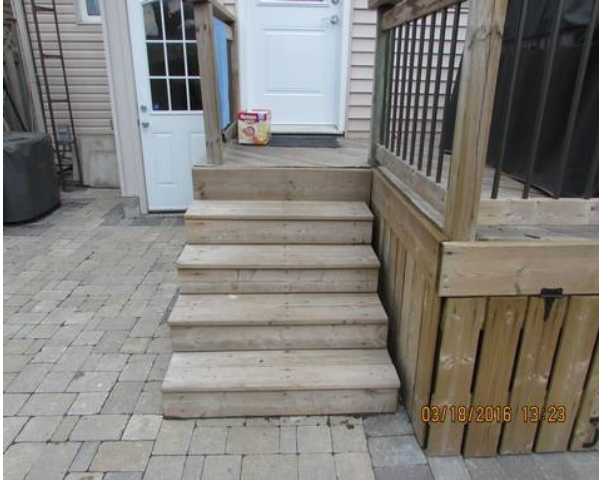
Deck Railing

Missing handrail

Install handrail to promote safety

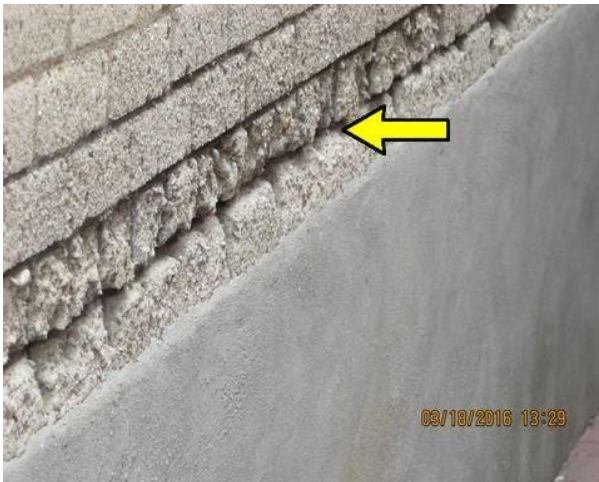
Exterior Walls

Some brick deterioration and settlement cracks noted on east and west side. Repair as necessary to prevent water entry.

Brick deterioration

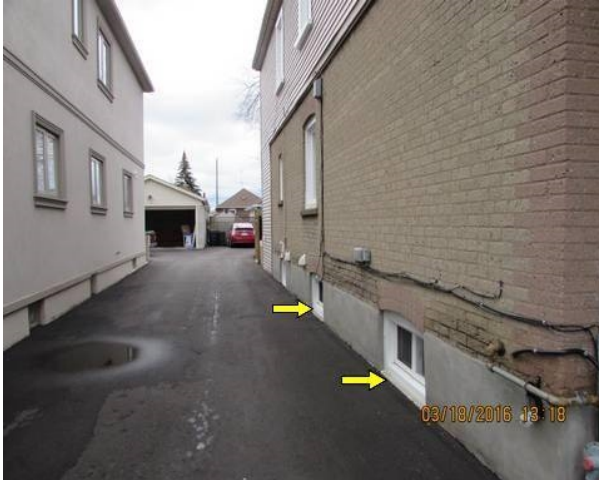
Window Well

Windows on east side are at grade. Providing a window ell with drainage is the best solution. At a minimum keep snow away from this area and keep windows well caulked to prevent water entry.

Windows at grade

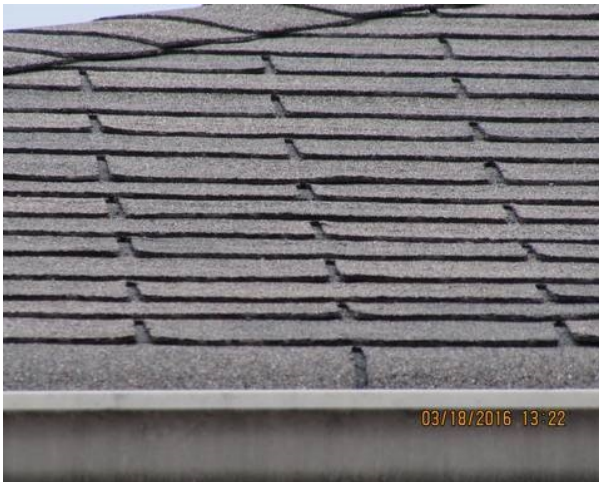
Covering

Shingles typically last 15 years. These shingles are in the last 3rd of their life. Inspect on an annual basis and replace as required.

Roof covering

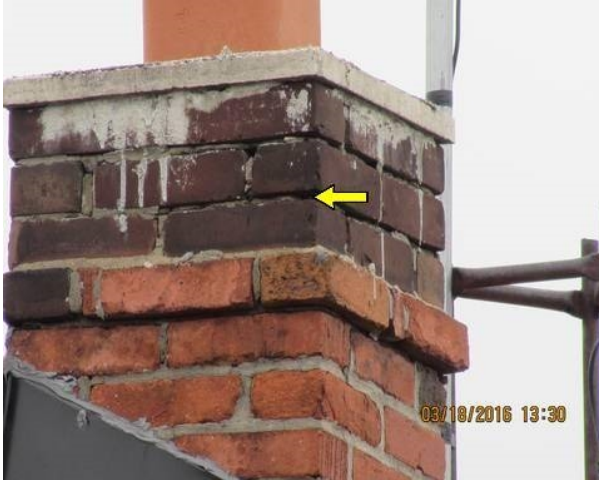
Chimney/Vent

Mortar deterioration

Repoint chimney mortar joints to reduce further deterioration.

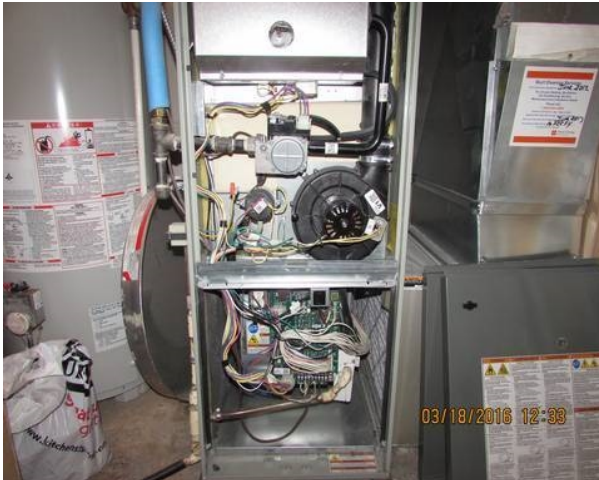
Heating System

High efficiency furnace is 5 years old and functioning as intended. Typical life expectancy is 20 years.

High efficiency furnace

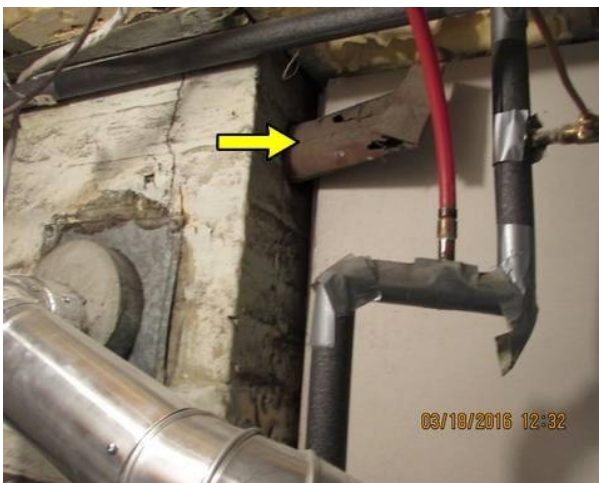
Venting

Remove old exhaust pipe and seal

Remove old furnace vent pipe and seal flue to prevent exhaust gases from entering the home.
