**Visual Property Inspection**

3157 St. Clair Ave E  
Toronto, ON M1L 1V5

# Report Commentary

Date: 14-Apr-2016

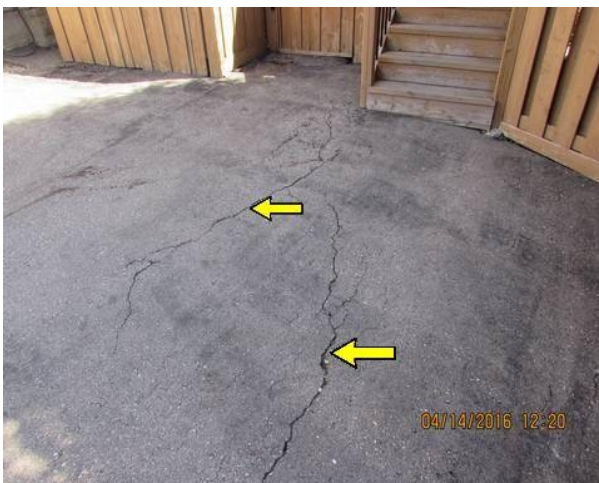
Fill and seal cracks to reduce water penetration further separation and potential trip hazards

Driveway cracks

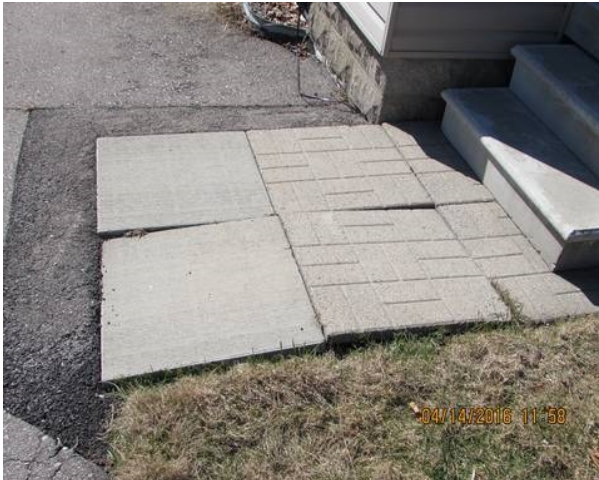
Reset/replace steps to provide level treads and even rises to promote safe travel

Uneven patio stones

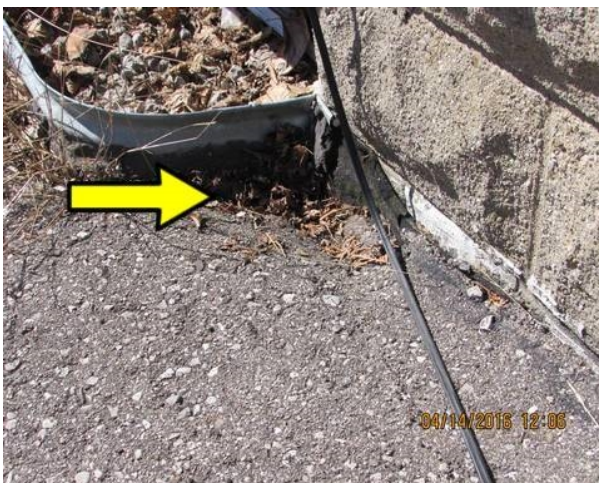
Grade slopes toward the foundation

Regrade to slope away from structure to reduce foundation deterioration potential water entry and subsequent damages.

Reslope perimeter grading to direct surface water away from structure to reduce wall deterioration potential water entry and subsequent damages .

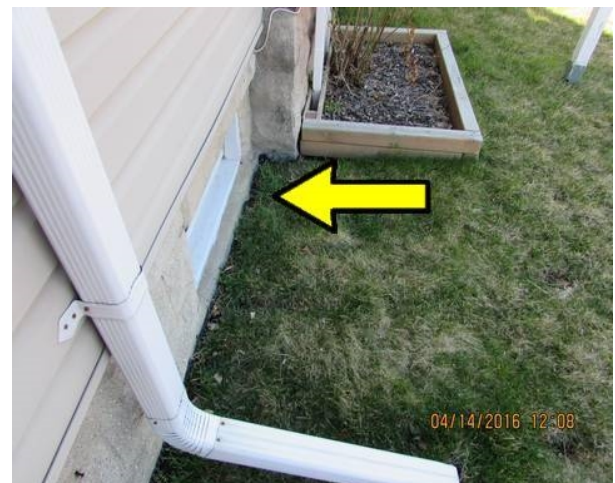
Grade slopes toward foundation

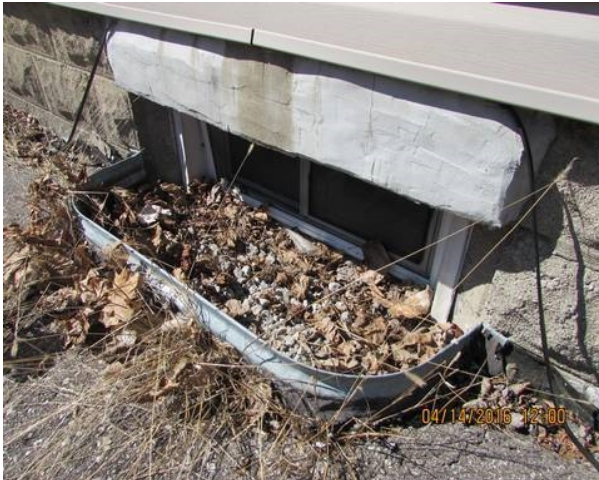
Increase window well depth

Add window wells to windows at grade to prevent water entry and related damages.

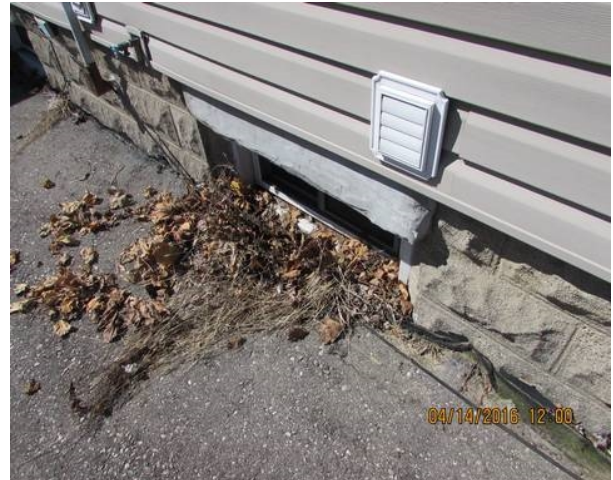
Basement window at grade

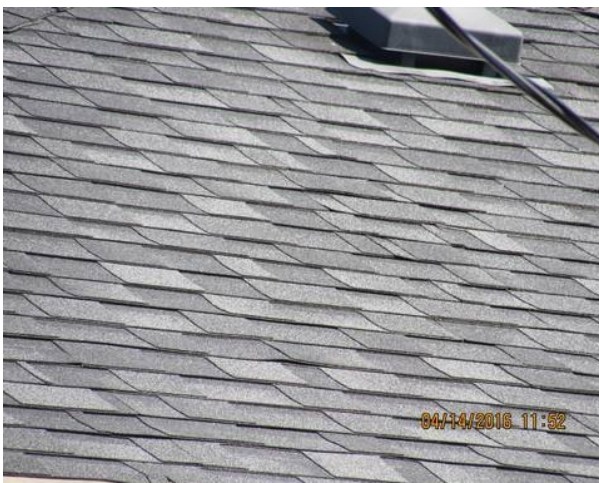
Architectural shingles are in good condition. Typical life expectancy is 25 to 30 years for this type of shingle.

Roof covering

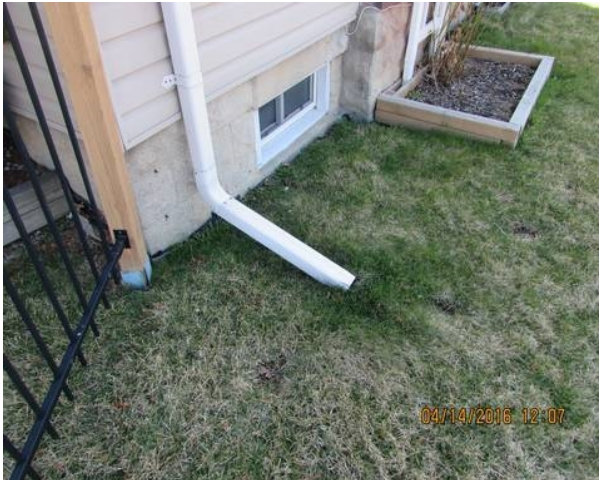
A downspout discharging too close to the foundation is the #1 reason for moisture in a basement. Ensure eaves are clean and clear and discharge six feet downhill.

Downspout discharging to close to foundation

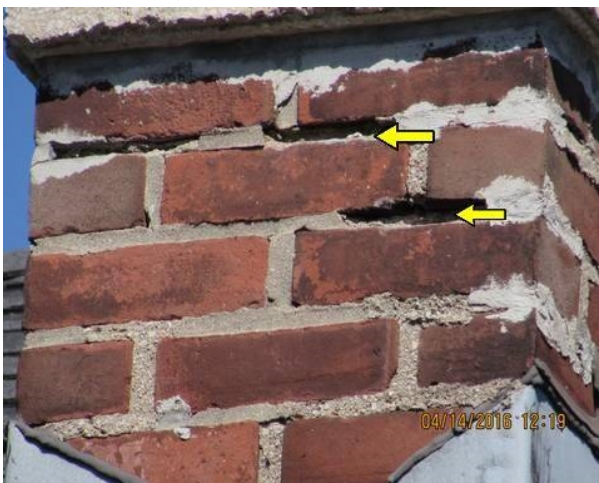
Abandoned south chimney has some minor mortar deterioration. Repair to prevent further deterioration and possible water entry or remove as it is no longer in use.

Mortar deterioration at abandoned south chimney

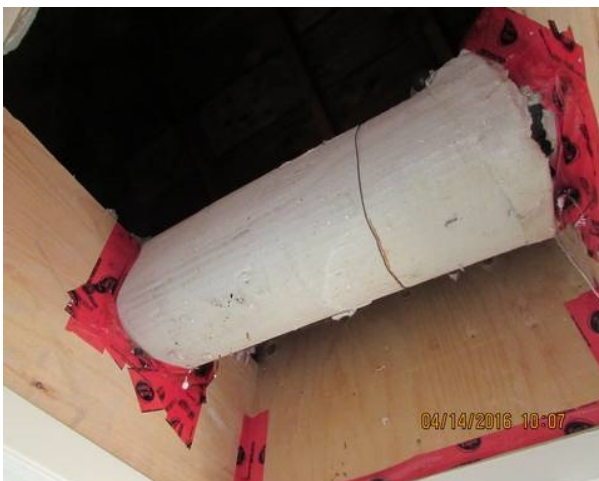
Caution is advised as the ducts in the attic are wrapped in insulation that could contain asbestos. Further testing is recommended.

Possible asbestos material in duct insulation

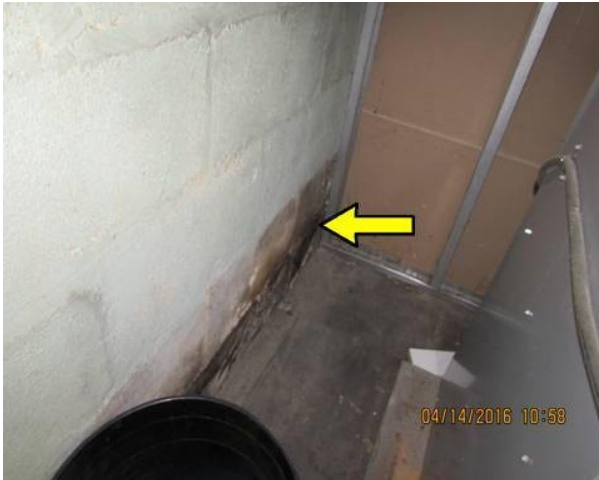
Monitor staining on wall and floor behind furnace and correct as required. Dry at time of inspection.

Staining on wall behind furnace

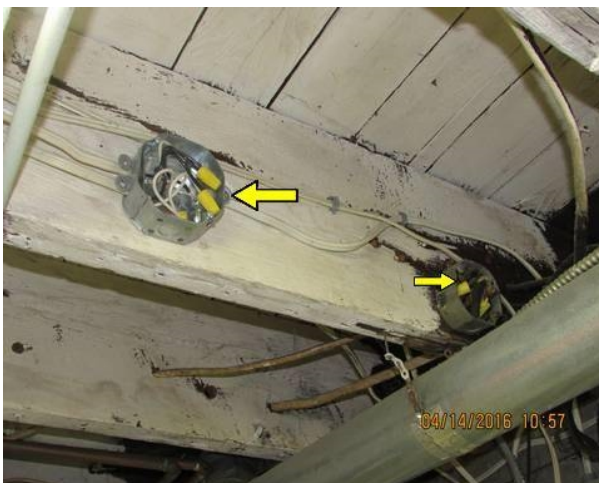
Consult qualified electrician to correct various safety hazards incomplete/incorrect connections noted. A partial list is as follows:

Missing covers on junction boxes

- Replace defective GFCI receptacle on the exterior
- Install covers on all junction boxes and switch boxes
- Install a ground clamp at the water main
- Terminate or remove exposed wire
- Secure loose wires

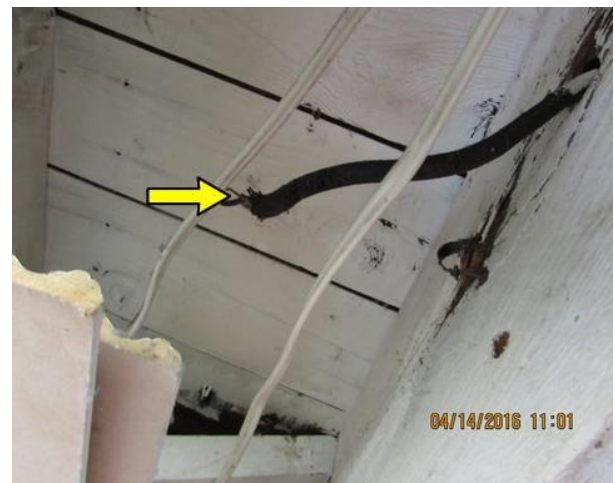
Unterminated and exposed electrical wire

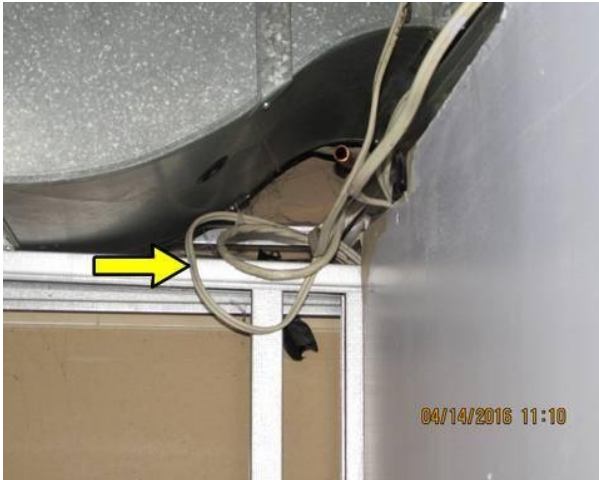
Unsecured wire

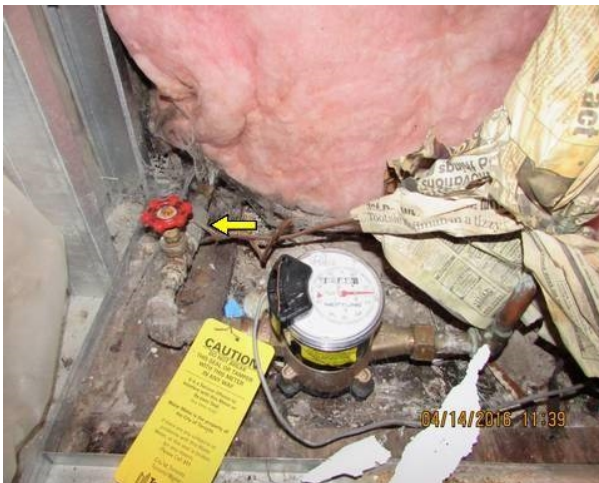
Missing ground clamp

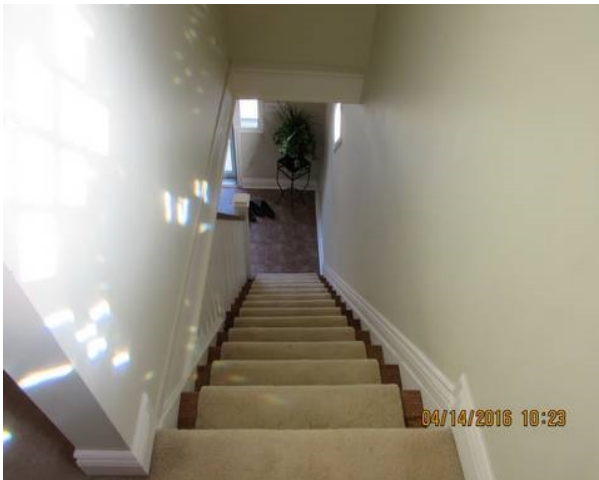
Incomplete hand rail
