**Visual Property Inspection**

**28 Holland Ave  
Toronto, ON M4B 2C6**

Date: 23-Apr-2016

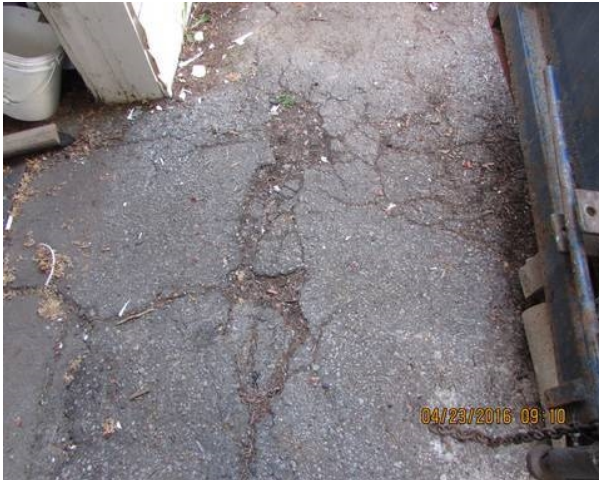
**Driveway**

Deteriorating asphalt

Resurface driveway to reduce further deterioration and promote weathering protection

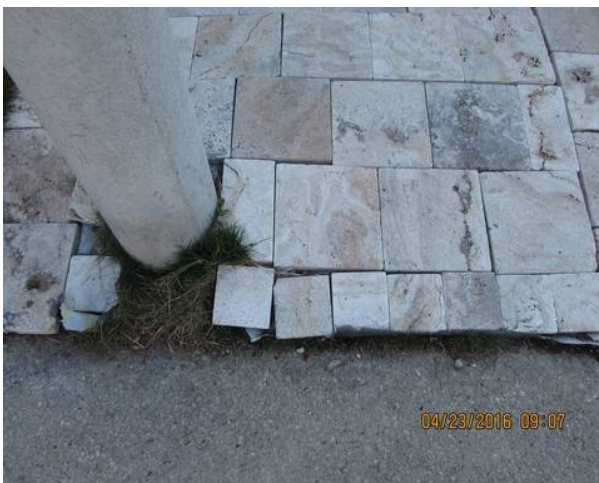
**Walkway/Path**

Loose and uneven walkway tiles

Level and secure loose tiles to promote safe travel.

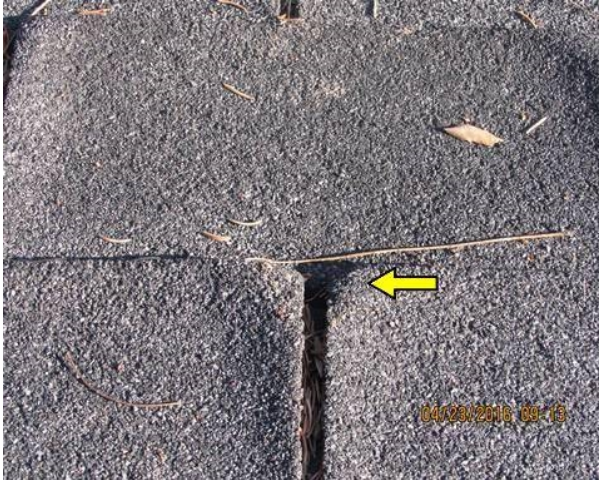
**Garage**  
**Ceiling**

*Shingle are starting to deteriorate. Budget to replace.*

Cupping shingles

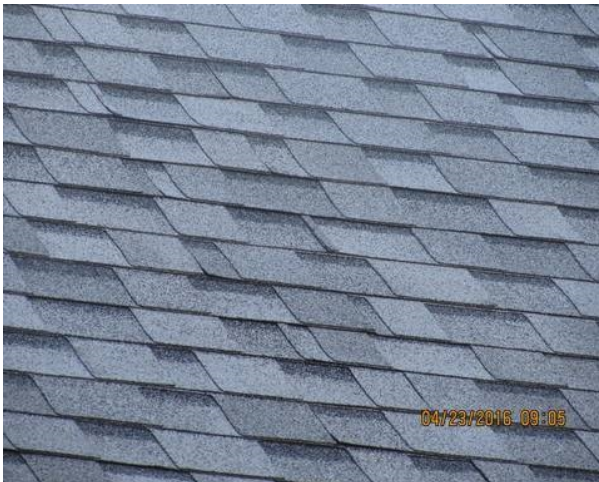
*Architectural shingles are in good condition. Seller advises shingles were replaced last year. Typical life expectancy of this type of shingle is 25 to 30 years.*

Roof covering

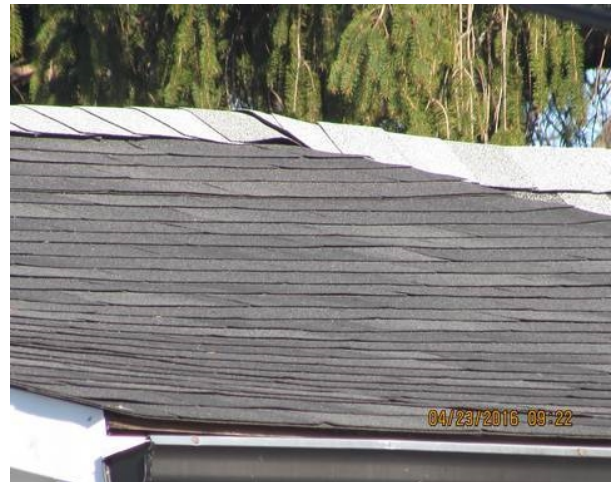
Shingles above east side dormer were not replaced. They appear to be in good condition. Check on an annual basis and replace as required to prevent water entry.

Shingles above east dormer

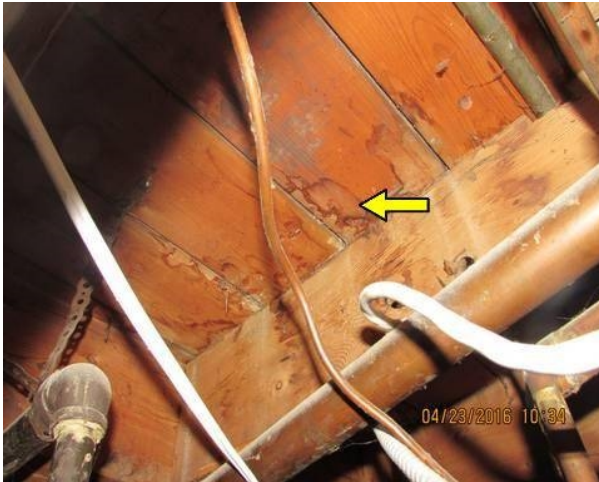
**Ceiling**

Water stains

Monitor previous staining to ensure leak remains inactive

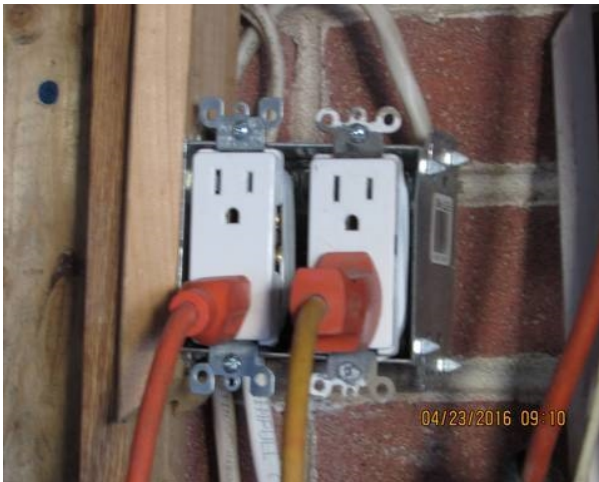
Missing receptacle cover

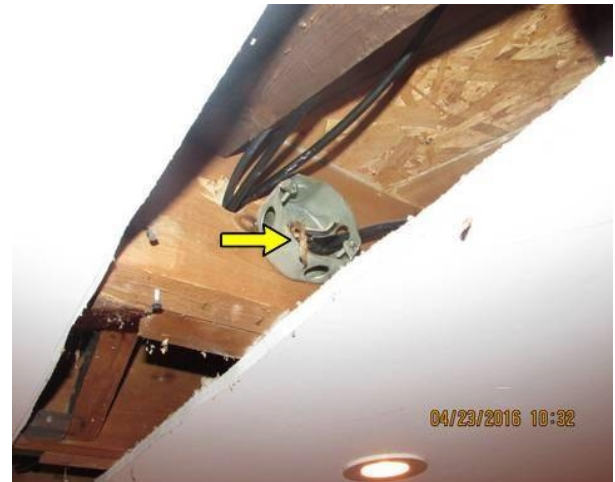
Exposed wires and missing junction box cover

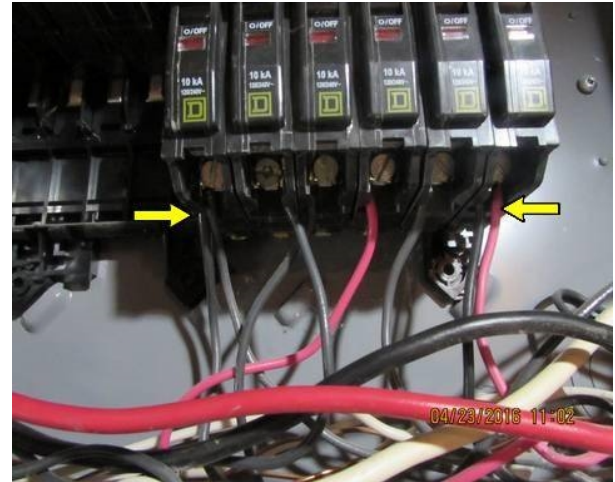
Double tapped connections

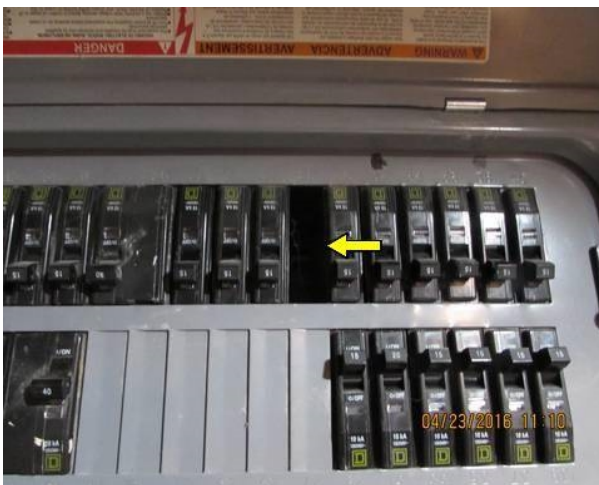
Openings to interior of panel

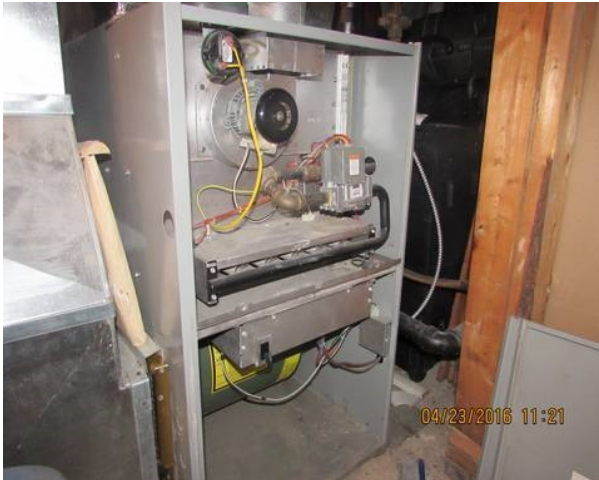
**Heating System**

*Mid efficiency furnace is 13 years old and functioning as intended. Typical life expectancy is 20 years.  
The seller can provide a letter from Adall Heating verifying service is done every two years.*

Mid efficiency furnace

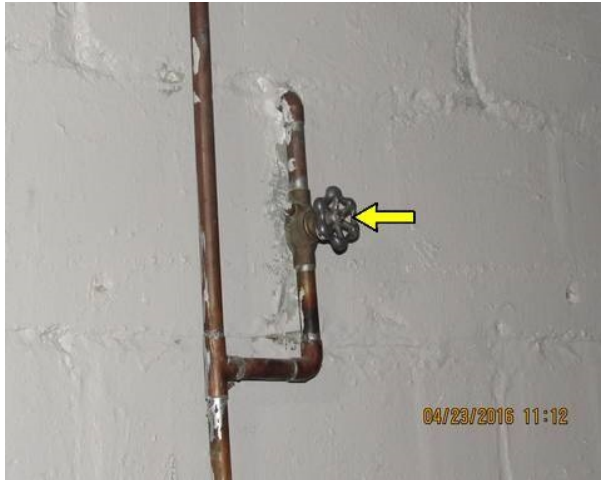
**Hose Bibb**

Hose Bibb shut off

Determine operation when weather permits. Hose bibb currently winterized
