Visual Property Inspection

662 Sammon Ave
Toronto, ON M4C 2E2

Date: 23-Apr-2016

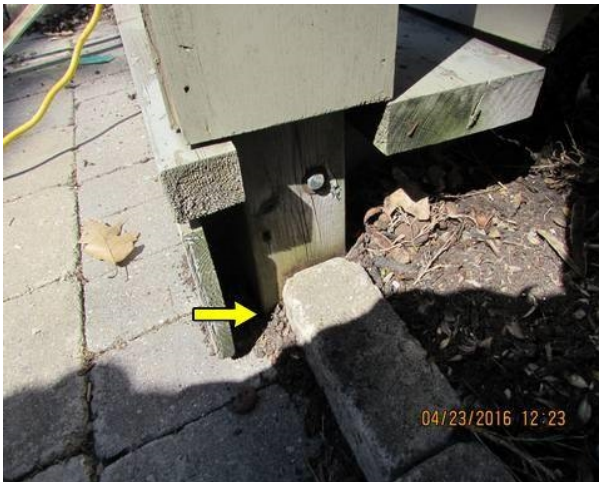
Front Porch

Unable to determine condition of underside of deck/porch due to solid skirting .

Wood to soil contact

Monitor wood to soil contact and correct as necessary to promote stability.

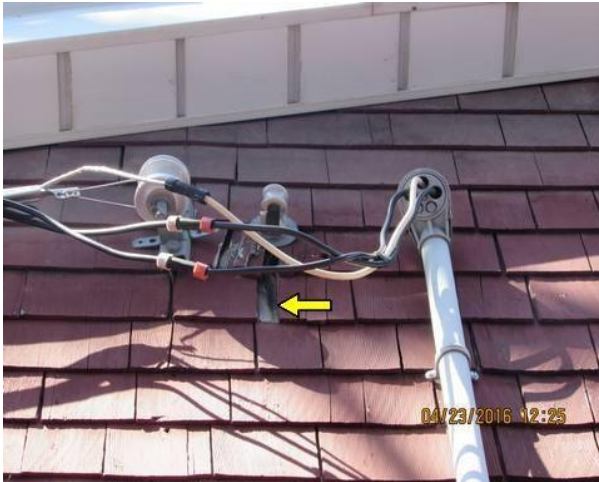
Exterior Walls

Missing wood siding

Repair or replace damaged or missing wood siding to prevent water entry and related damages.

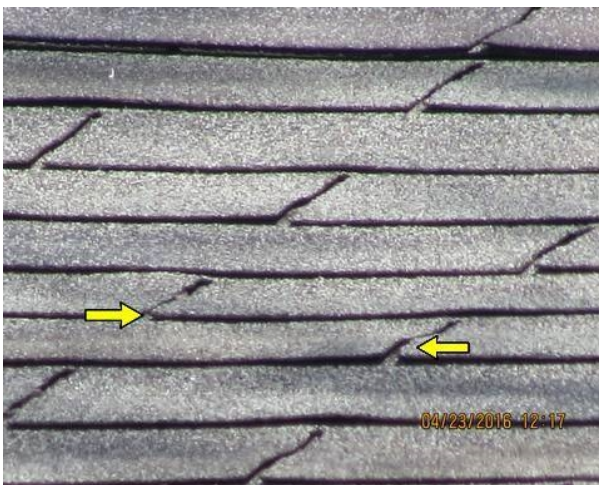
Shingles are in their last 3rd of there life expectancy. Monitor on an annual basis and replace as required.

Shingles just starting to cup and curl

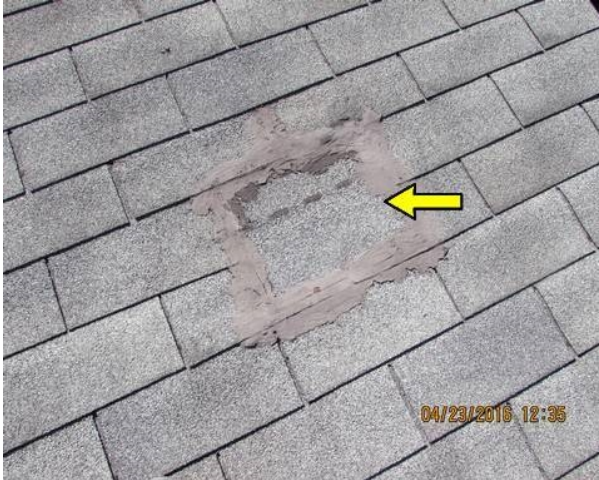
Previous repair

Monitor previous repairs to prevent leakage.

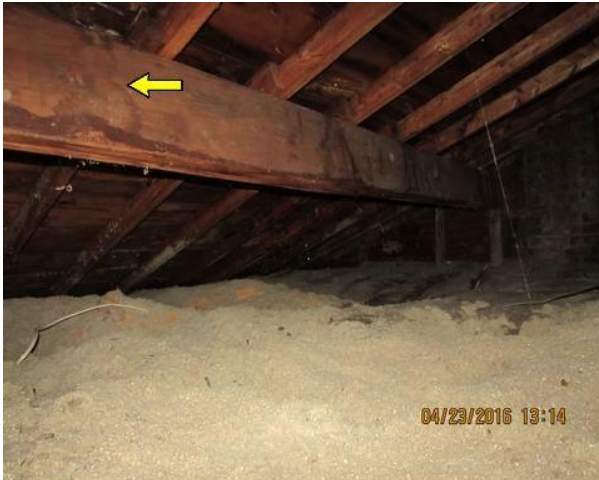
Water staining on beam

Monitor water staining on beams and boards and correct as required. Insulation was dry at time of inspection.

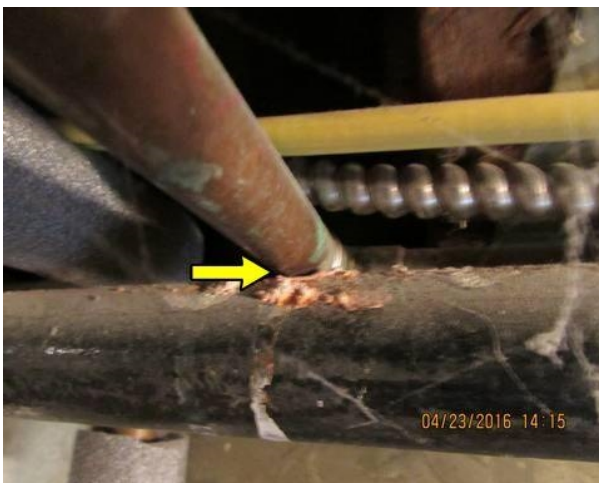
Basement/Structure
Pipes/Ducts

Dissimilar metals in contact

Provide clearance between pipes of dissimilar material to prevent corrosion and pipe failure.

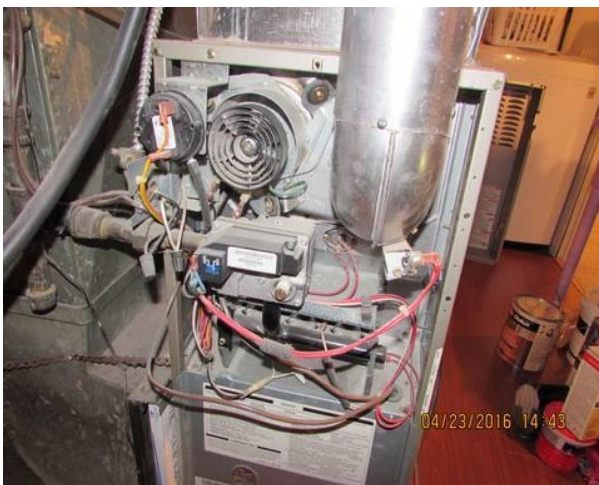
Heating System

Mid efficiency furnace is 12 years old and functioning as intended. Typical life expectancy is 20 years.

Mid efficiency furnace

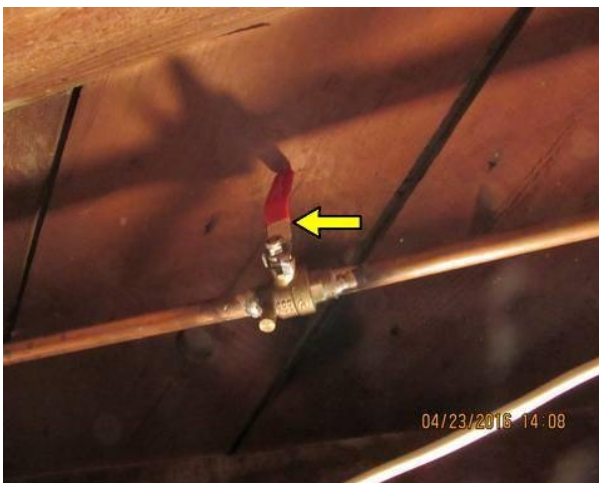
Hose Bibb

Determine operation when weather permits. Hose bibb currently winterized

Hose bibb shutoff

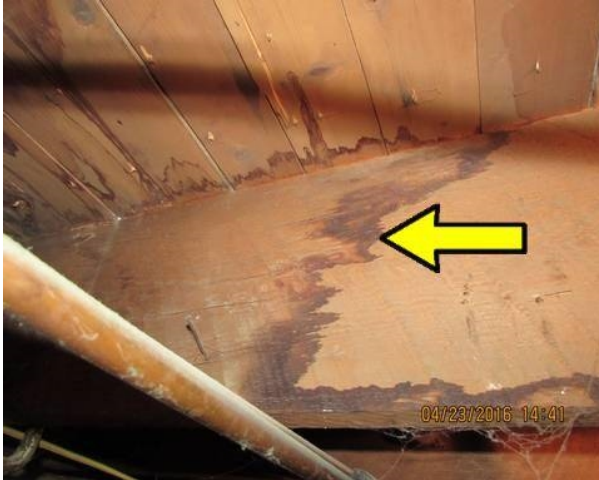
Laundry
Ceiling

Water stains

Monitor water stains and correct as required. Dry at time of inspection.
