## Visual Property Inspection

251 Woodfield Rd  
Toronto, ON M4L 2W8

Date: 06-Jun-2016

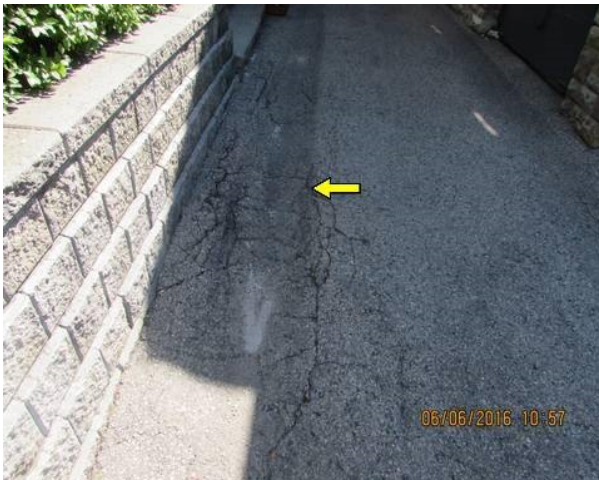
Driveway depression

Fill drive/walkway ruts/depressions to provide even surface to reduce potential trip hazards.

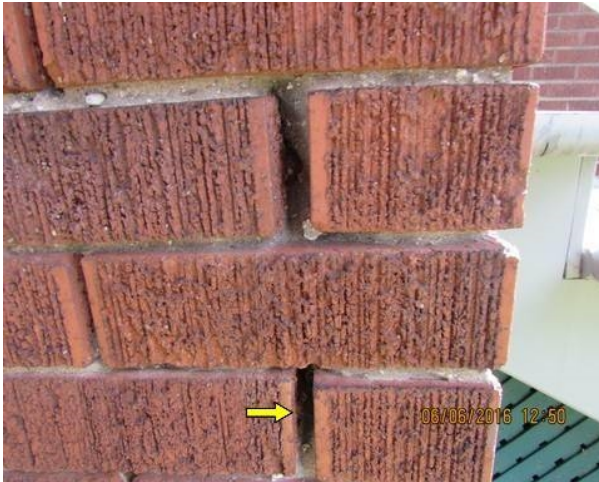
deteriorating mortar

Repoint porch columns to prevent further deterioration and promote stability

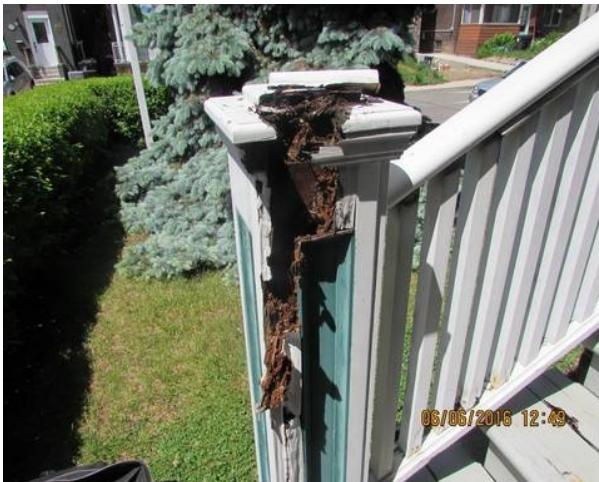
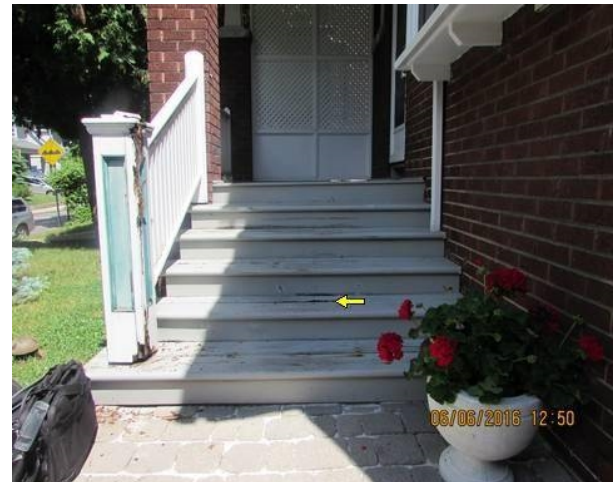
**Front Porch Rail**

deteriorating railing

Boards are rotting

Replace rotted handrail and steps to promote safe travel.

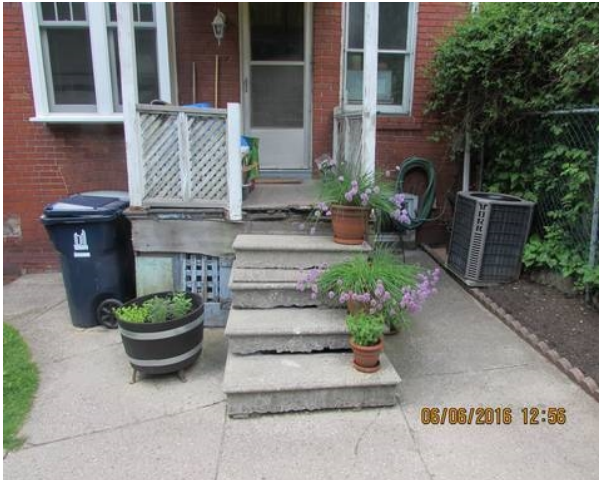
Missing hand rail

Add handrail for safety

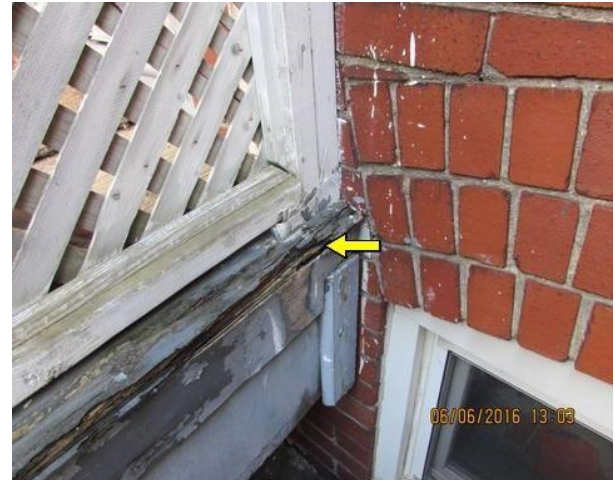
*The deck is in an advanced state of deterioration and should be repaired/replaced to promote stability.*

Deteriorating deck

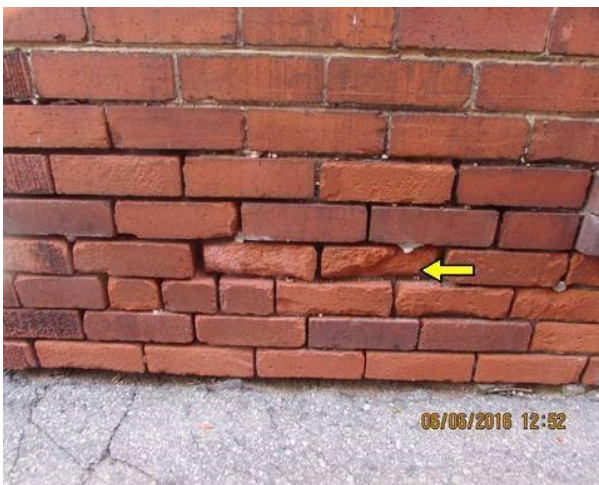
**Foundation Wall**

Deteriorating brick and mortar

*Repair mortar and brick deterioration to prevent water entry and related damages.*

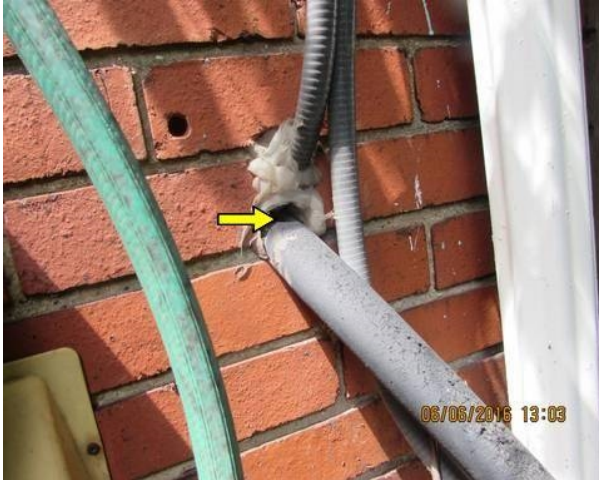
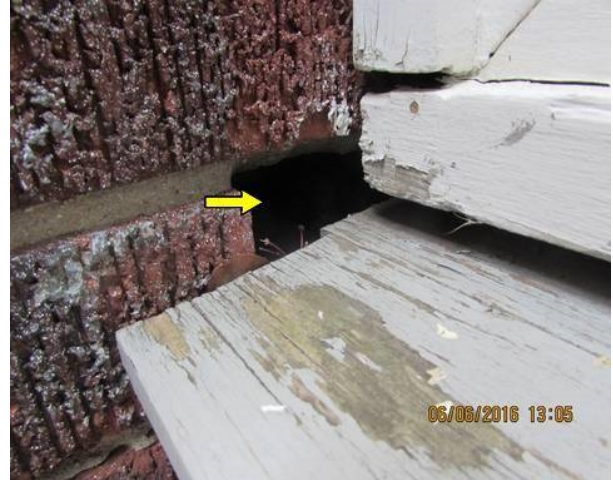
Hole in exterior wall

hole in exterior wall

Fill and seal holes to prevent pest entry and related damages

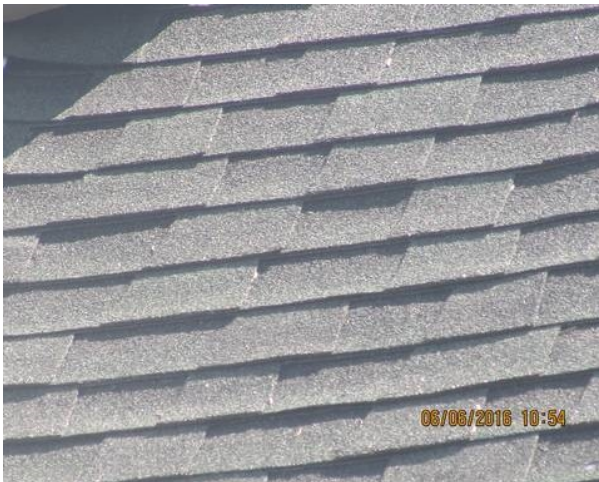
*Seller advises roof was re-shingled in 2014. Roof is in good condition . Architectural shingles typically last 25 to 30 years*

roof covering

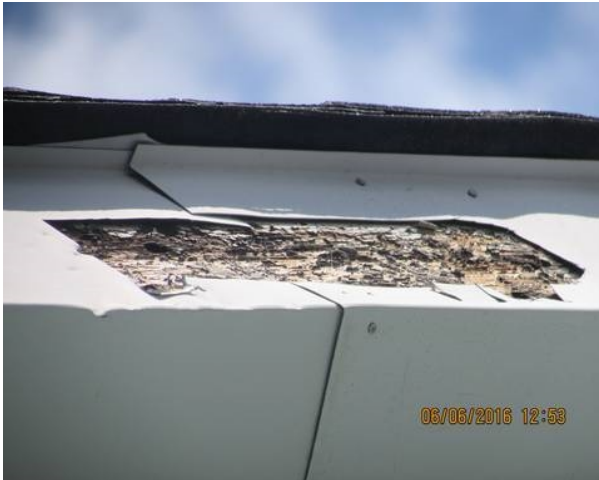
Wood fascia exposed

Replace fascia flashing to prevent wood deterioration and possible water entry

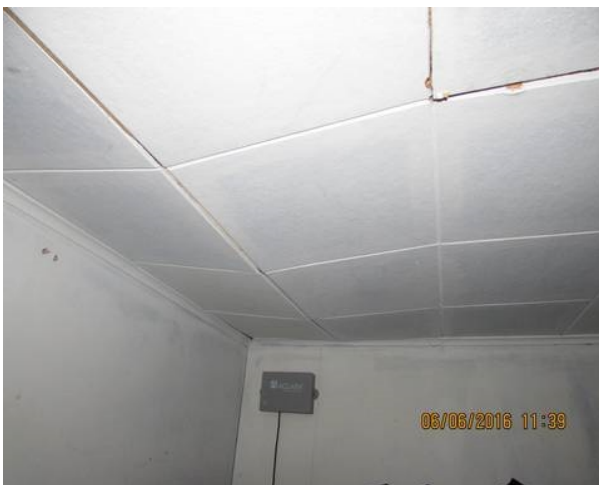
Sagging in ceiling tiles

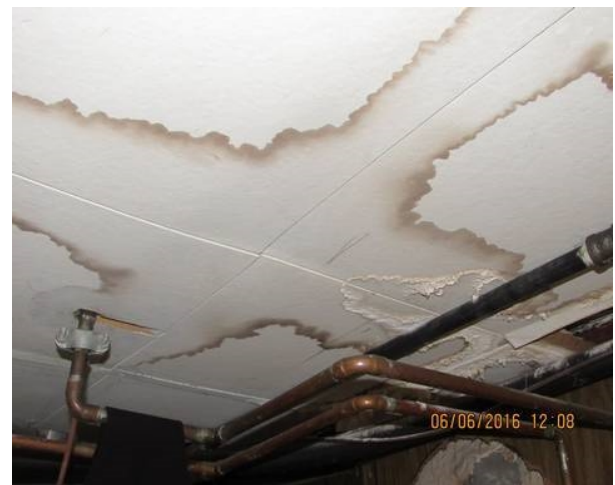
Water stains

Monitor previous staining to ensure leak remains inactive

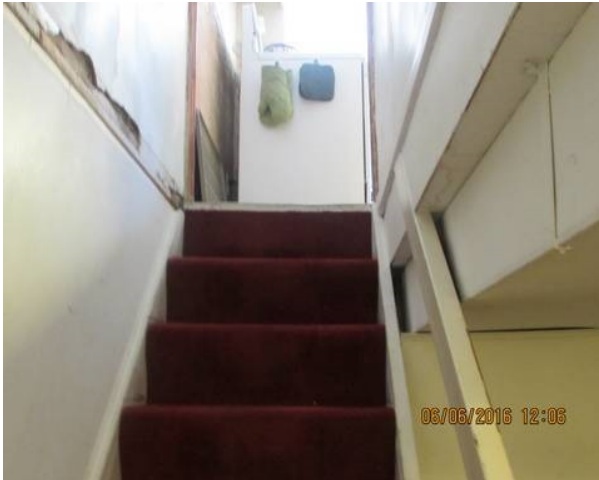
Incomplete railing

Install continuous handrail to promote safety

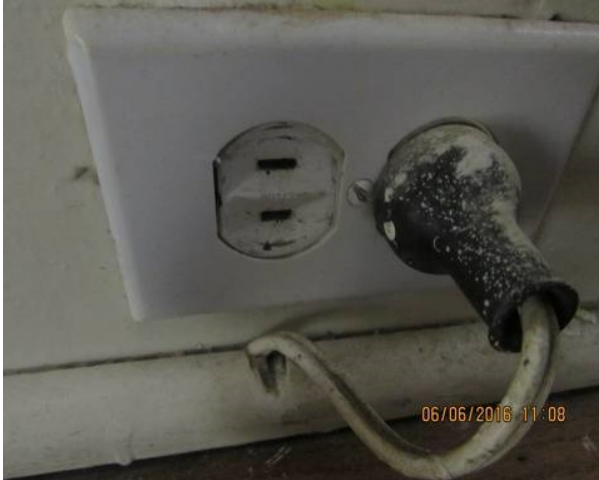
2 prong receptacle

-upgrade receptacles to include a ground connection

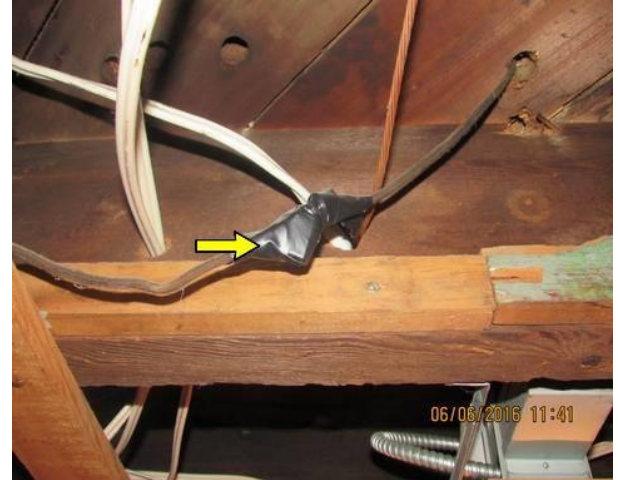
Spliced connection

-spliced and exposed connections should be terminated inside a junction box

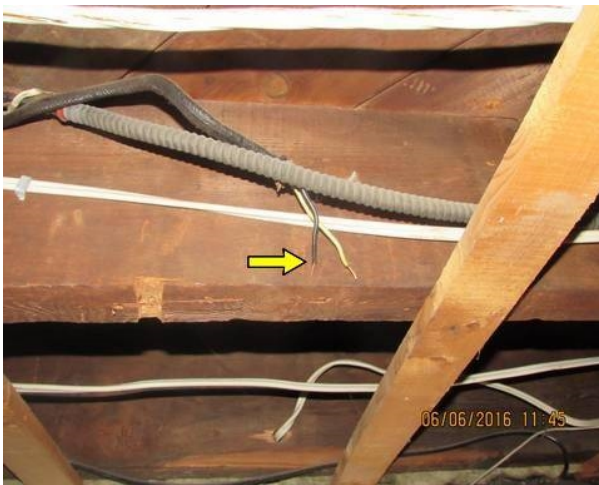
Exposed wires

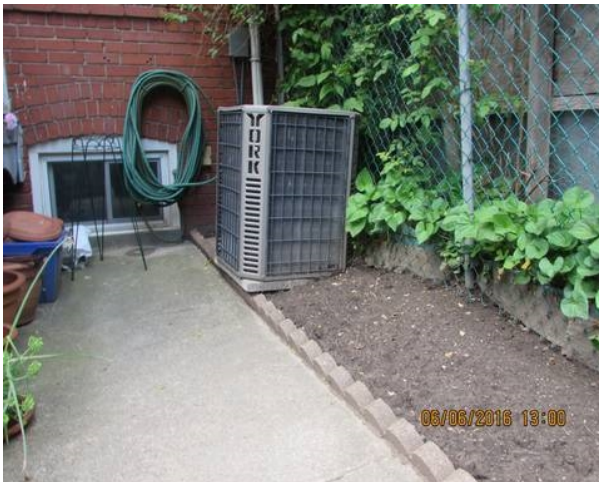
AC not level

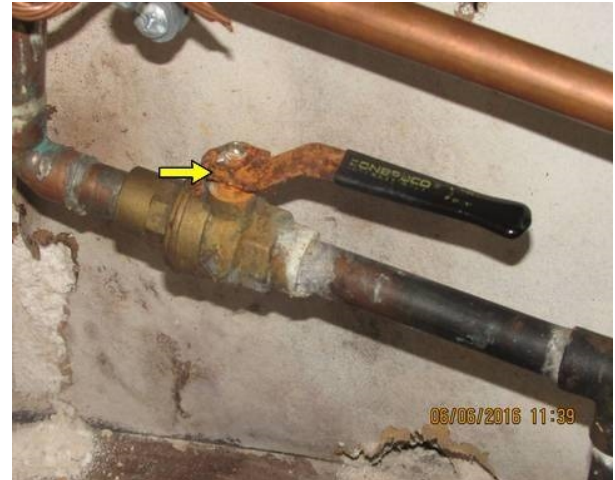
Corroded shut off handle

Replace corroded handle to prevent failure.

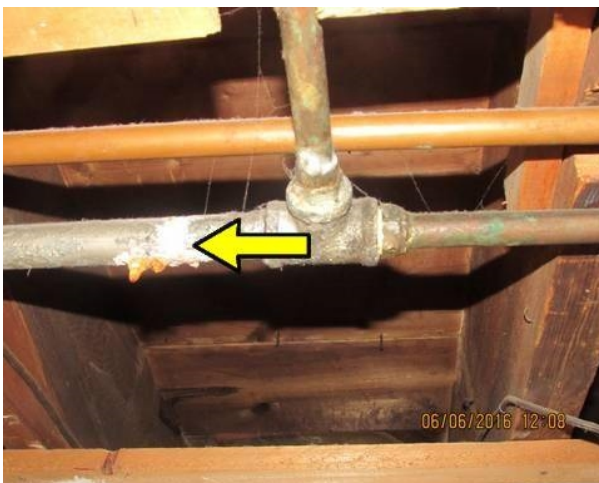
Galvanized pipe

Budget to replace galvanized sections of pipe . Galvanized plumbing is corrosive by nature. Monitor for decreased water flow indicating initial signs of failure.

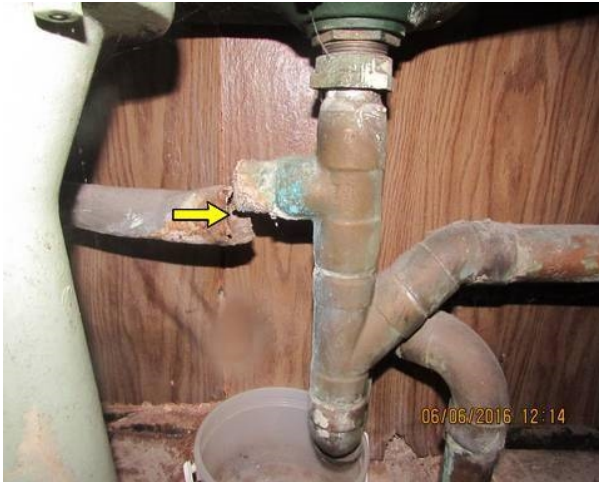
Corroded and disconnected pipe

*Replace corroded and disconnected pipe to regain function of tub.*

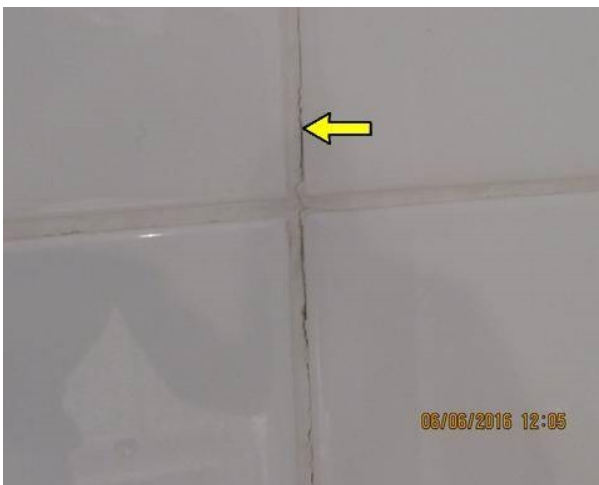
Cracked grout

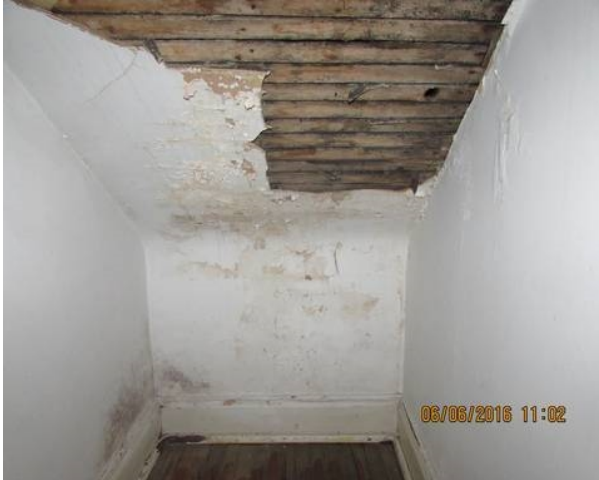
Wall staining

Further investigate cause of wall staining and correct as required . Dry at time of inspection.

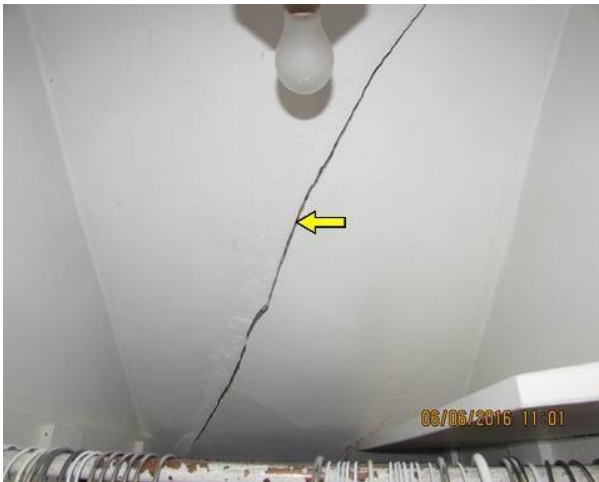
Cracked plaster

Repair cracked plaster to reduce further separation.

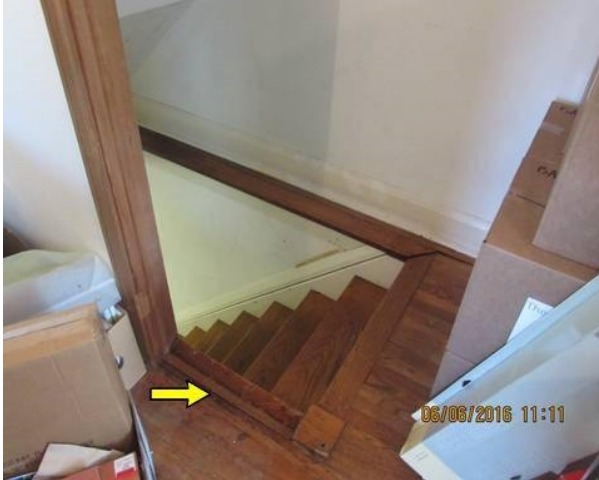
No railing

Install railing to promote safety
