**Visual Property Inspection**

65 Highfield Rd  
Toronto, ON M4L 2T9

Date: 27-May-2016

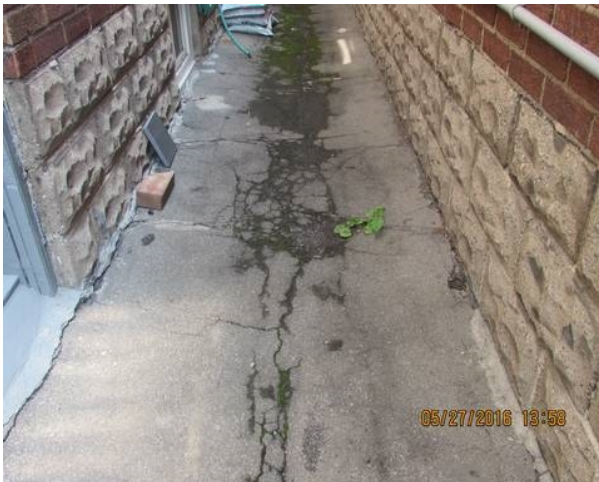
Cracks in walkway

Fill and seal cracks in walkway between houses to reduce water penetration further separation and potential trip hazards

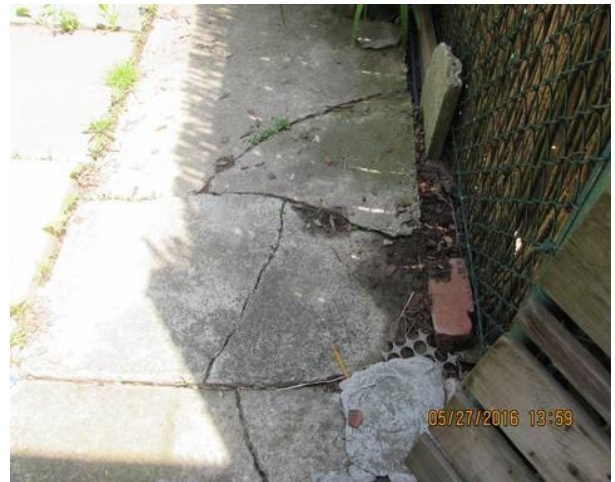
Broken and uneven patio slabs

Reset/replace steps to provide level treads and even rises to promote safe travel

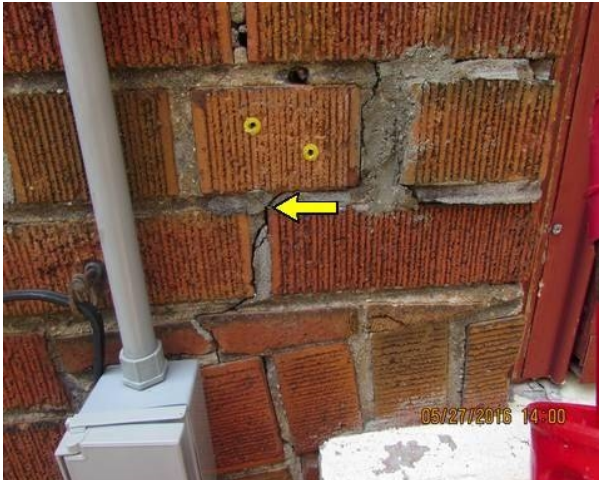
Wall cracked at rear of structure

Fill and seal small settlement crack at east side of building to prevent further deterioration.

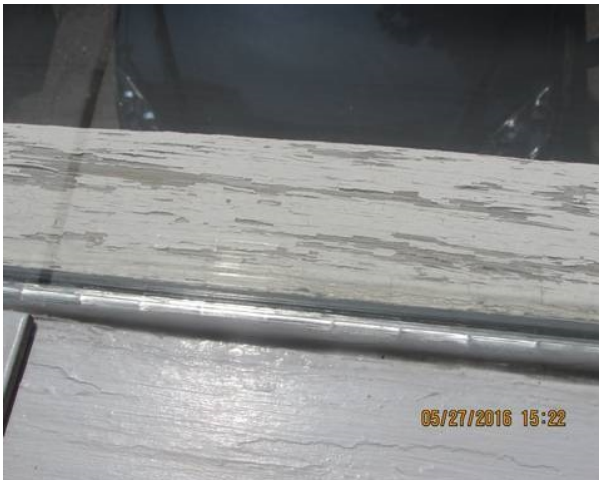
Peeling paint at front bay window

Paint wood window trim to promote weathering protection

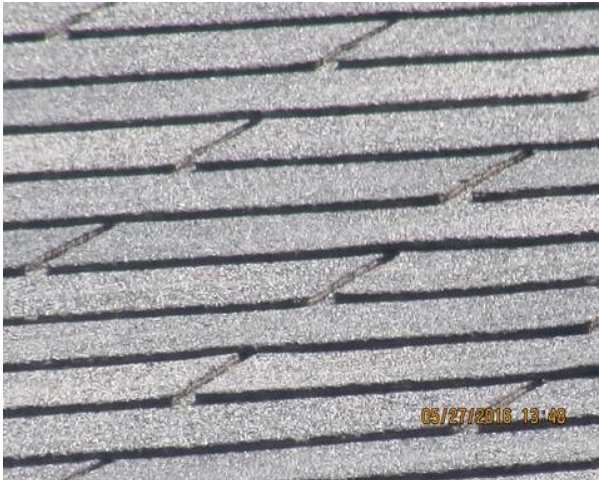
Shingles

*Shingles are in their last 3rd of life. Typical life expectancy is 15 years. Monitor on an annual basis and replace as necessary to prevent water entry and related damages.*

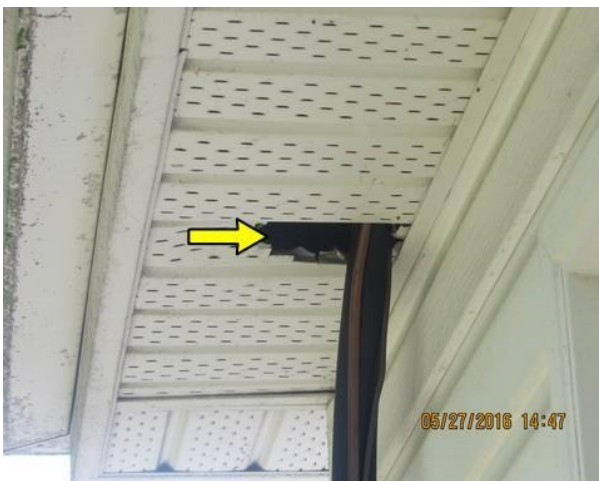
Hole in soffit

Fill and seal soffit opening for Air conditioner to prevent pest entry and related damages.

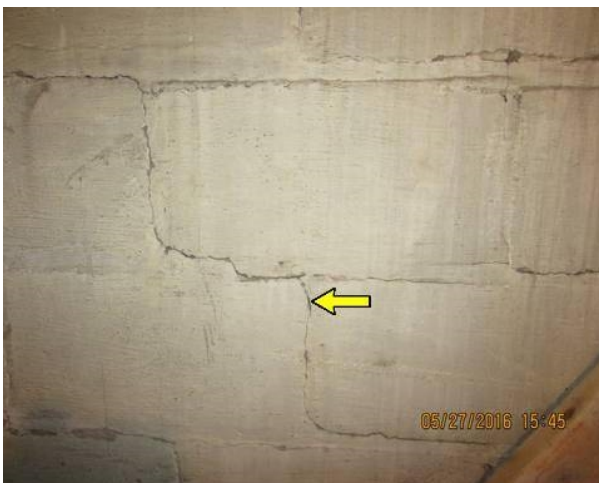
Crack in wall

Fill and seal cracks to reduce further separation and potential water entry .

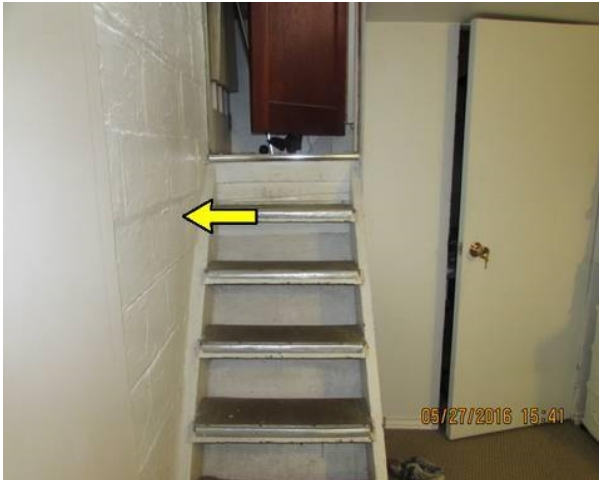
Missing handrail

Install handrail to promote safety

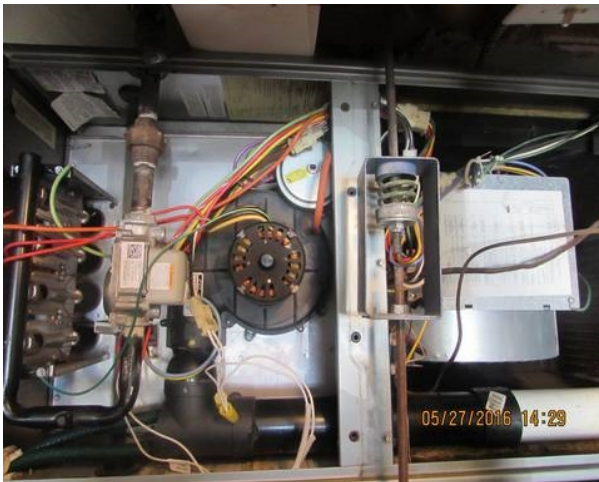
*High efficiency furnace is 14 years old and in good condition. Typical life expectancy is 20 years.*

High efficiency furnace in garage

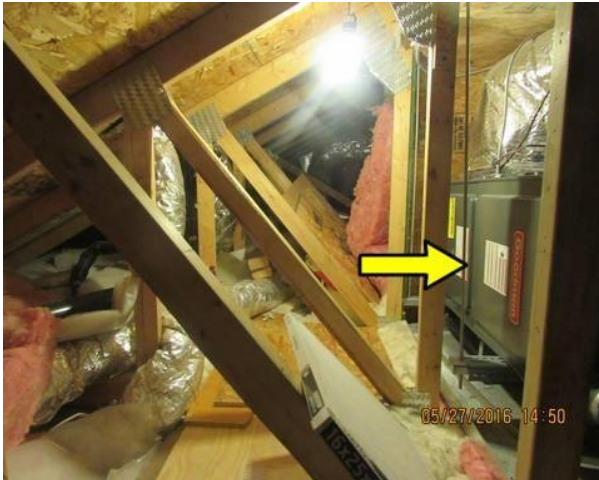
*High efficiency furnace is 10 years old and in good condition.*

Furnace in attic

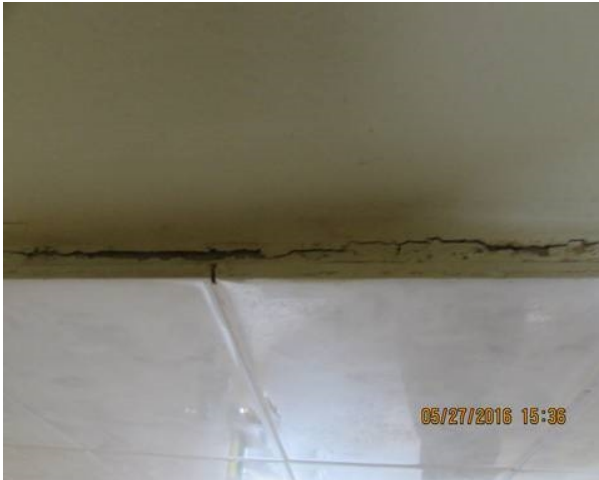
Deteriorating caulking

Replace deteriorated caulking at top of tiles to prevent water entry and related damages.
