**Visual Property Inspection**

115 Craven Rd  
Toronto, ON M4L 2Z4

# Report Commentary

Date: 24-Sep-2016

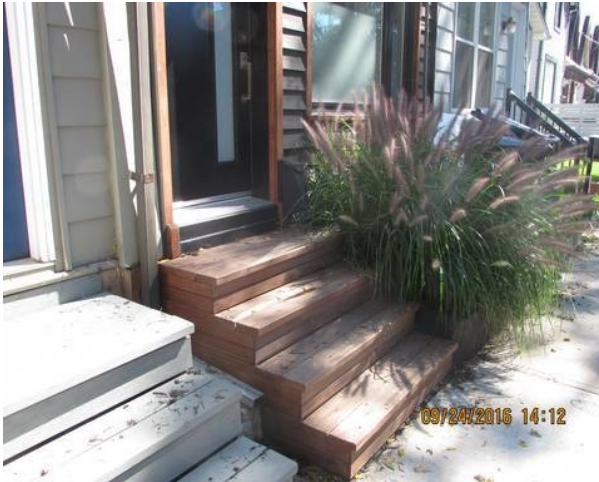
**Front Porch Rail**

Missing handrail

*Install handrail for safety*

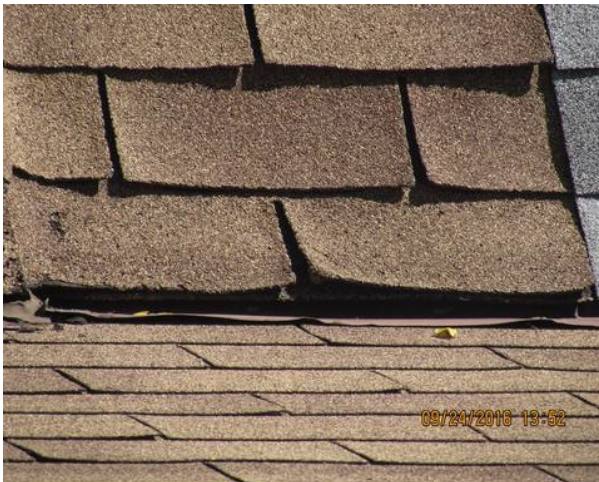
Worn shingles used as siding

*Budget to replace worn shingles above dormer and shingles being used for siding at the front of the house.  
The rest of the shingles appear to be in good condition.*

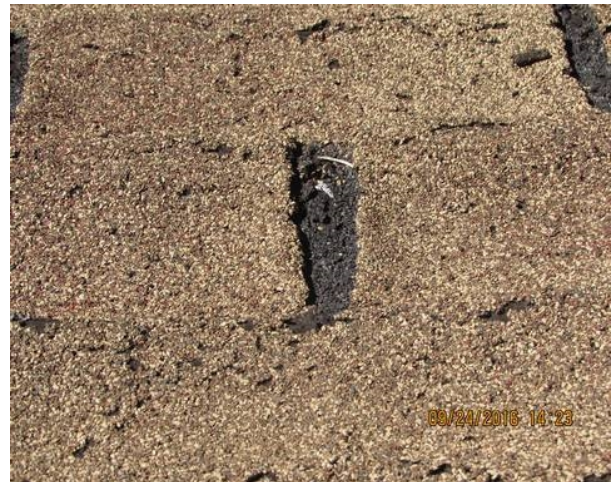
Deteriorated shingles over dormer

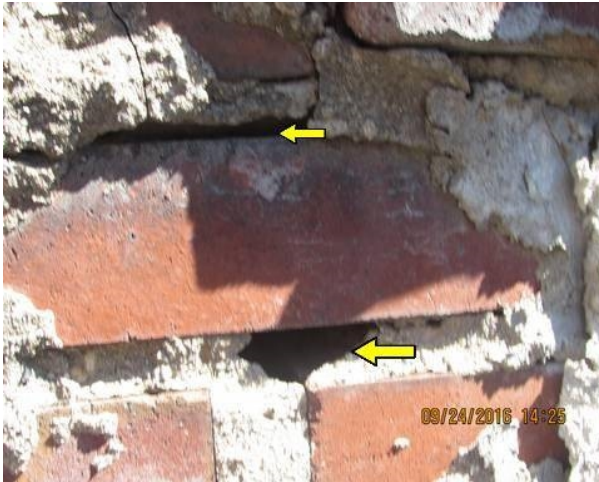
### **Chimney/Vent**

Deteriorated mortar

Repair mortar deterioration to prevent water entry and related damages.

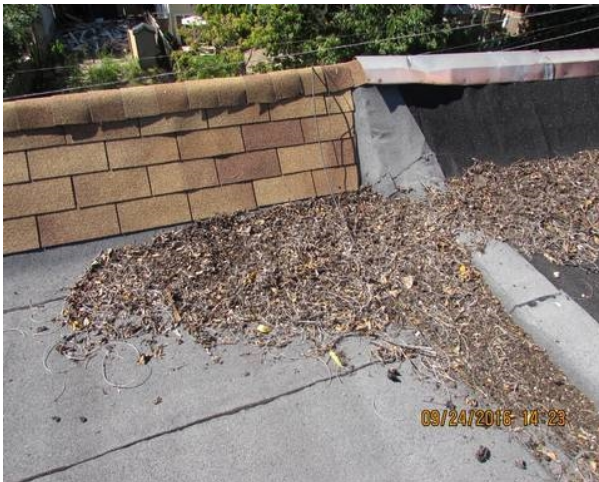
### **Sec. Roof Life Expectancy**

Debris on flat roof

*Torched down membrane over flat roof is in good condition. Remove debris to prolong life. Seller advises it is approximately 8 years old. Typical life expectancy is 10 years. Inspect on an annual basis to maintain performance.*

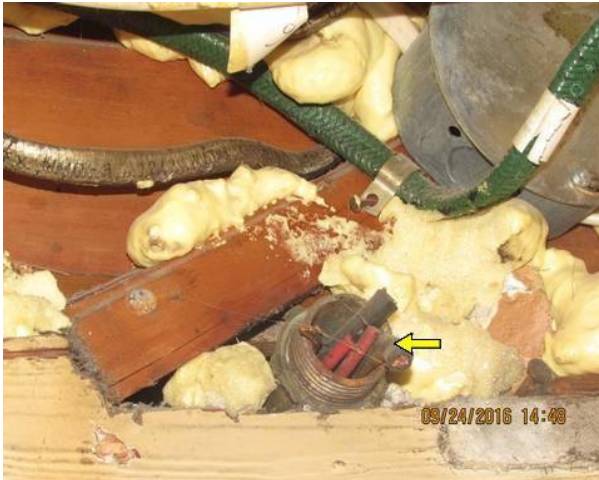
### **Circuit Wires/Receptacles**

Exposed wires

*Terminate exposed wires inside a junction box or remove to prevent hazards from exposed wire.*

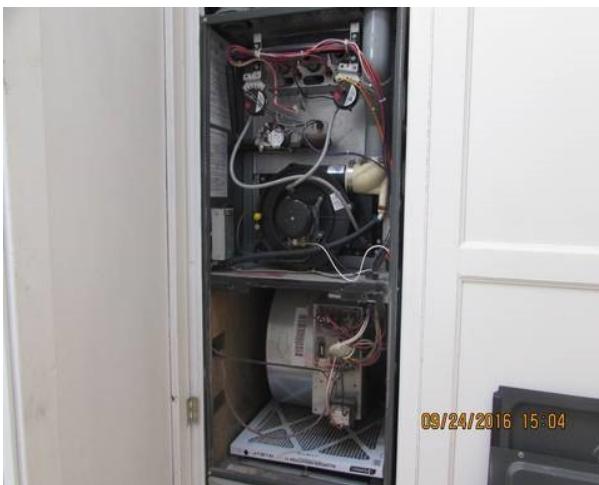
### **Heating System**

*High efficiency furnace is 11 years old and functioning as intended. Typical life expectancy is 20 years.*

High efficiency furnace

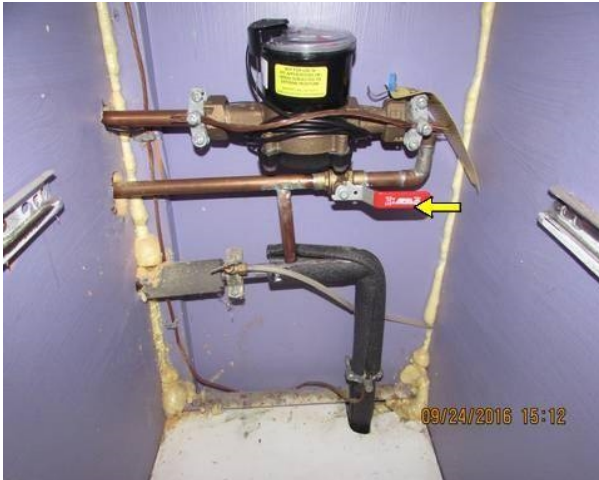
### **Public Supply**

Water meter and main shut off

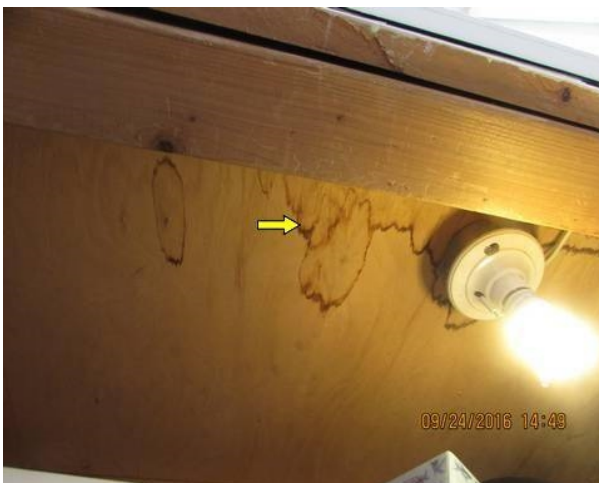
### **Ceiling**

Water stains

Monitor previous staining to ensure leak remains inactive. Dry at time of inspection.

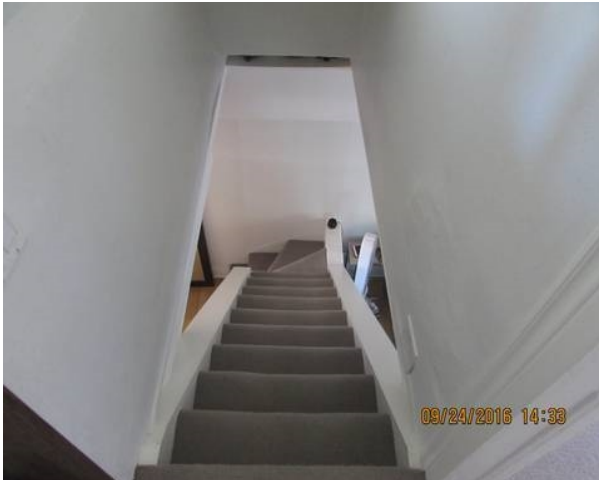
### **Railing**

Missing handrail

Install handrail to promote safety
