## Visual Property Inspection

571 Jones Ave  
Toronto, ON M4J 3H2

Date: 12-Oct-2016

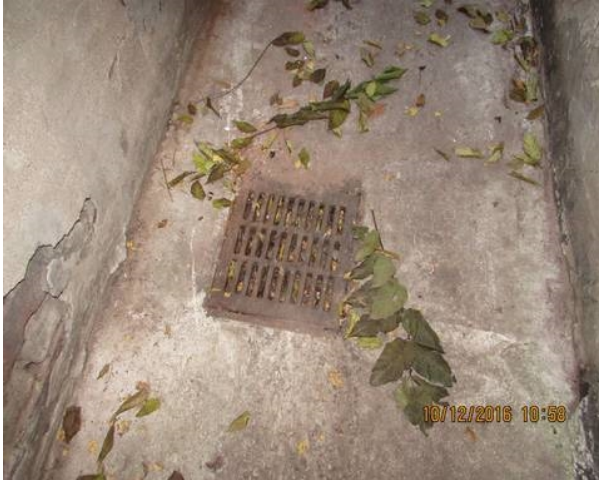
Drain clogged with debris

Clean and clear drain at side of structure to promote drainage

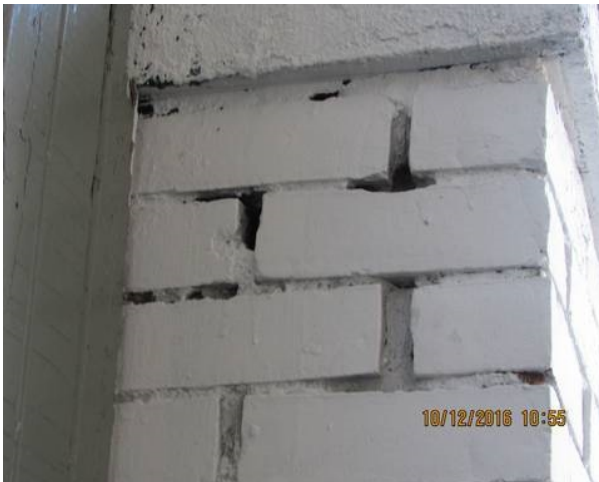
Mortar deterioration at column

Repair porch column mortar and brick deterioration to promote stability.

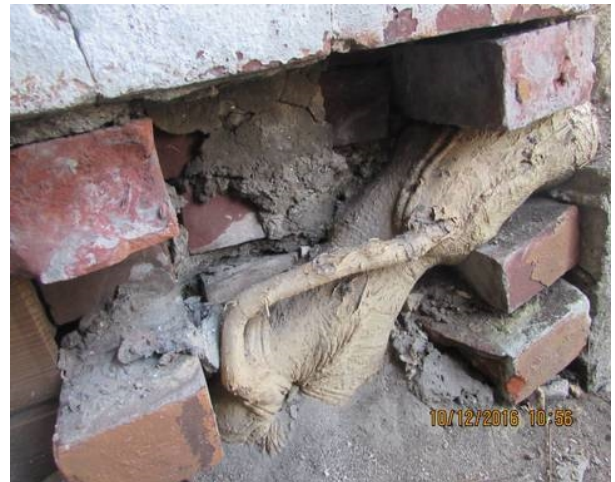
Tree growing out of base of damaged column

Consult a qualified contractor to discuss removal of tree at base of column to prevent further damage. Bricks are missing at bottom of column due to tree growth.

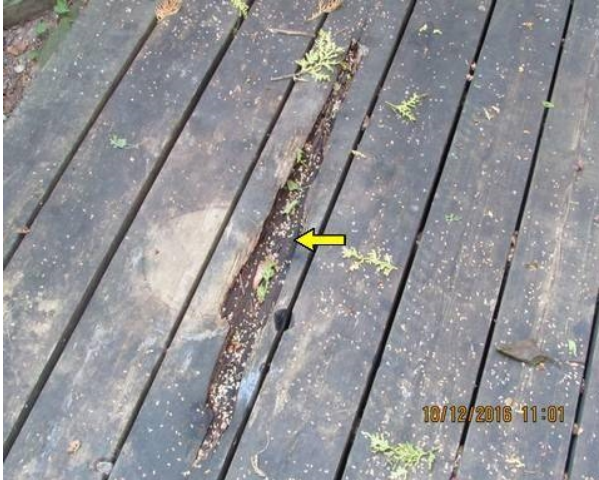
Rotted deck boards

Replace rotted sections of deck to prevent further deterioration.

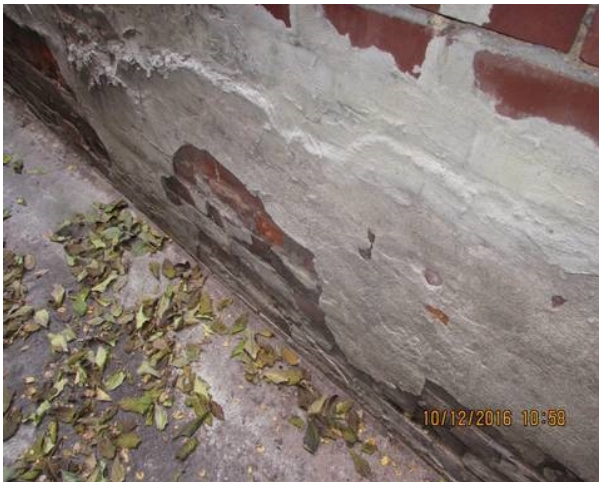
Deteriorated parging

Repair brick and mortar deterioration to prevent water entry and related damages.

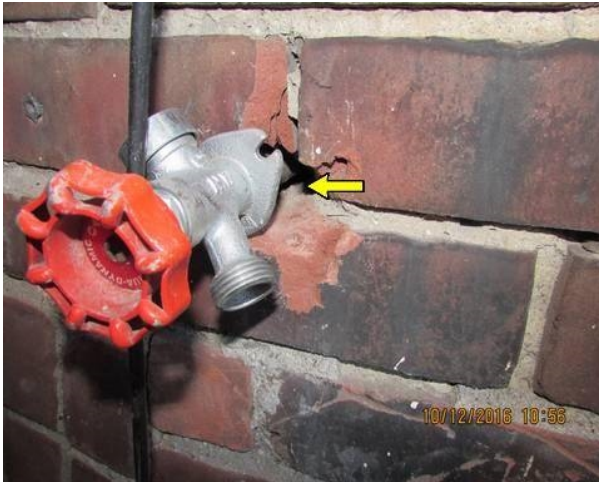
Opening in wall

Fill and seal openings in brick to prevent pest entry.

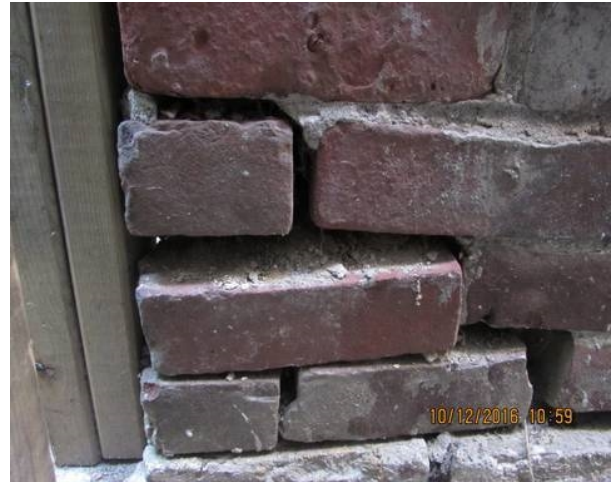
Mortar deterioration

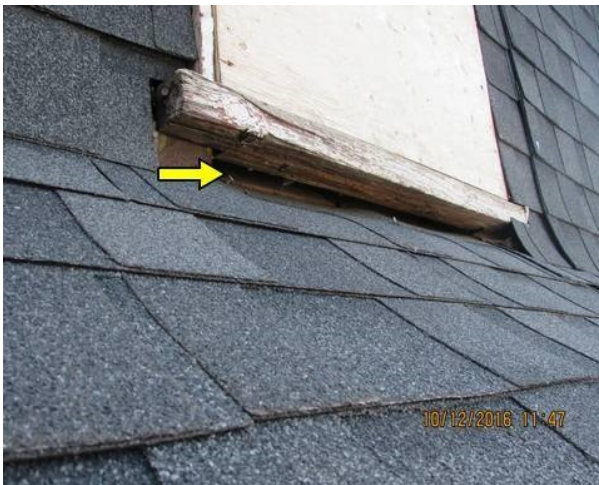
Opening under boarded up attic window

Install flashing under attic window opening to prevent water and pest entry and related damages.

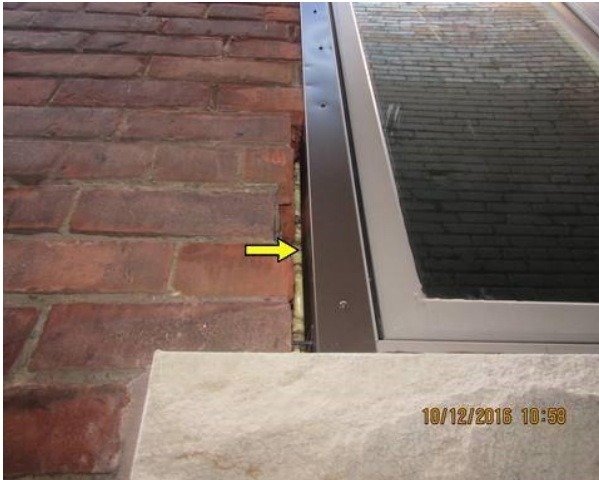
Opening at window

Fill and seal opening around window or install flashing to prevent water entry.

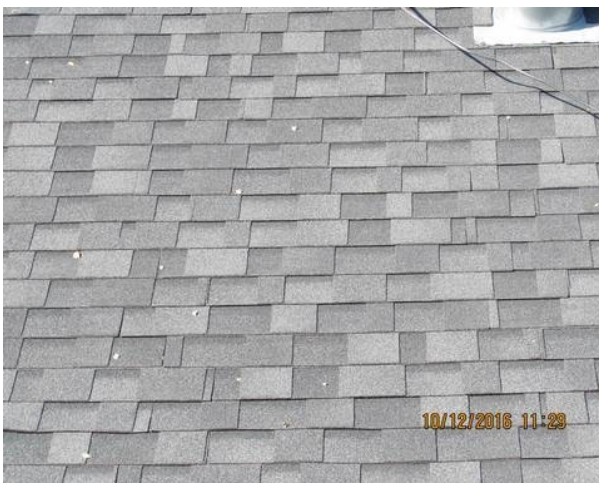
Shingles

*Shingles are in good condition.*

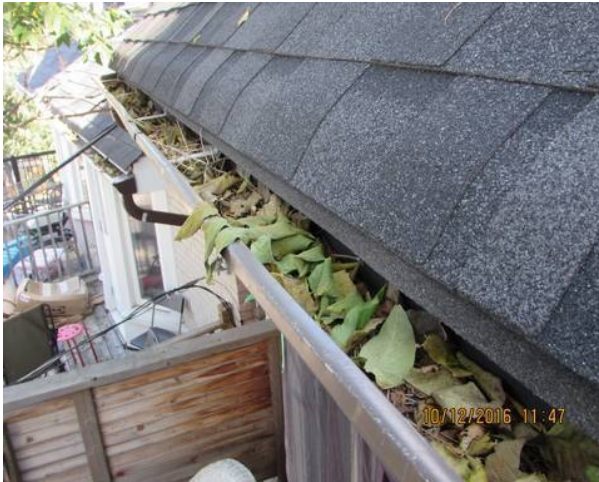
Gutters full of debris

Clean and maintain gutter system to promote drainage toward downspout.

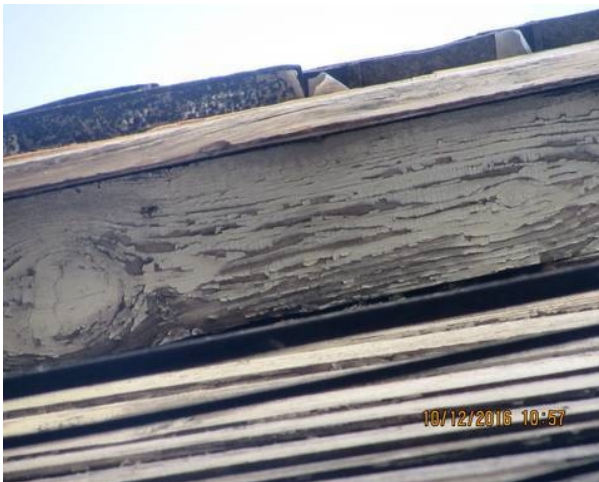
Peeling paint on soffit

Paint boards for weathering protection.

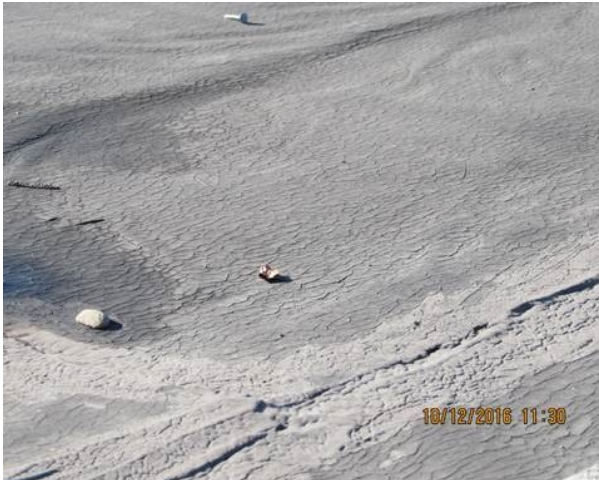
Deteriorated flat roof membrane

*Budget to replace flat roof membrane to prevent water entry.*

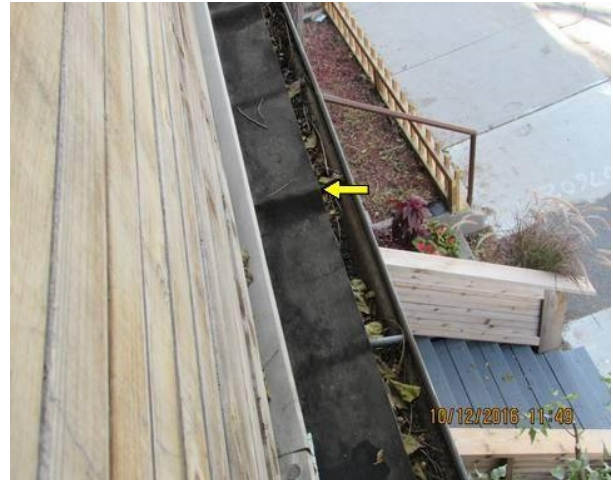
Buckled membrane under second floor decking at front of house

*Budget to replace flat roof membrane under decking at the front of the house. It is buckling.*

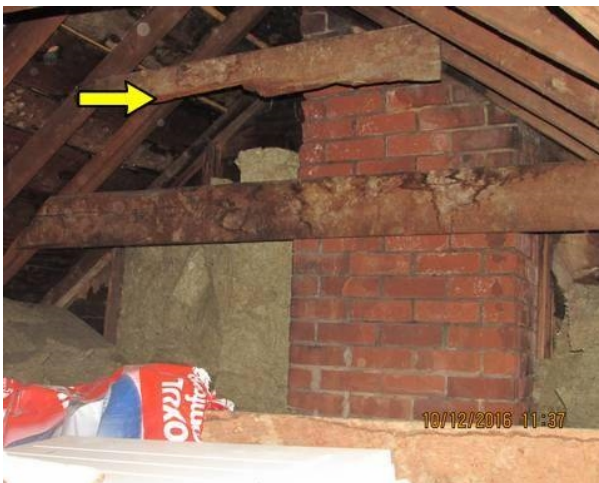
Damaged board

Replace damaged support in attic to promote stability

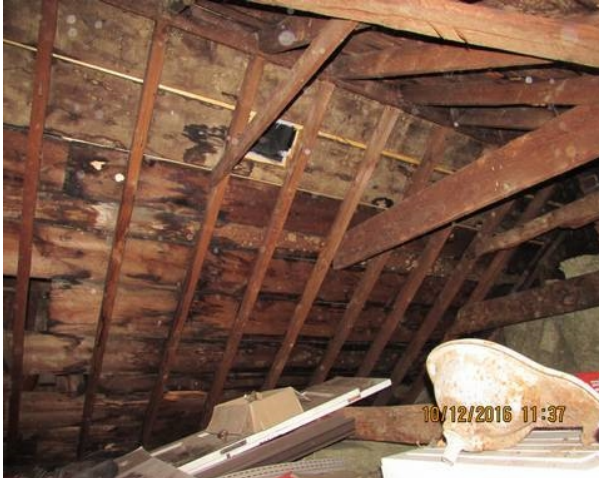
Staining on sheathing

Monitor staining to ensure leak(s) remain inactive. Attic was dry at time of inspection. Seller advises there was a leak in the attic and new shingles were installed after.

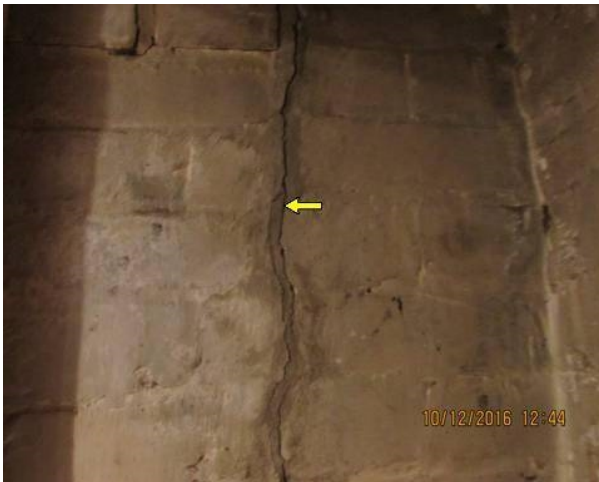
Crack in wall

Fill and seal cracks to prevent further separation.

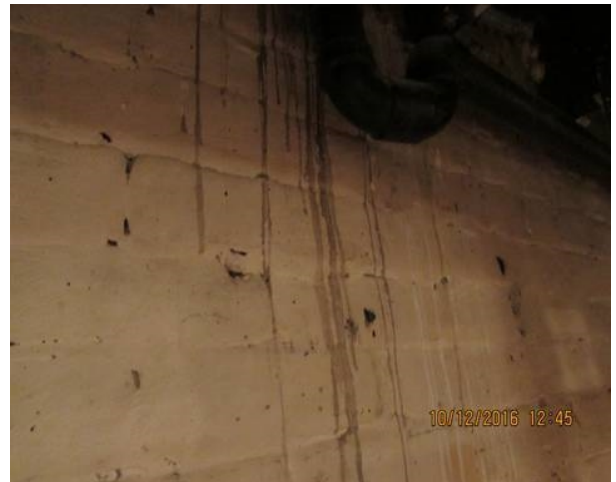
Staining on wall

Monitor stains to ensure leak remain inactive . No moisture evident at the time of inspection.

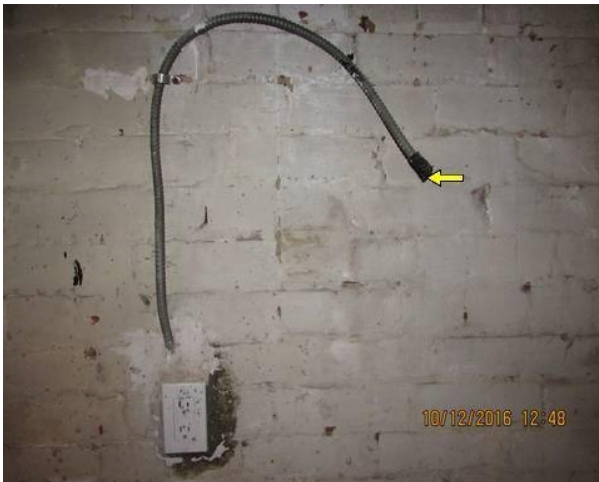
Exposed wire

- Replace defective GFCI receptacle in powder room*
- Install covers on junction boxes and outlets*
- Could not locate main ground*
- Could not locate bonding to gas and water lines*
- Terminate unused wires inside a junction box or remove*
- Provide filler pieces at knockout locations at panel*

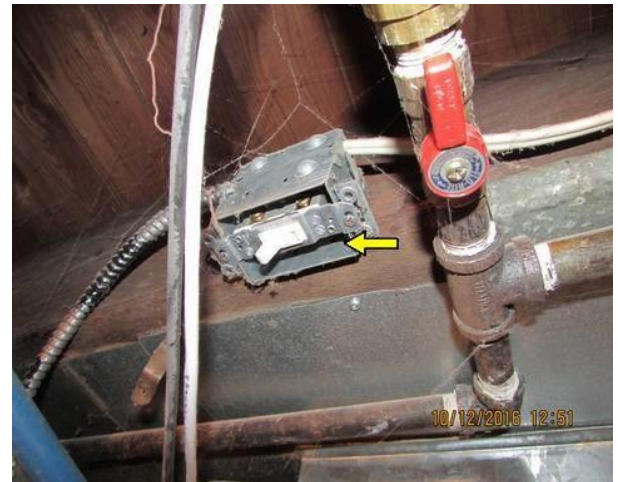
Missing cover

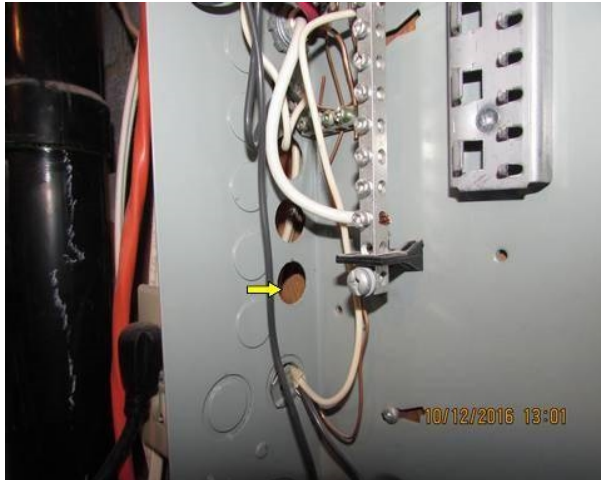
Knockouts exposed

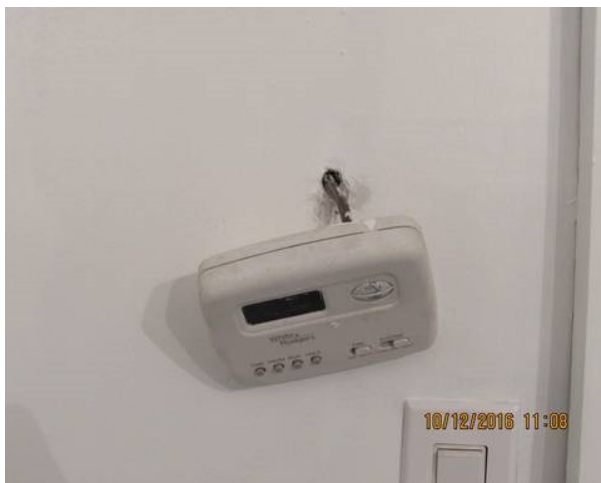
Unsecured thermostat

Secure thermostat to reduce damages due to stress on internal components and wiring.

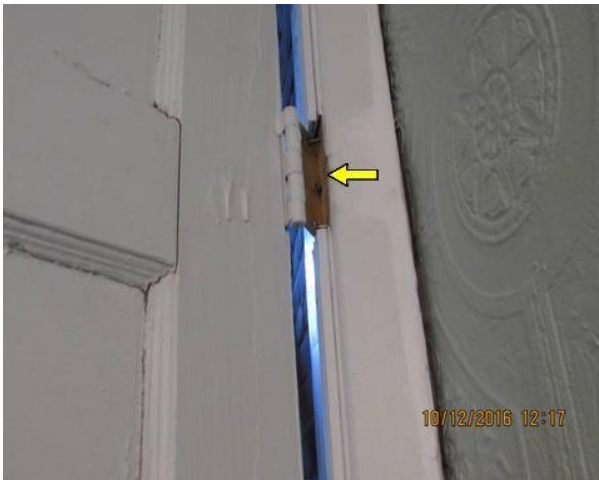
Damaged door

Repair door to second floor to regain function.
