Visual Property Inspection

119 Craven Rd
Toronto, ON M4L 2Z4

Report Commentary

Date: 04-Jan-2016

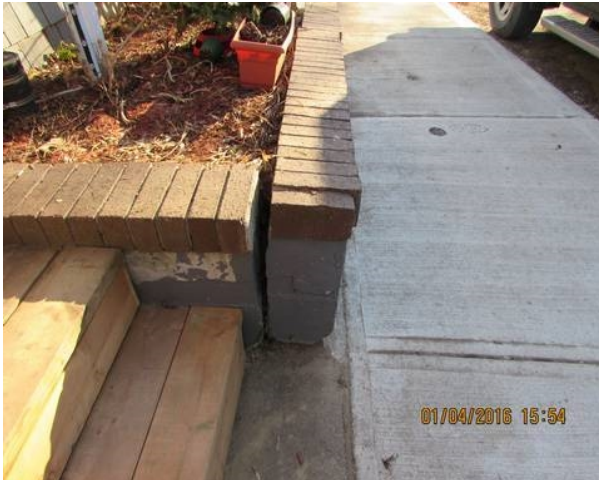
Retaining Wall

- Wood Metal Concrete Leaning slightly - Typical

Retaining wall leaning slightly

Monitor retaining wall movement and correct as required to reduce potential safety hazards

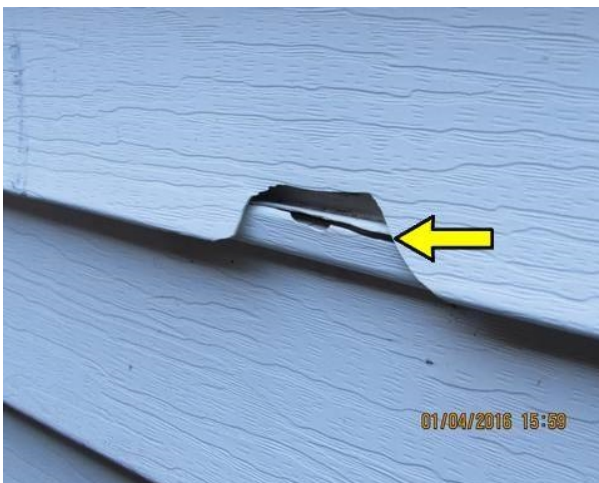
Exterior Walls

Damaged siding

Repair siding to prevent water and pests penetrating and related damages.

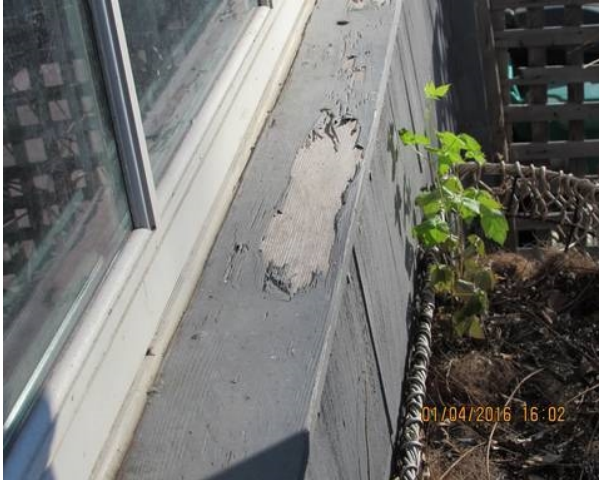
Window Exterior

Paint wood trim

Maintain wood windows/trim work to reduce deterioration

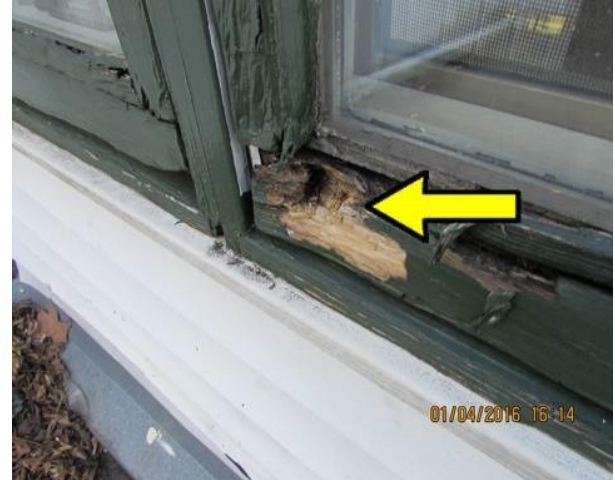
Further investigate extent of window frame rot and replace as required. Window frame at the rear of the house shows substantial rot/deterioration.

Rotted window frame

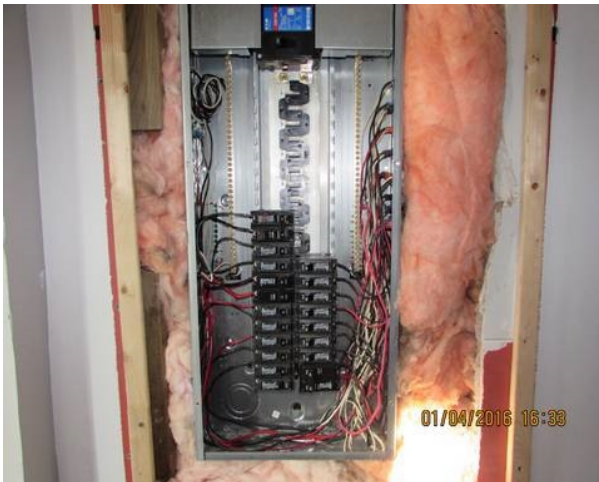
Distribution Panel

200 amp service, copper wire.

200 Amp electrical panel

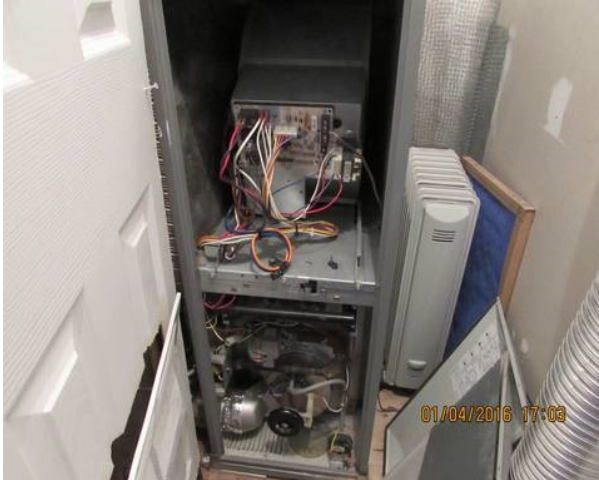
Heating System

Mid efficiency furnace is 8 years old. Typical life expectancy is 20 years. Functioning as intended at time of inspection.

Furnace

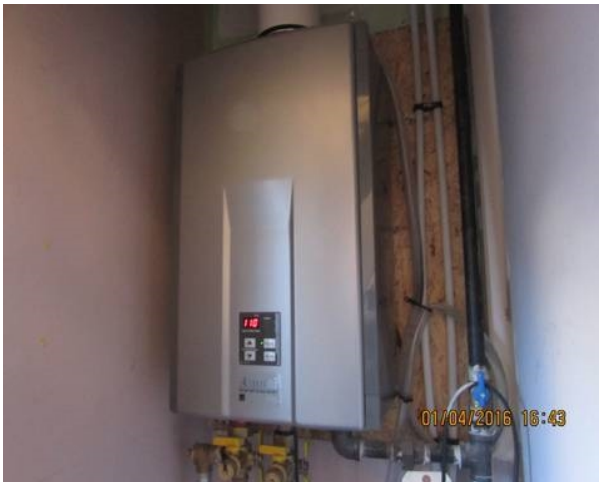
Hot Water Tank

Hot water on demand system is 5 years old. Functioning as intended at time of inspection. See additional information at the end of the report.

Tank less hot water system

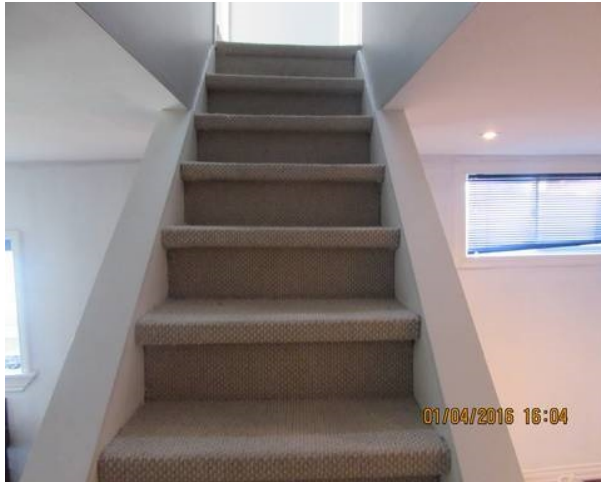
Railing

Missing handrail

Install handrail to promote safety
