Visual Property Inspection

89 Walpole Ave
Toronto, ON M4L 2J2

Date: 20-Aug-2015

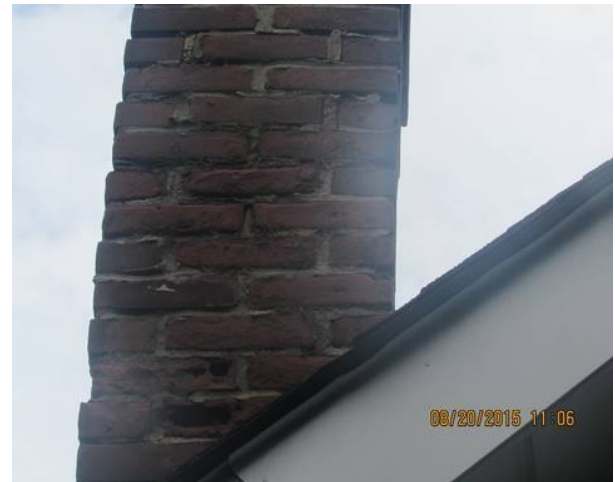
Leaning chimney

Consult a structural contractor to provide methods of chimney restoration to reduce further leaning/movement and potential risk of collapse.

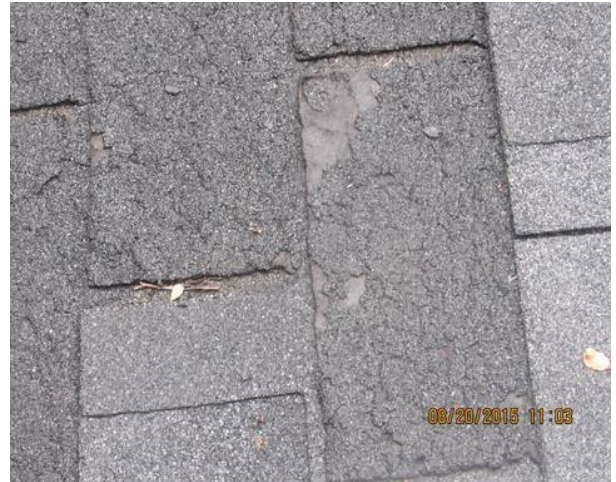
Sec. Roof Life Expectancy

Budget to replace shingles on back extension over kitchen . Shingle material has exceeded typical life expectancy.

Deteriorating shingles over kitchen

Budget to replace shingles on back extension over kitchen . Shingle material has exceeded typical life expectancy.
