Visual Property Inspection

3157 St. Clair Ave E
Toronto, ON M1L 1V5

Date: 14-Apr-2016

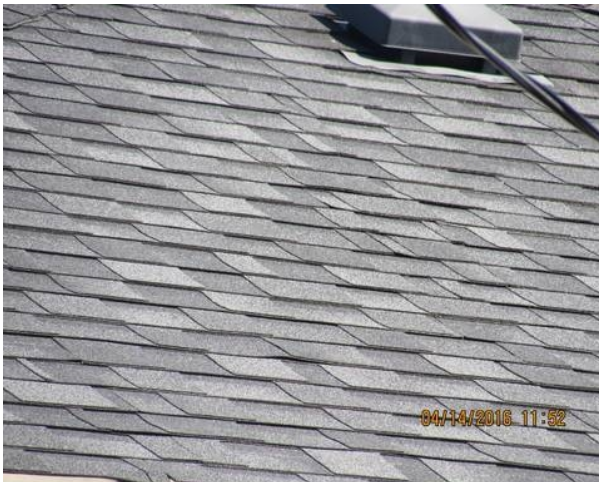
Architectural shingles are in good condition. Typical life expectancy is 25 to 30 years for this type of shingle.

Roof covering

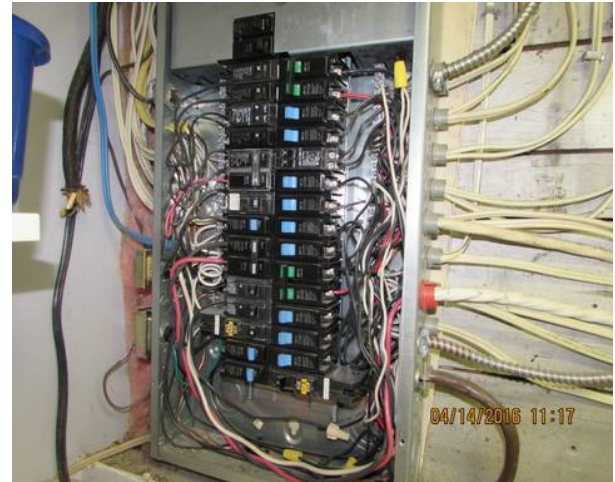
Electrical panel

Consult qualified electrician to correct various safety hazards incomplete/incorrect connections noted. A partial list is as follows:

- *Replace defective GFCI receptacle on the exterior*
- *Install covers on all junction boxes and switch boxes*
- *Install a ground clamp at the water main*
- *Terminate or remove exposed wire*
- *Secure loose wires*

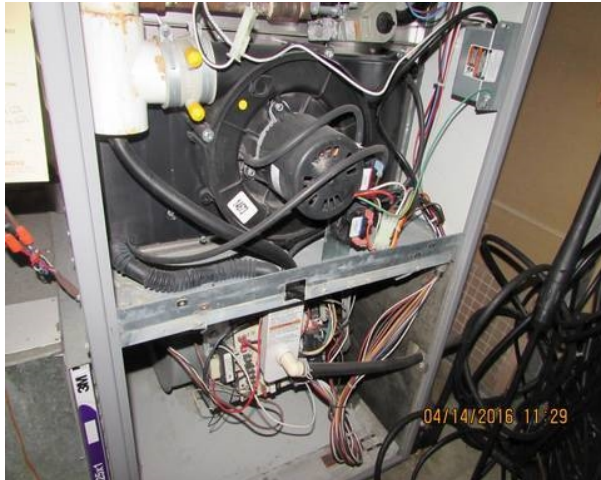
High efficiency furnace is 9 years old and functioning as intended at time of inspection. Typical life expectancy is 20 years.

High efficiency furnace

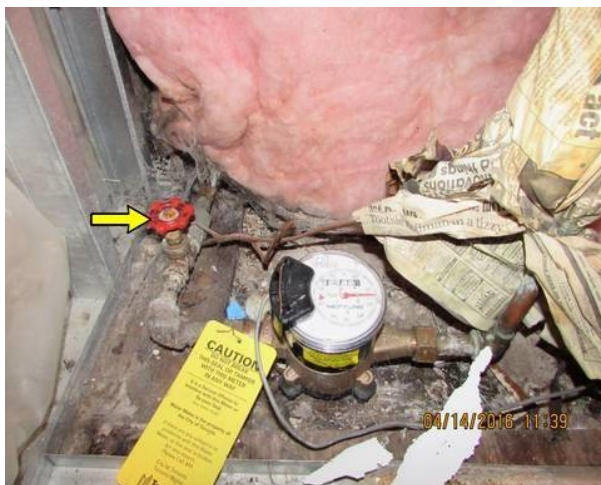
Water meter and main shut off

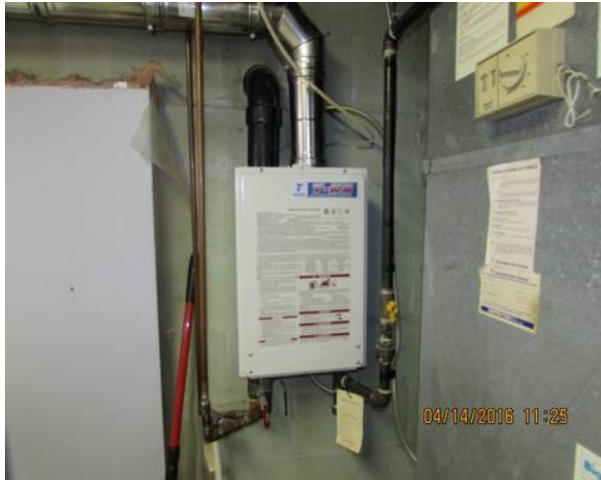
Tankless on demand water heater

Install a dielectric fitting on the hot water outlet to prevent further corrosion of the copper pipe to prevent eventual failure and water damage.
