Visual Property Inspection

102 Knox Ave
Toronto, ON M4L 2P2

Report Commentary

Date: 16-Oct-2015

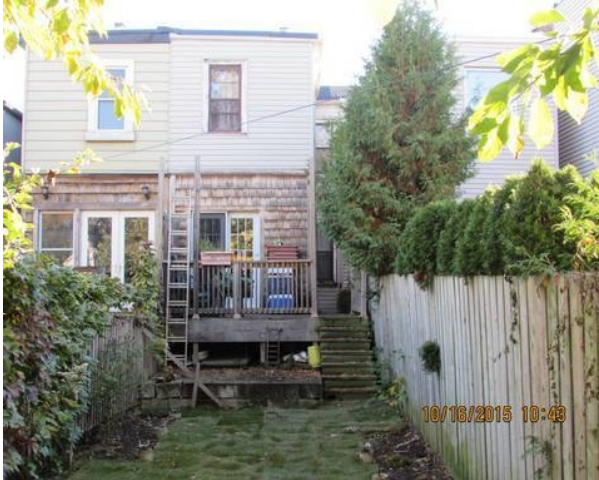
Front Porch

- Floor boards are not attached to the joists under porch
- Support beams are not level under porch
- The rear deck is not anchored to the house instead the ledger board appears to be nailed.

Rear image

Consult a qualified carpenter to determine stability/effectiveness of support system for the front porch and the rear deck. A partial list of defects include:

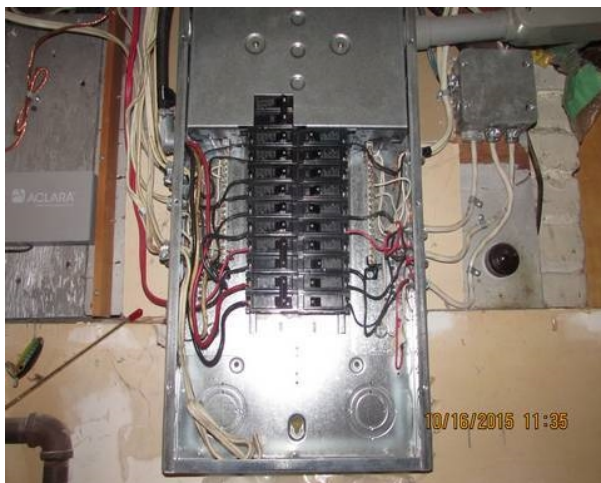
Electrical Panel

Consult qualified electrician to correct double tapped connections to reduce hazards associated with over fusing.
