Visual Property Inspection

9 Homeview Ave
Toronto, ON M6N 1S9

Report Commentary

Date: 18-Mar-2016

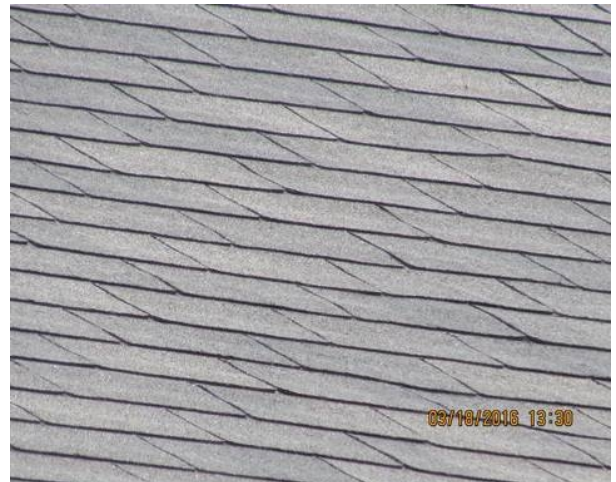
Roof covering

Shingles typically last 15 years. These shingles are in the last 3rd of their life. Inspect on an annual basis and replace as required.

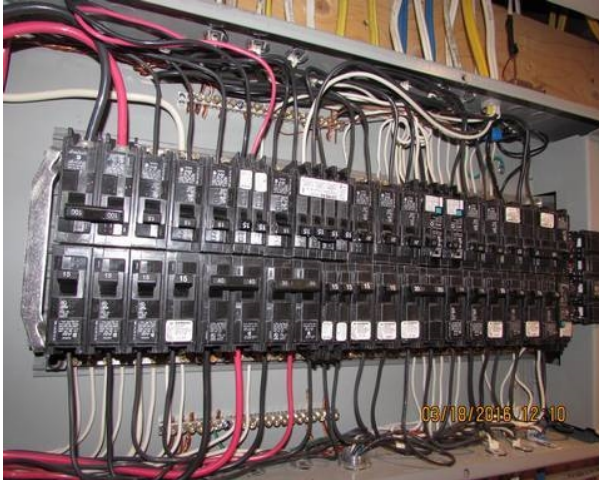
Electrical panel

200 amp service, copper wire.
