**Visual Property Inspection**

3157 St. Clair Ave E  
Toronto, ON M1L 1V5

# Report Commentary

Date: 14-Apr-2016

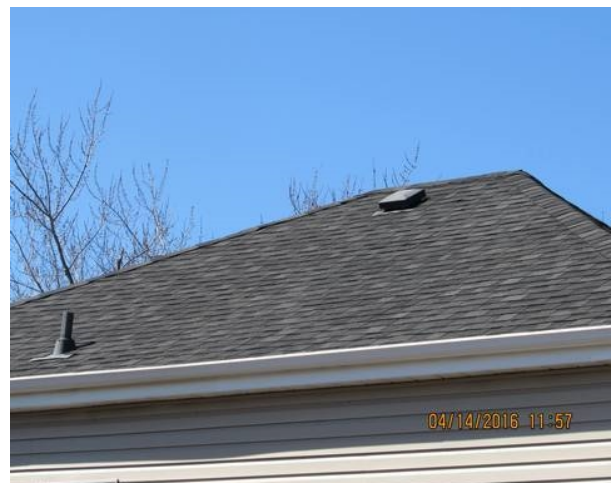
Roof covering

Architectural shingles are in good condition. Typical life expectancy is 25 to 30 years for this type of shingle.

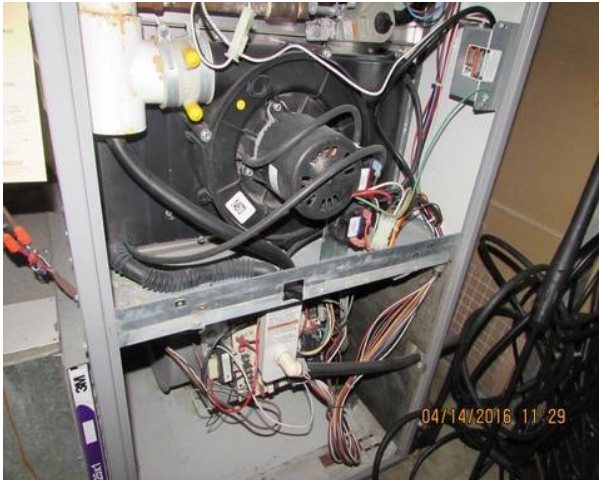
High efficiency furnace

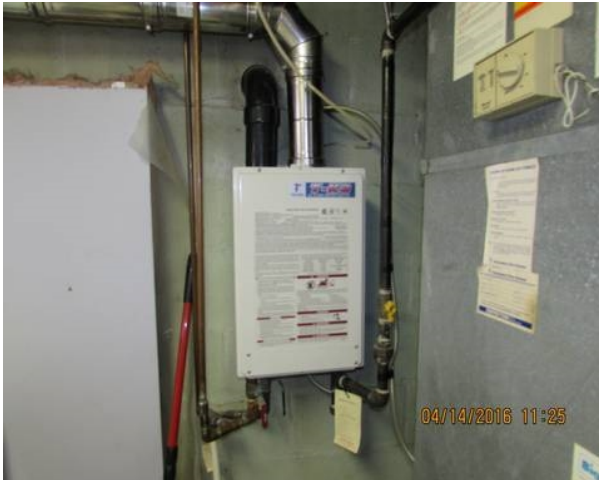
Tankless on demand water heater

Install a dielectric fitting on the hot water outlet to prevent further corrosion of the copper pipe to prevent eventual failure and water damage.
