Visual Property Inspection

662 Sammon Ave
Toronto, ON M4C 2E2

Date: 23-Apr-2016

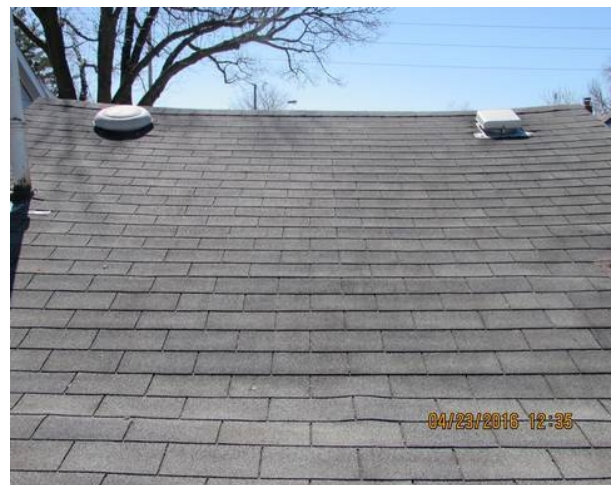
Roof covering

Shingles are in their last 3rd of there life expectancy. Monitor on an annual basis and replace as required.

Shingles just starting to cup and curl

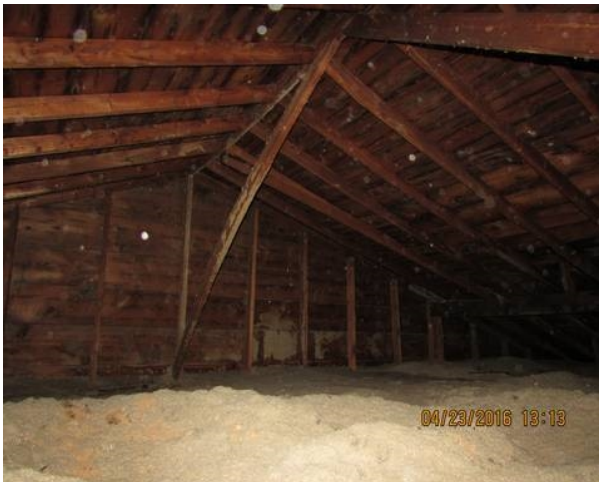
Attic

Monitor water staining on beams and boards and correct as required. Insulation was dry at time of inspection.

Insulate and weatherstrip hatch to limit the amount of moisture from entering attic space .

Install additional roof vents to promote attic ventilation and reduce attic moisture/condensation related damages.

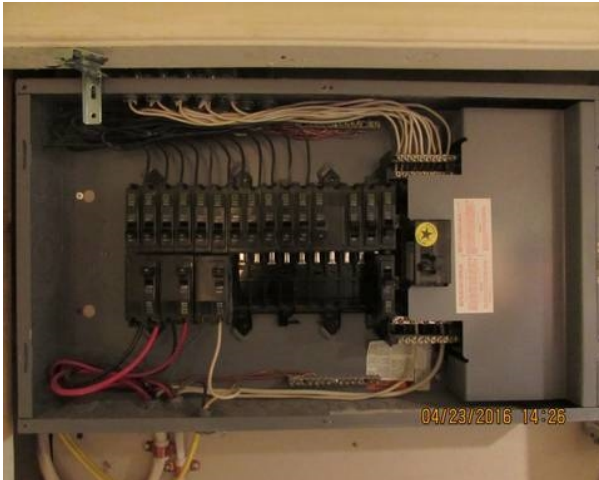
100 amp service, copper wire.

Distribution panel

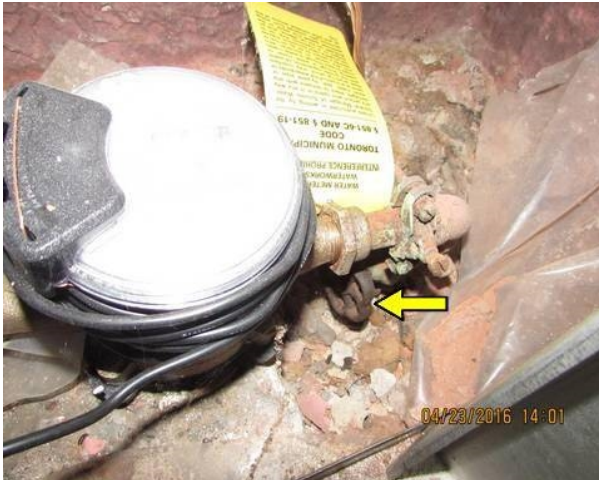
Water meter and main shutoff
