## Visual Property Inspection

571 Jones Ave  
Toronto, ON M4J 3H2

Date: 12-Oct-2016

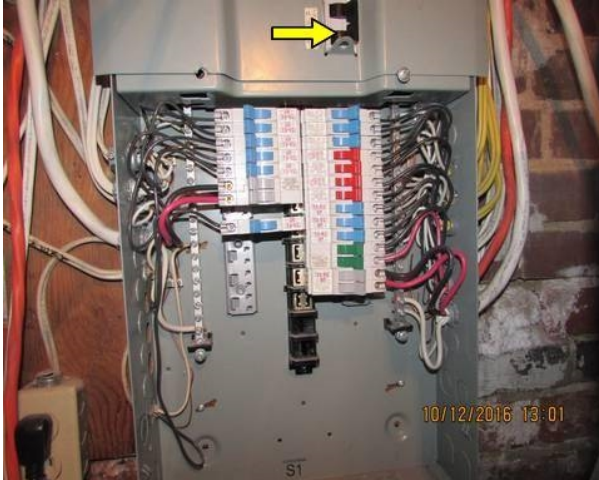
**Electrical Service**  
**Distribution Panel**

Electrical panel and main shut off

*Consult qualified electrician to evaluate various safety hazards incomplete/incorrect connections noted. A partial list is as follows:*

- Replace defective GFCI receptacle in powder room*
- Install covers on junction boxes and outlets*
- Could not locate main ground*
- Could not locate bonding to gas and water lines*
- Terminate unused wires inside a junction box or remove*
- Provide filler pieces at knockout locations at panel*

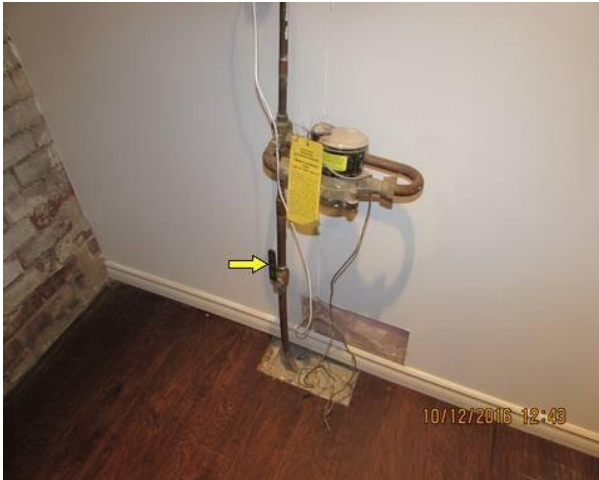
**Public Supply**

Water meter and main shut off
